Roof Inspection Report

HCI Number 201505203

Meals On Wheel—McKinney
600 North Tennessee Street
McKinney, TX 75069

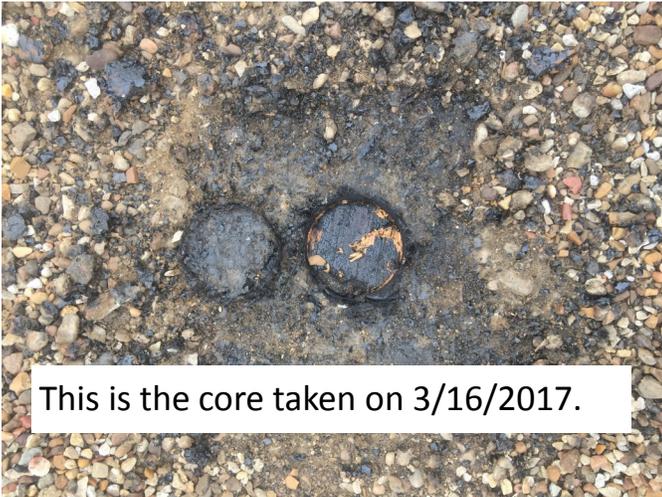
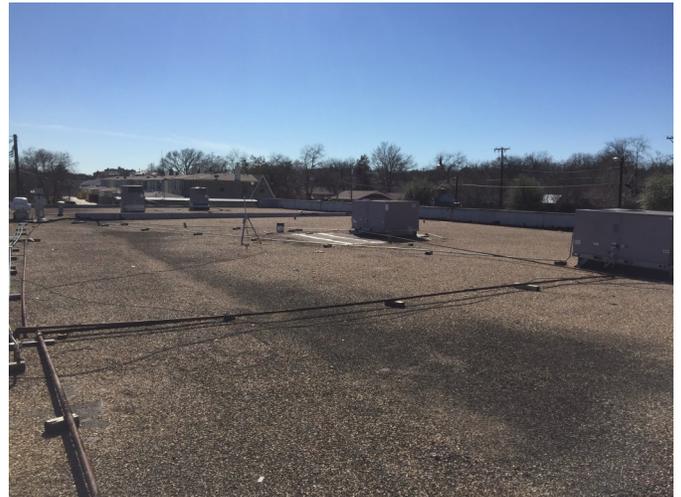
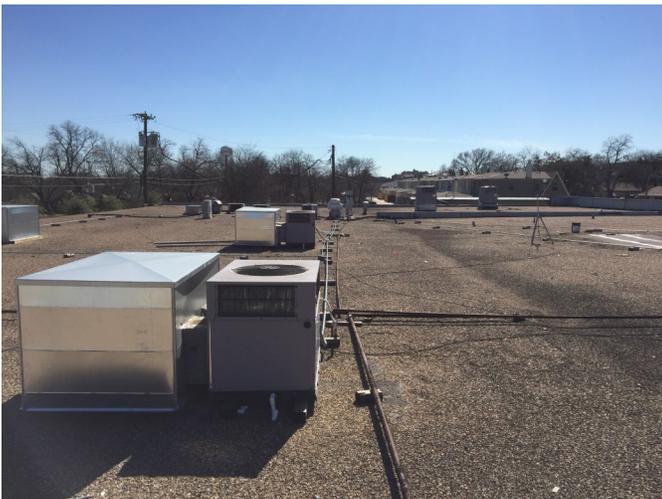
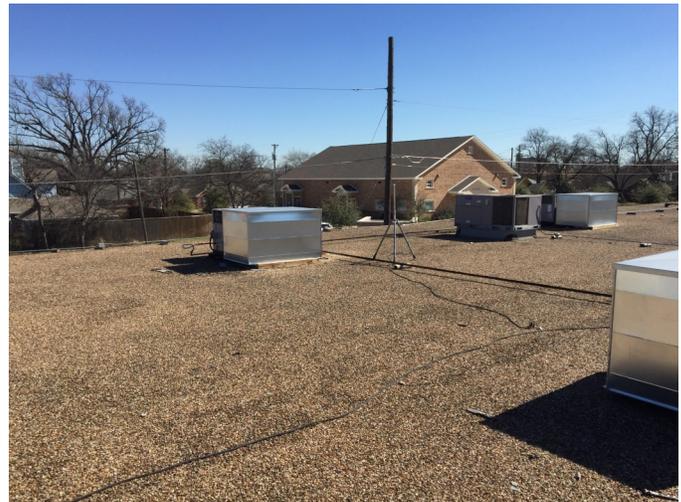
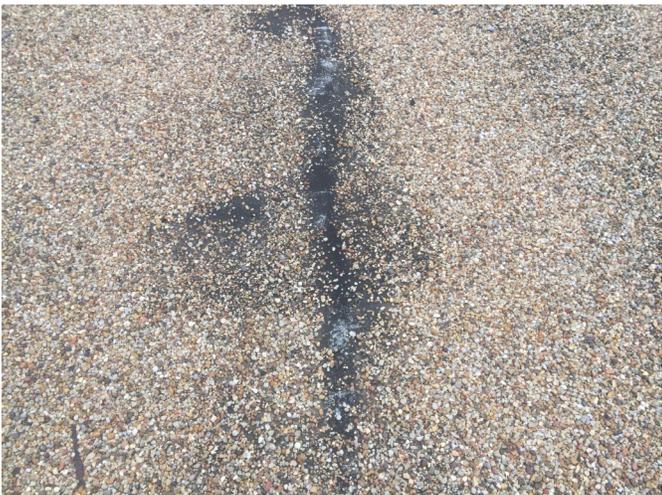
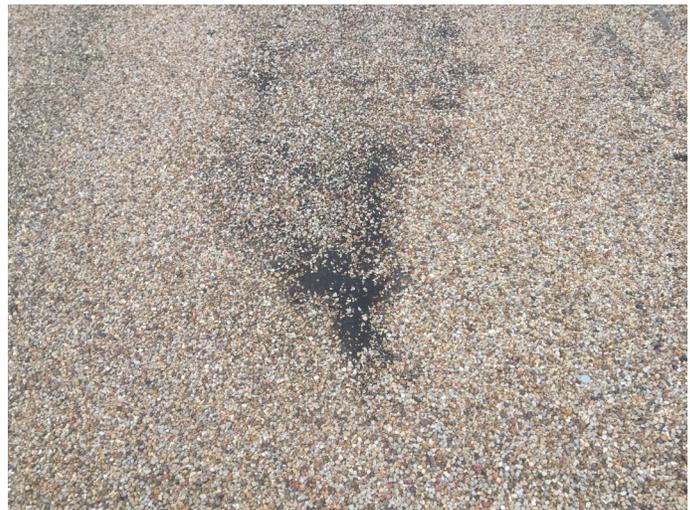
The roof system is in poor condition and is very old.

The parapet walls need to be flashed. The joints have been repaired and are coming apart. The coping cap has been repaired with a self-adhering cover strip. It is weathered and the fasteners are backing out.

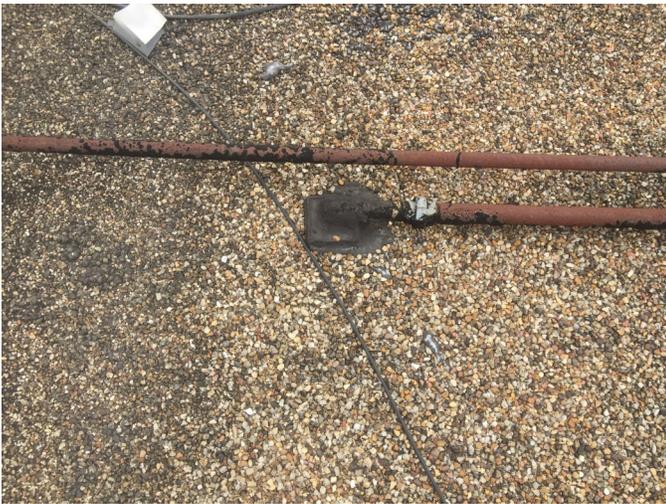
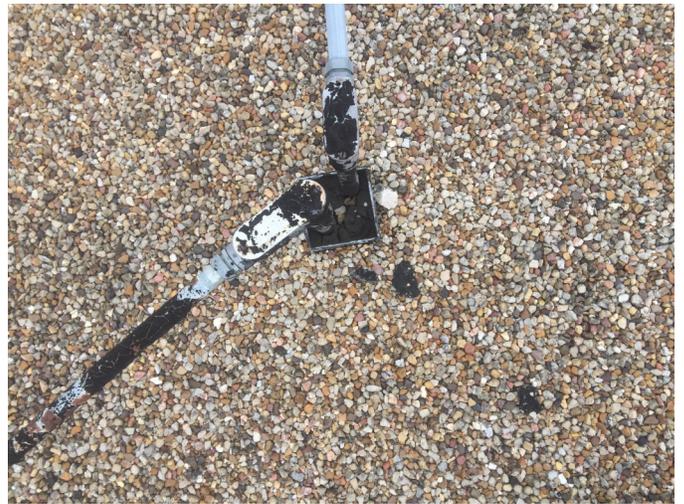
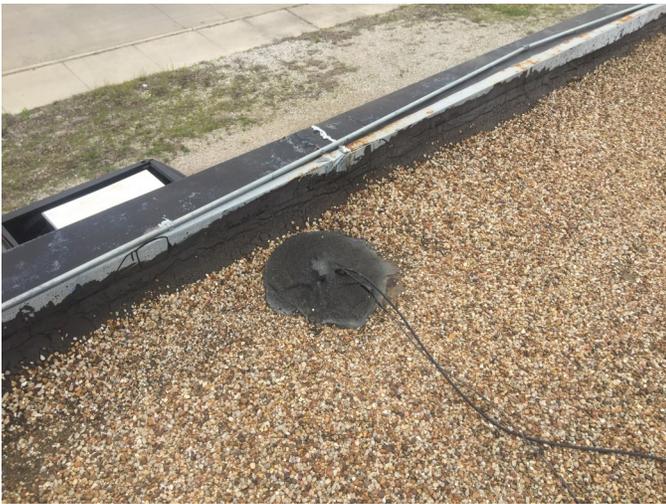
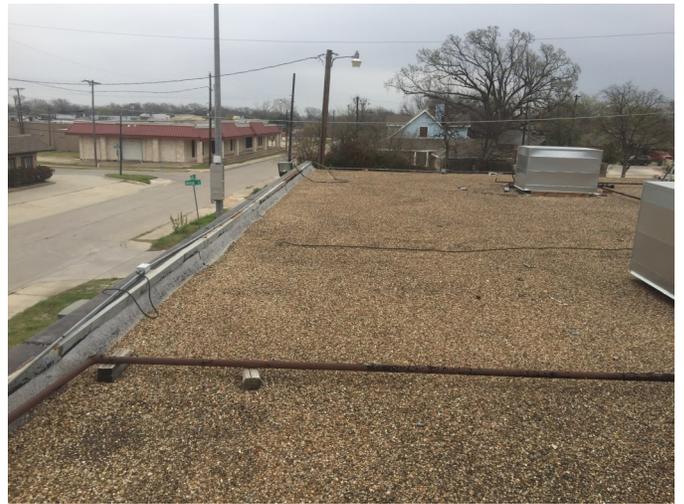
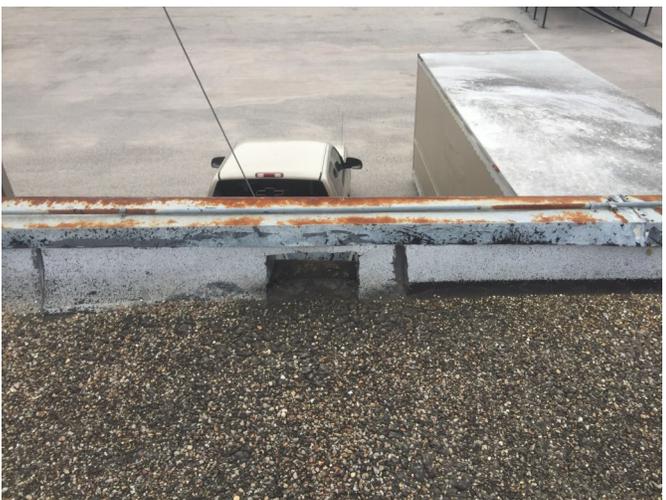
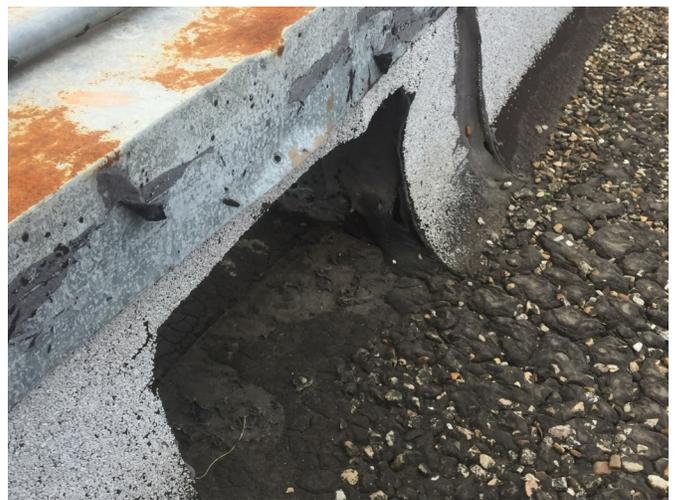
Below are more pictures of worn out penetrations.

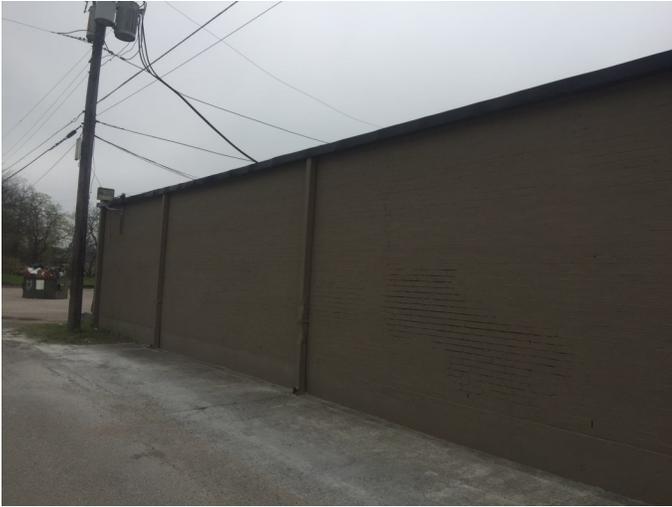
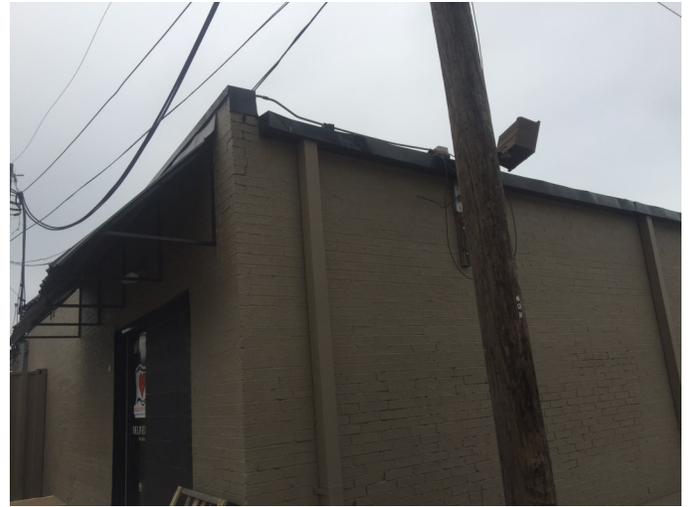
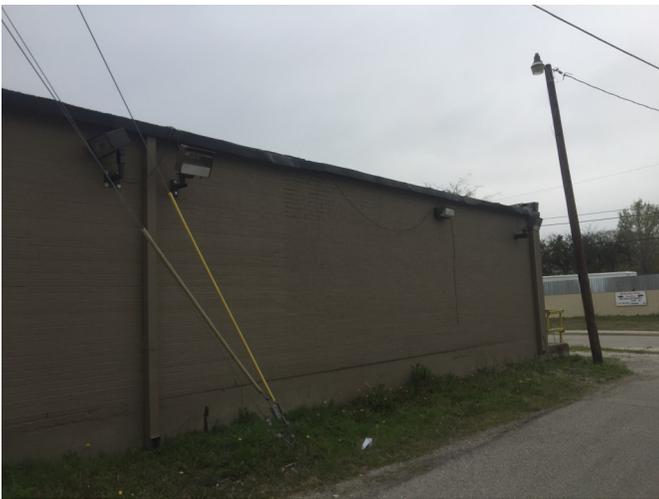
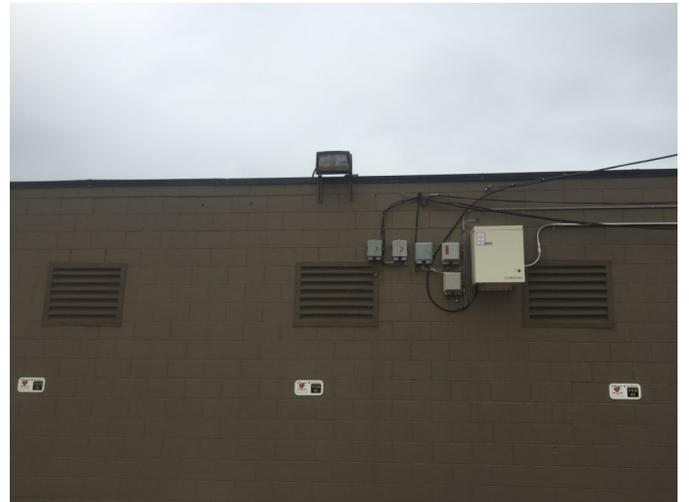
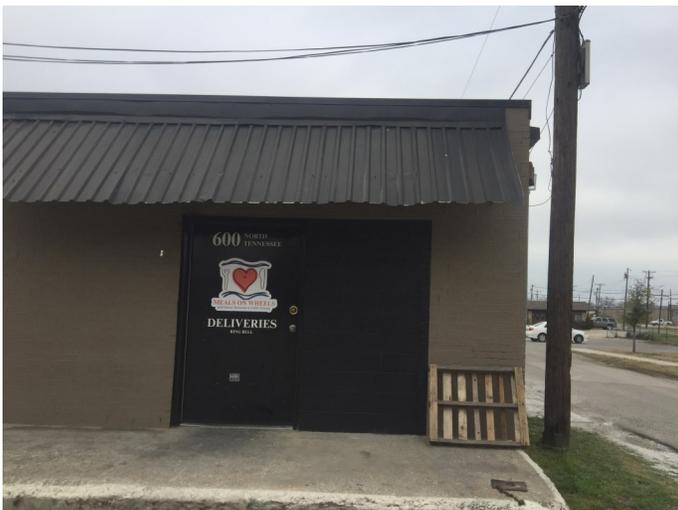
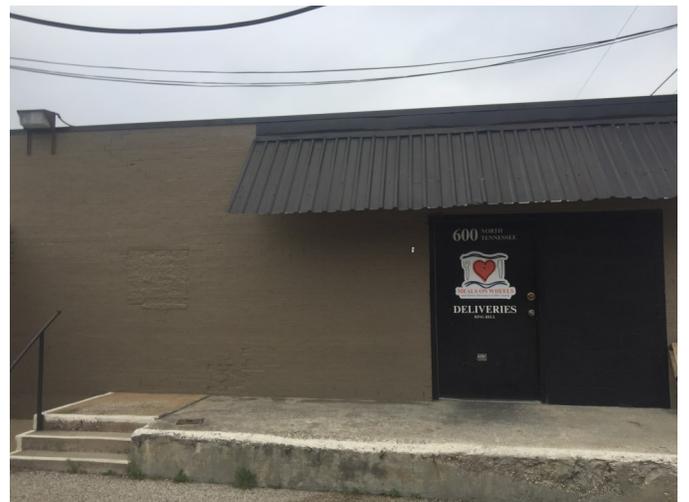
Below are the pictures of the metal. The copings are worn and need to be replaced or repaired. The gutter is made of light gauge metal. That is the likely cause of the bending. It can be terminated into or replaced. The metal awning around the front of the building appears to be in average condition.
