**INVOICE #195**

209 E Louisiana Street, 209 E Louisiana Street Mckinney, TX

**WORK PERFORMED:**

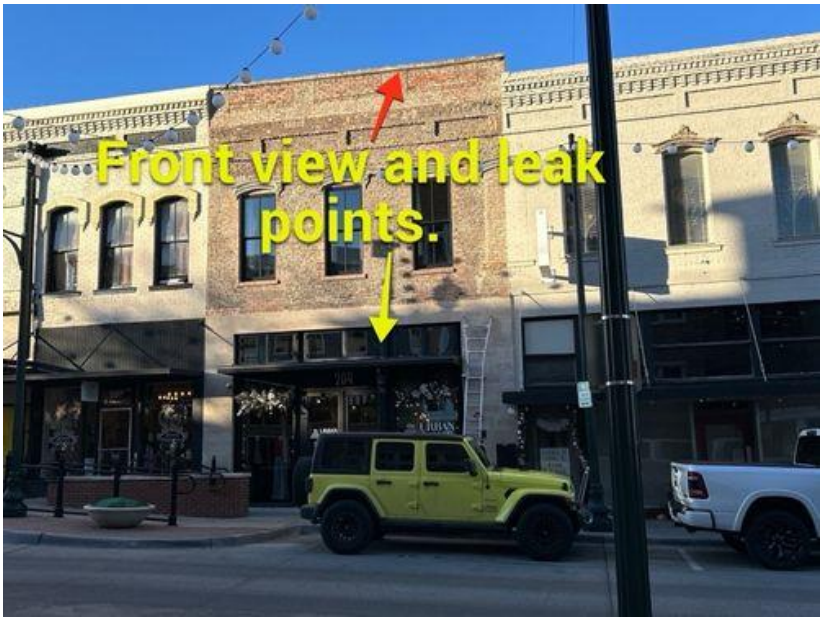
Label	Title	Type	Sub Type	Comments
A	URGENT - Leak on top floor near the front exterior wall.	Inspection Defects		URGENT - Leak on top floor near the front exterior wall.

Red arrow shows the third floor leak area.

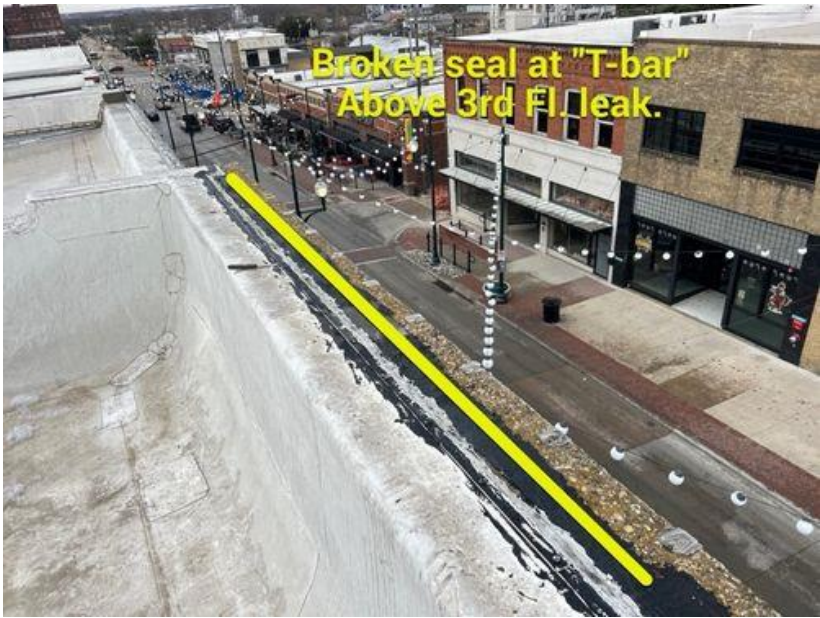
Above the third floor leak we found bad sealant on top of the parapet wall where the TPO transitioned back to stone. We removed the sealant along the length of the termination bar, cleaned the debris, primed and applied new sealant. THESE ISSUES HAVE BEEN COMPLETED.

Termination/transition point with bad seal.

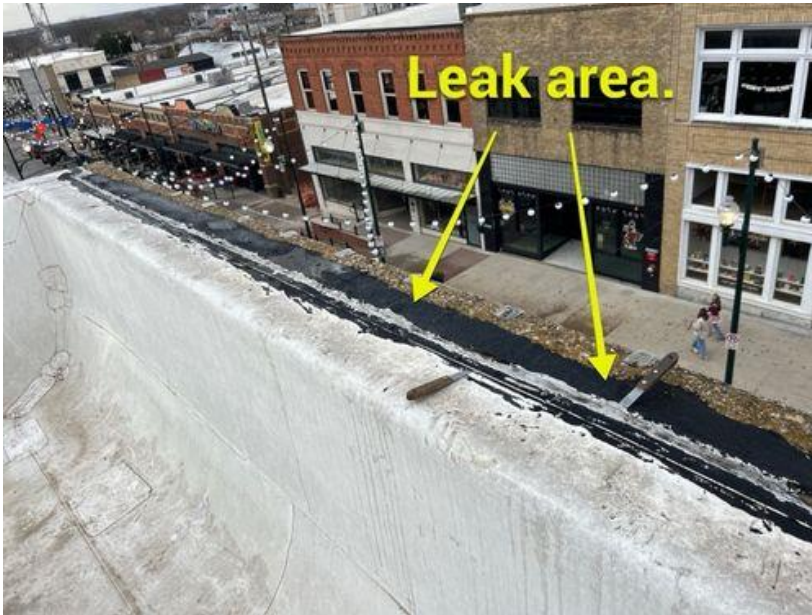
Point above leak on the third floor.

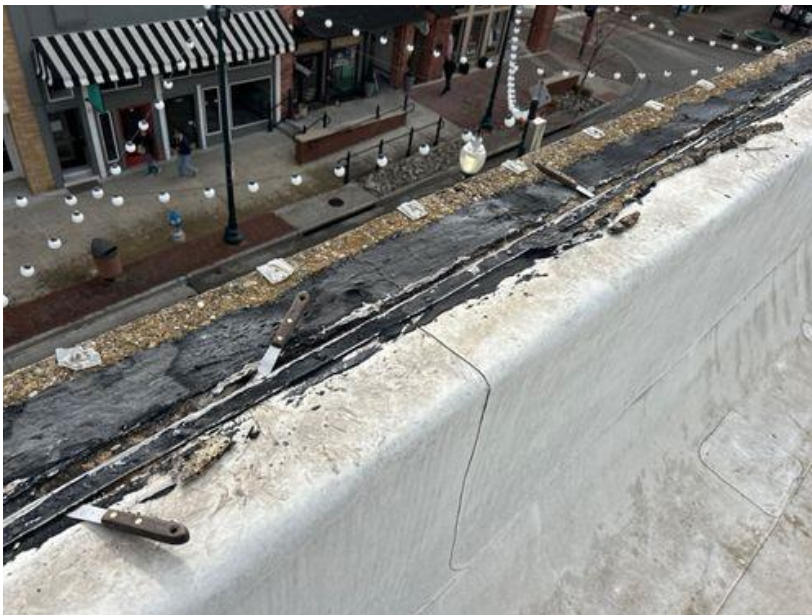
Several points for water infiltration.

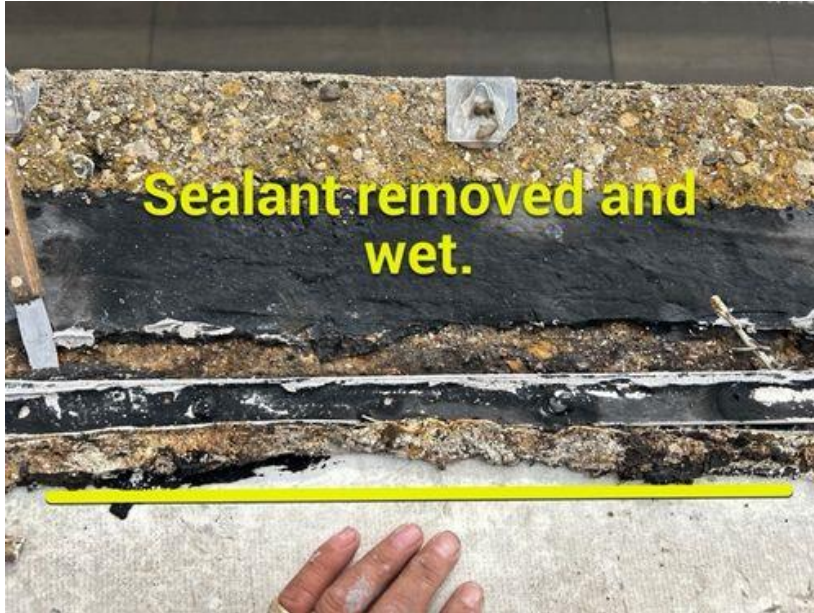
**Sealant removed and wet.**

Bad sealant removed and is wet underneath.

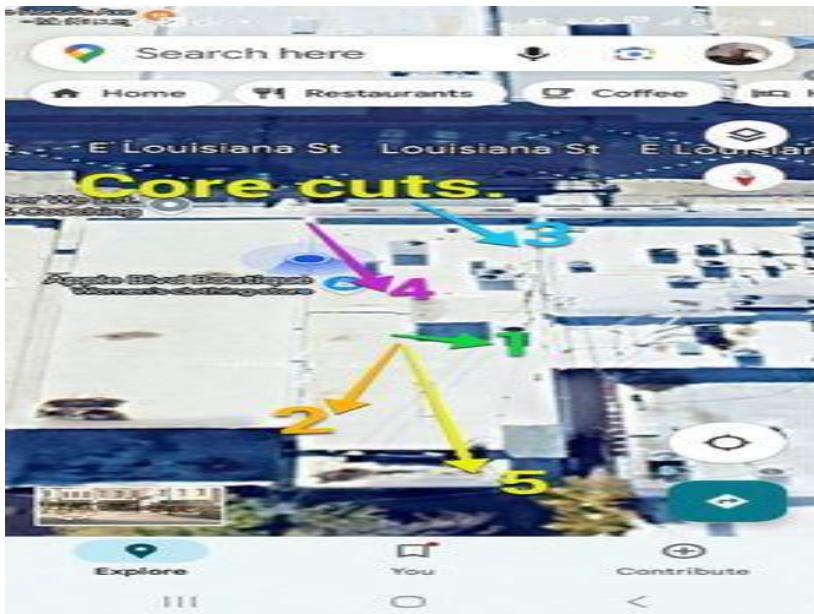
Core cuts.

Location of all core cuts. Three distinct sections, three roof systems, all have two roofs already. ALL HAVE SOME MOISTURE UNDERNEATH AND #5 IS SOAKING WET.

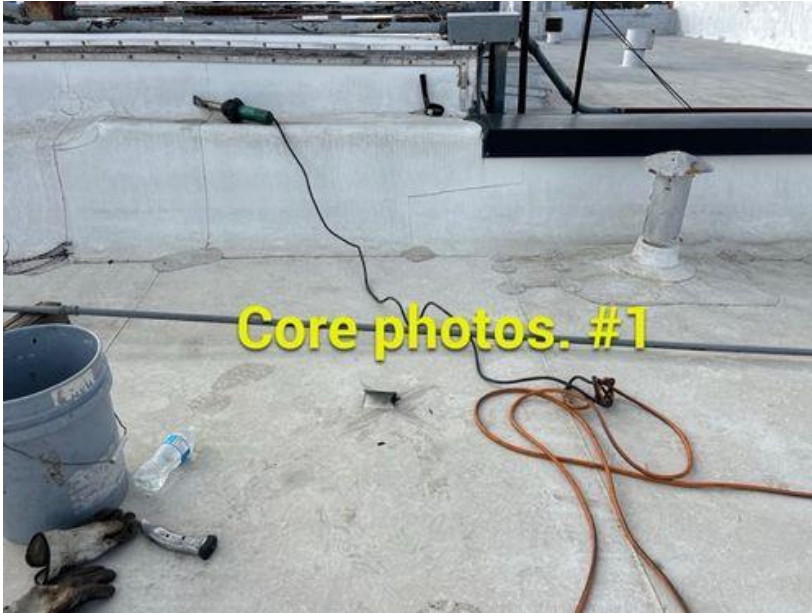
#1 core cut. The middle of three sections.

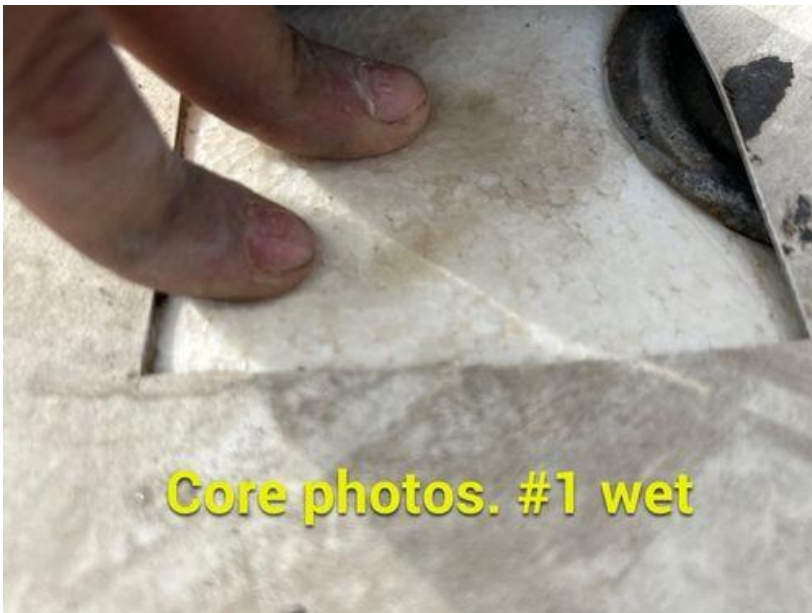
Foam ISO is wet.

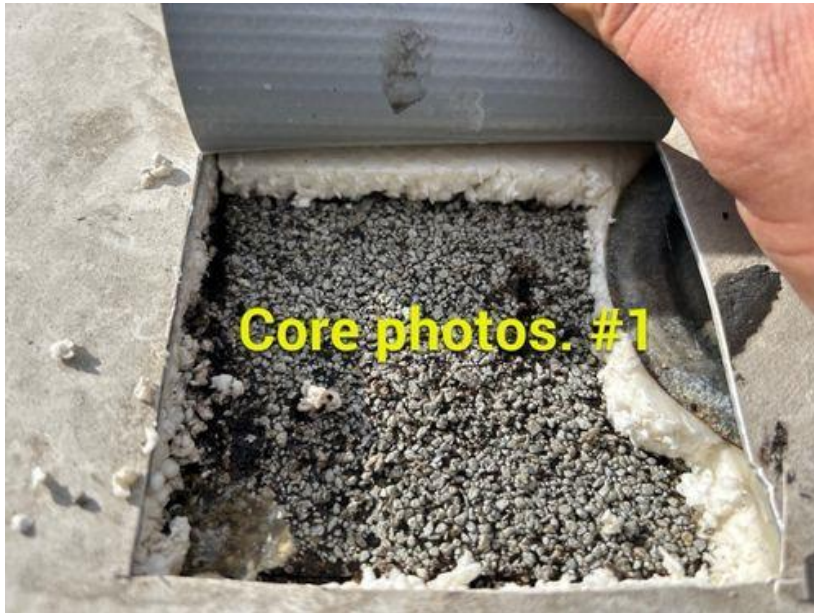
Exposed mod/bit roof underneath.

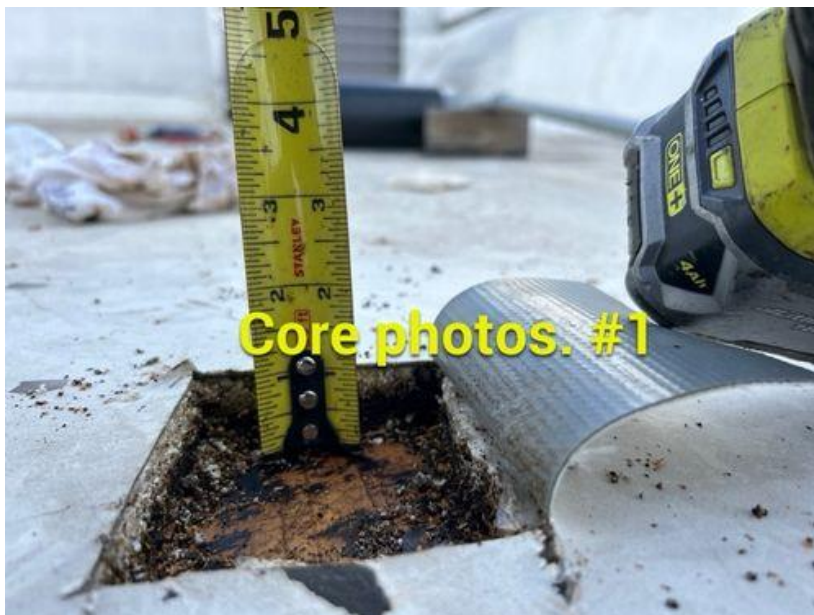
Wooden deck and 1" roof system.

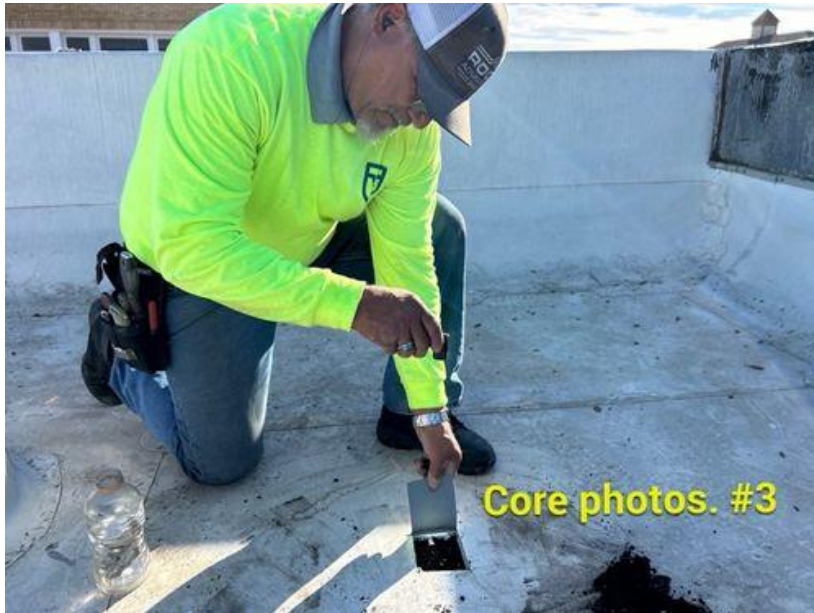
#3 Core cut. Top section of the roof. Lower material is moist.

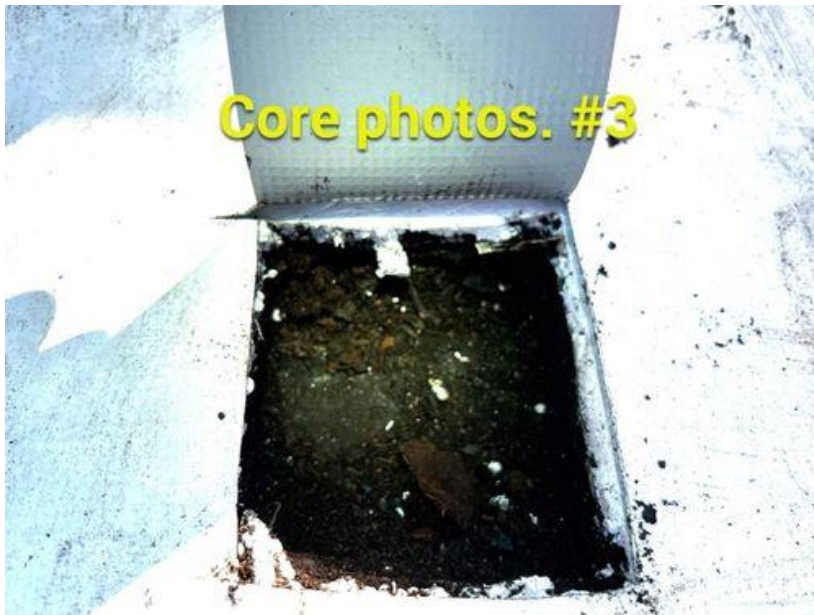
Two roof systems. Appears to be BUR UNDER TPO.

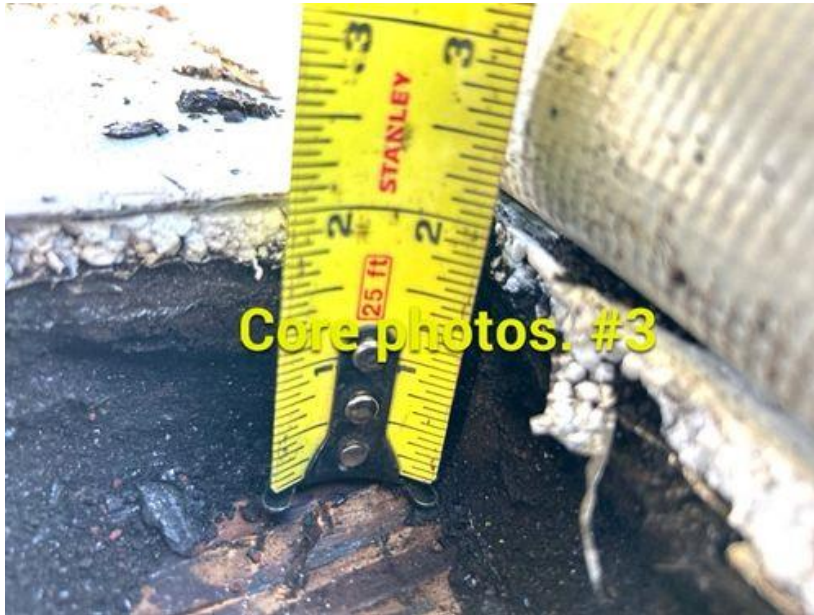
Total depth of the roof system 2".

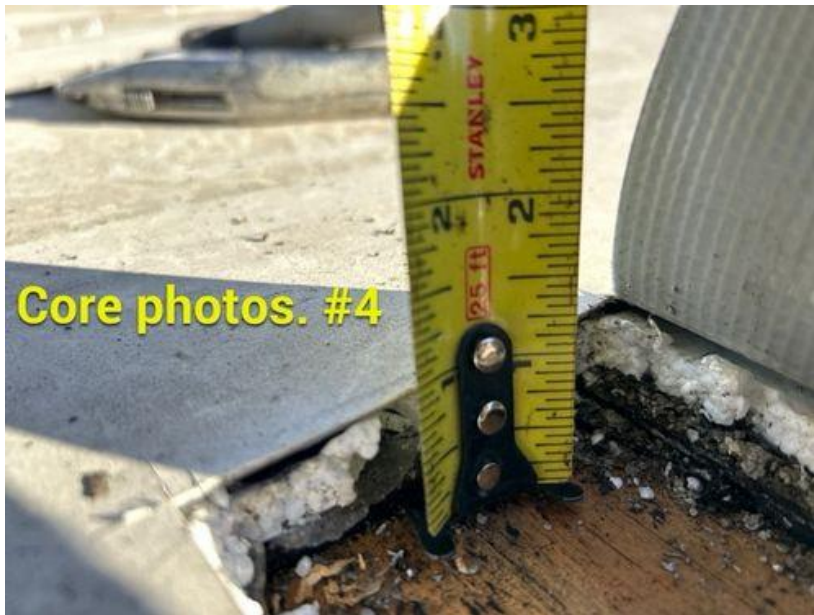
#4 Bottom part of the top section.

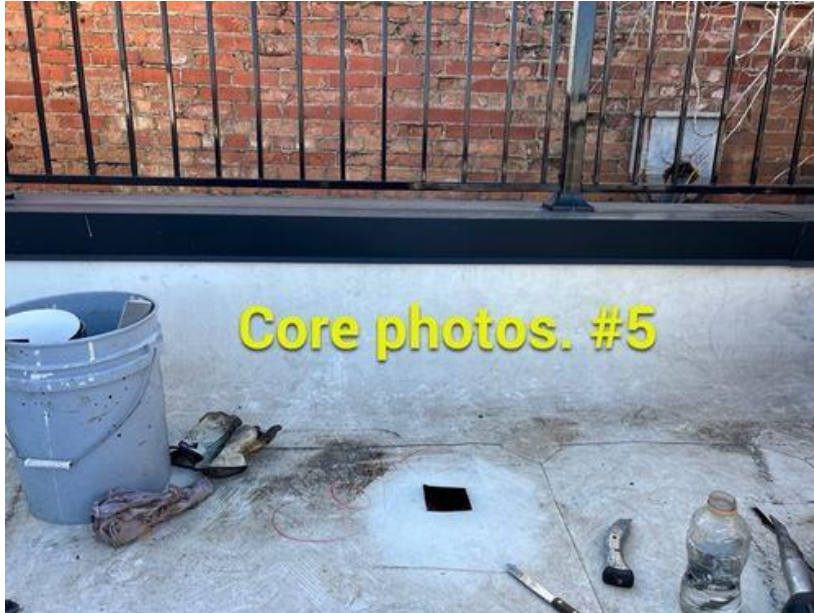
#5 Bottom section as you walk out the door.

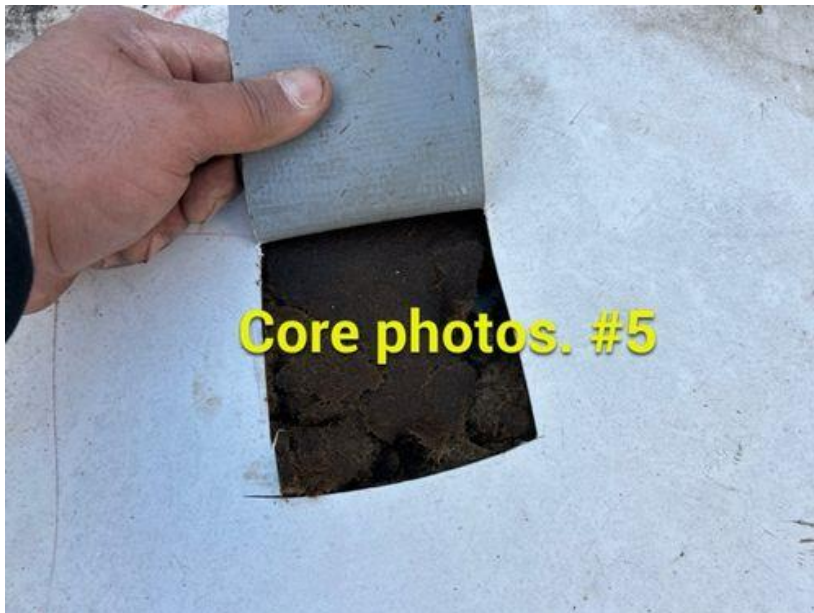
Perlite ISO is soaking wet!

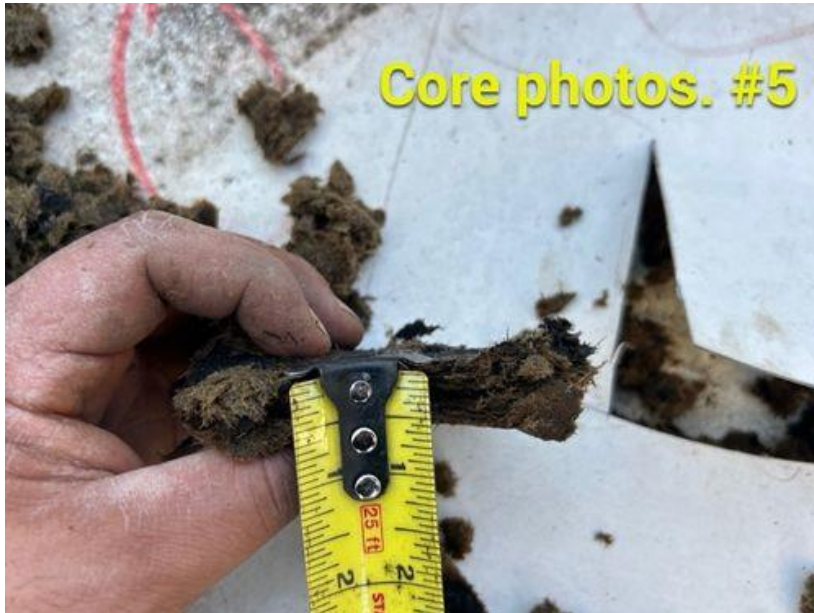
Notice the water absorbed into the perlite.

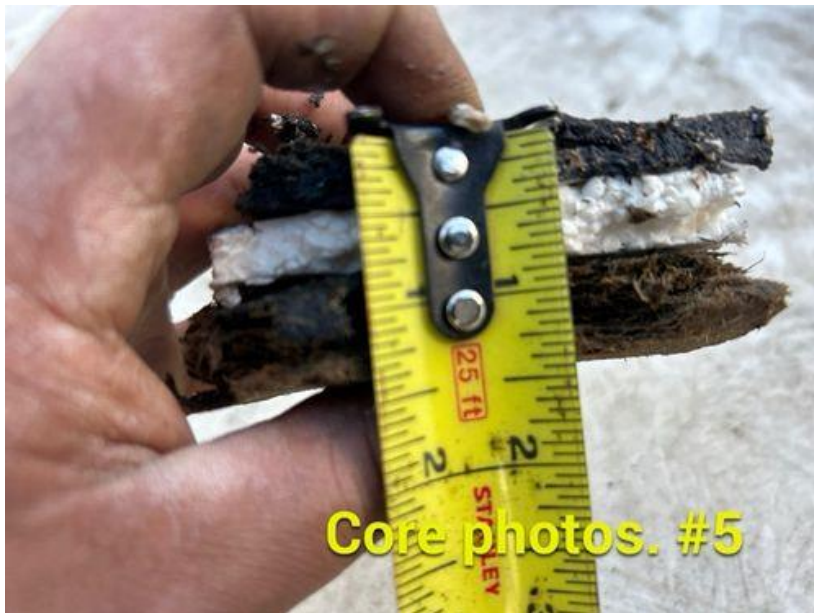
Depth of roof system, appears to be BUR under TPO.

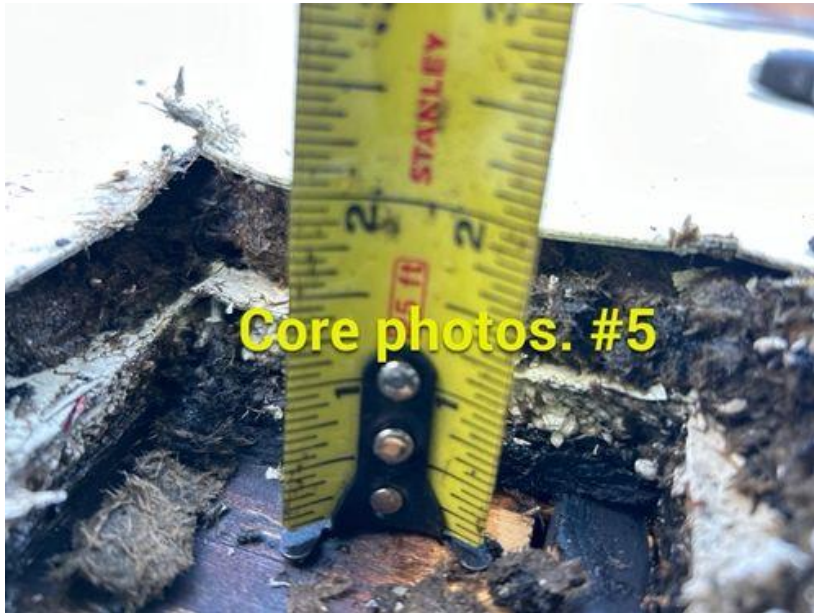
Wooden dec appears to be wet.

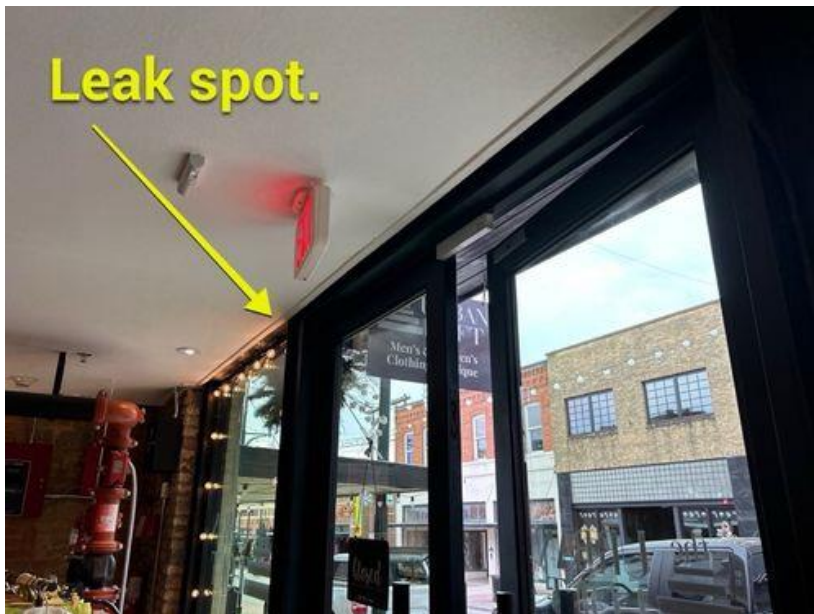
Leak at front entry door.

Reported leak at front entry door.

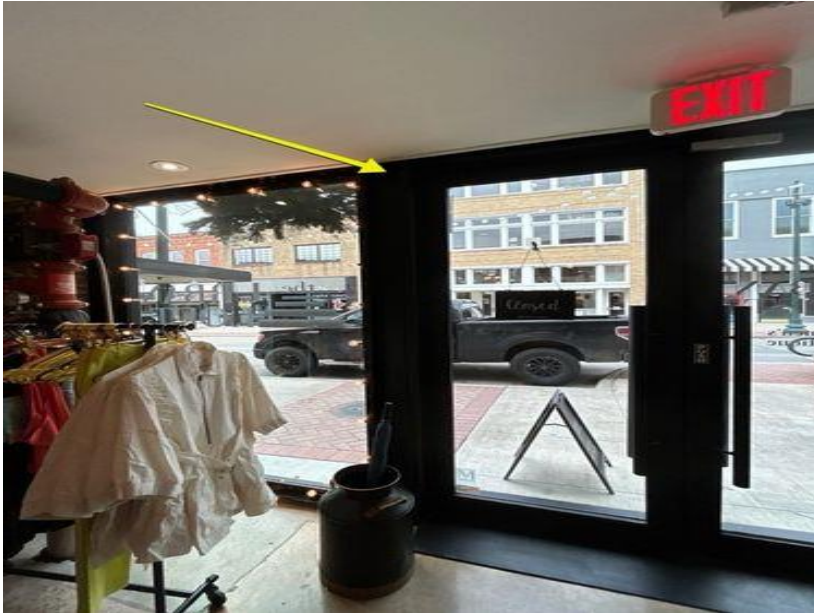
Leak point.

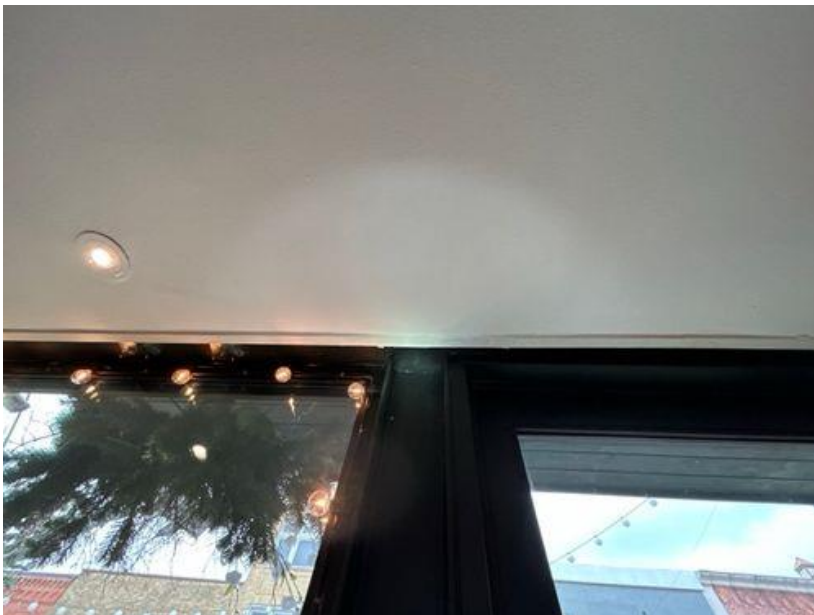
Leak point in and around the channel iron door jam.

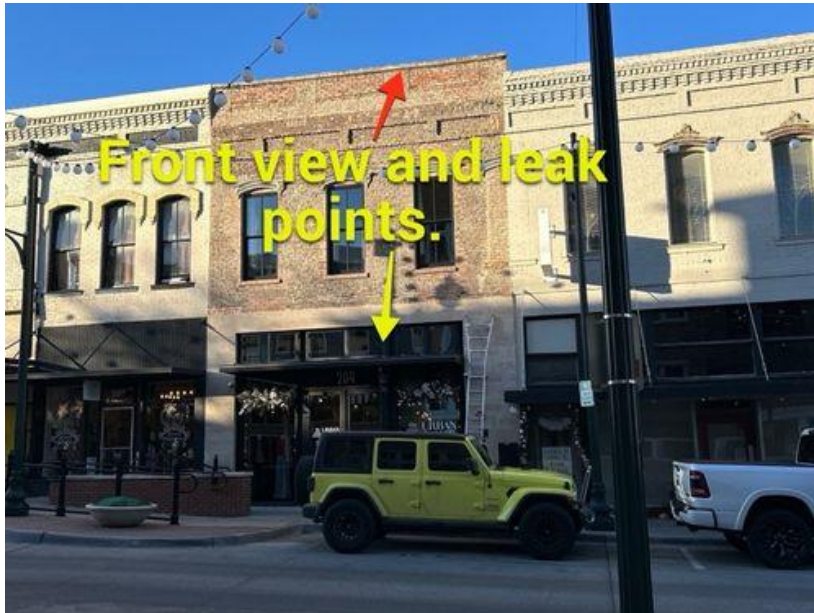
Exterior view of the leak point.

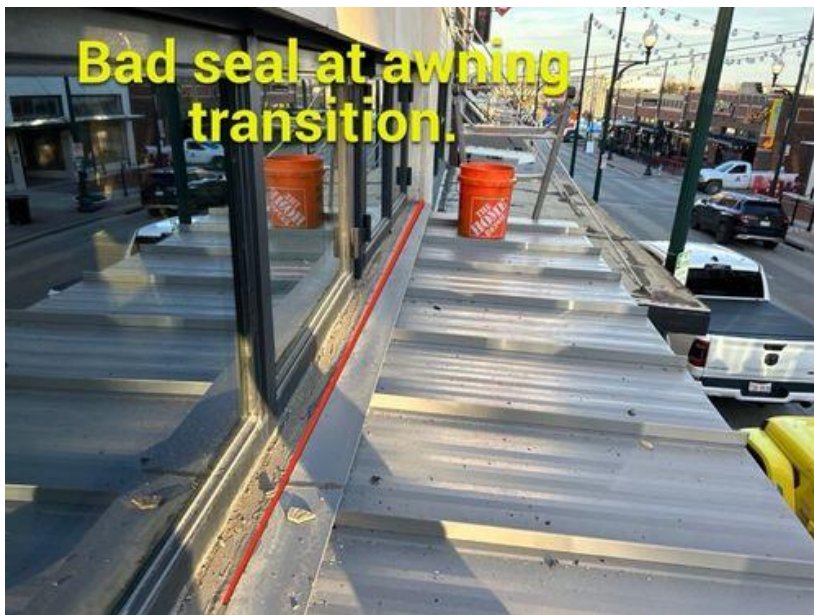
The front entry leak appeared to originate from an over hanging awning. Above the awning we found bad sealant at the transition between window frames and the awning. We also found bad mortar joints in the brick above the windows. REPAIR CONDUCTED: We removed the old sealant along the length of the transition point, cleaned, primed and applied new sealant. At the mortar joints we applied primer and new colored sealant, to match original.

Bad sealant the the window frame transition to awning.

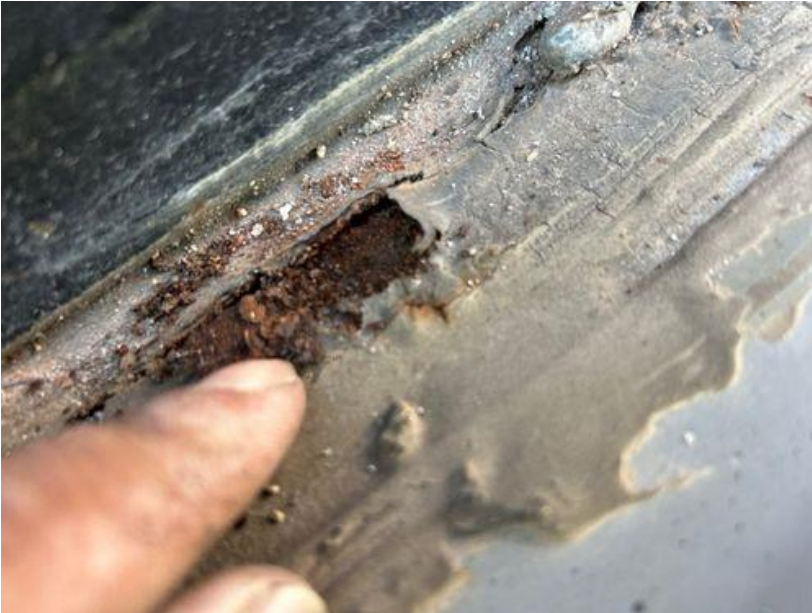
Close up view bad seal.

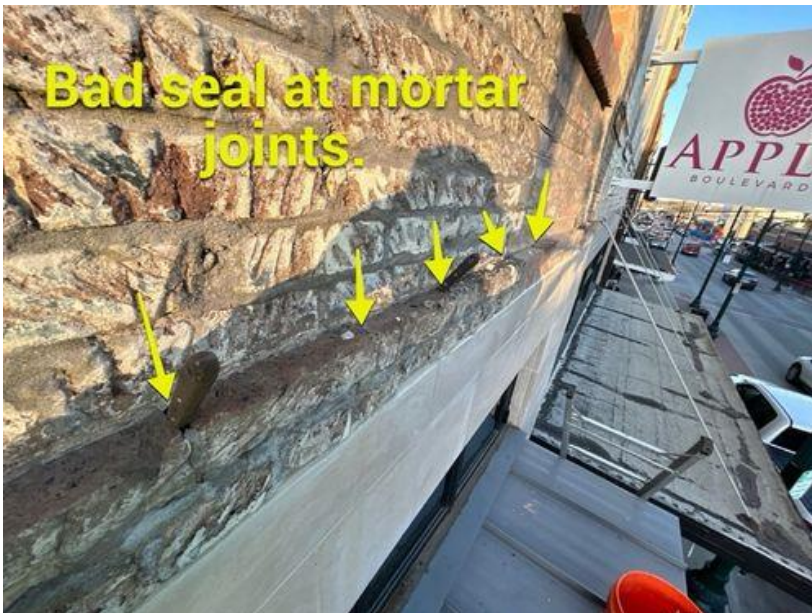
Also above the leak point,... bad mortar joints on top side of the window frames.
