Photos of roof and chimneys  
prior to repair

Inspection Report

Post roof repair and shingle replacement and chimney repair

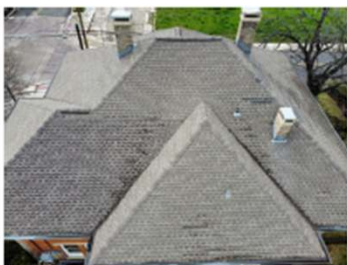
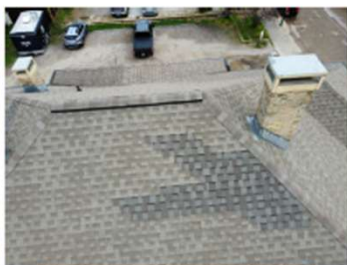
Previous repairs to roofing materials

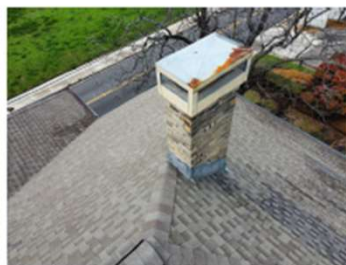
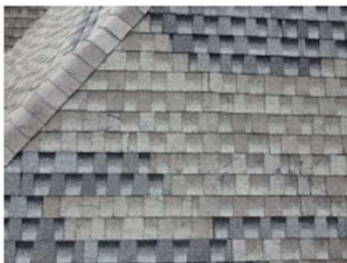
Previous repairs to roofing materials

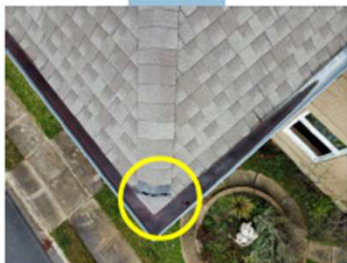
Shingle damage

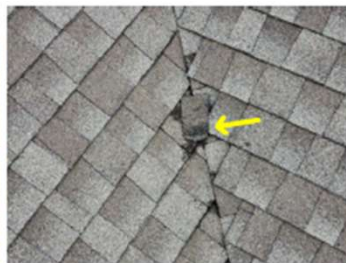
Shingle damage (possible source of water stain in southeast office ceiling)

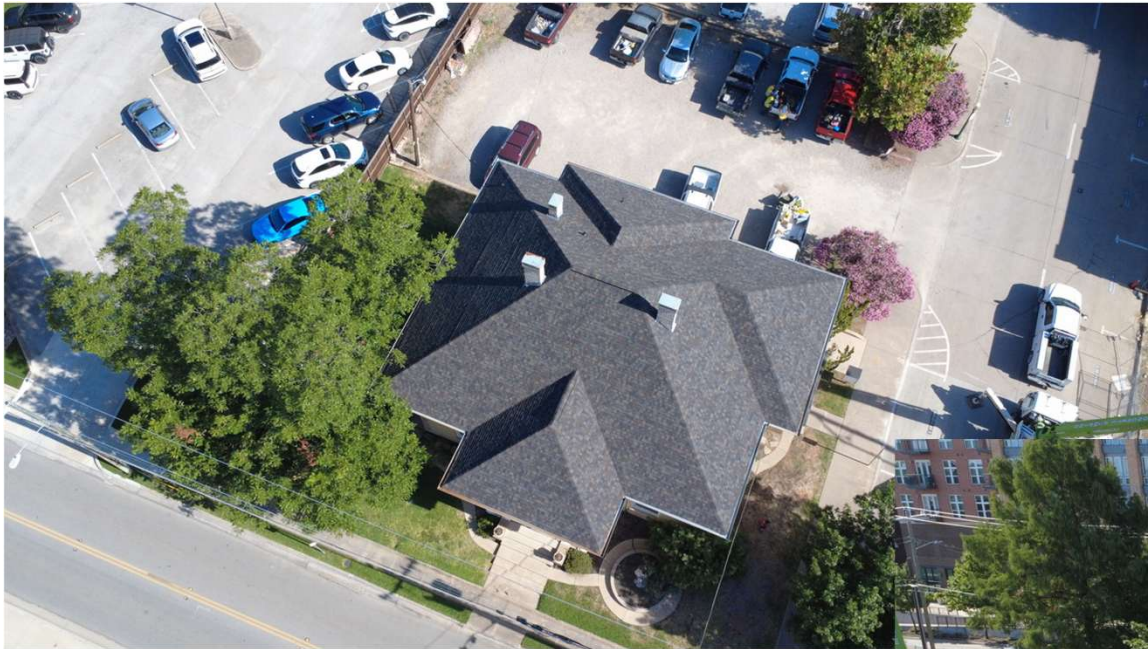
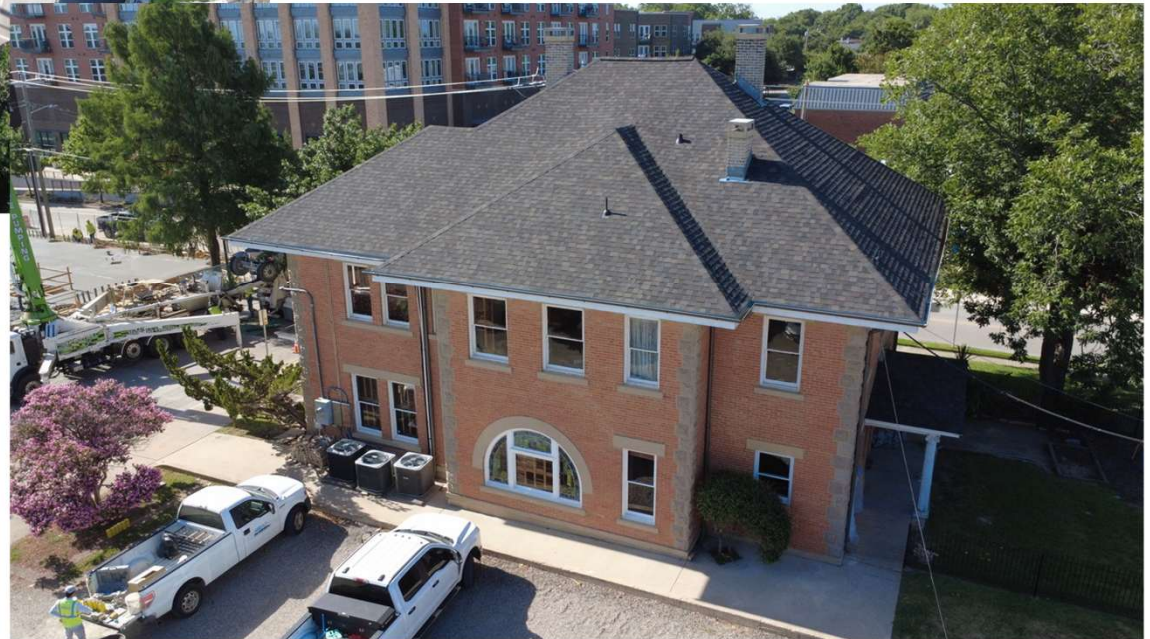
Before and after photos of SW corner of the building where brink and stucco were restored

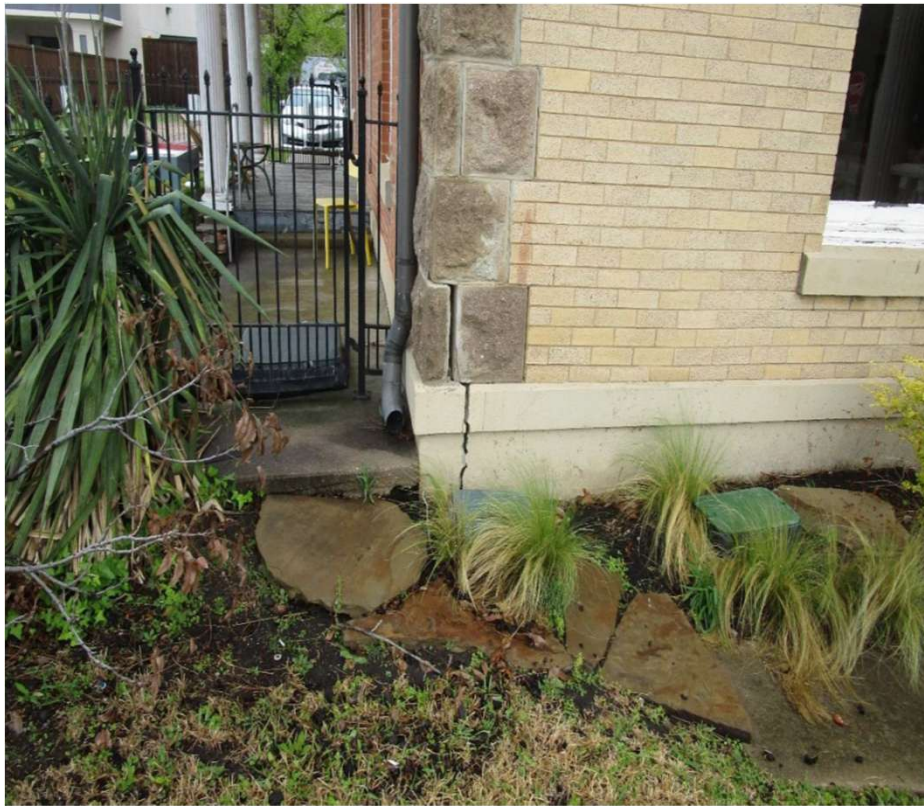
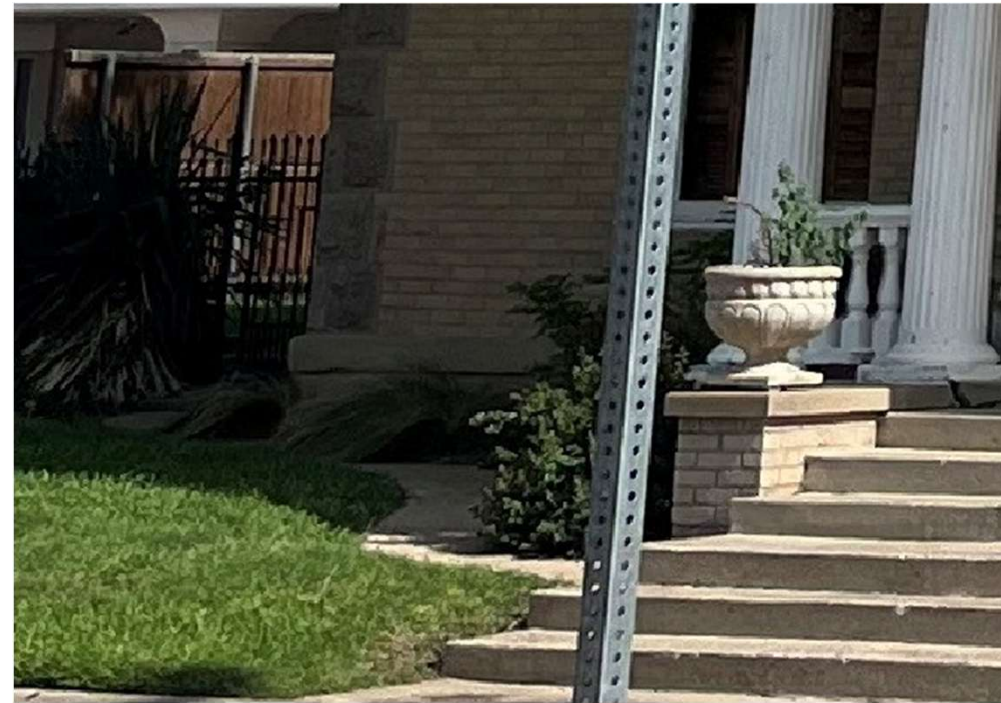
## Façade damage for repair

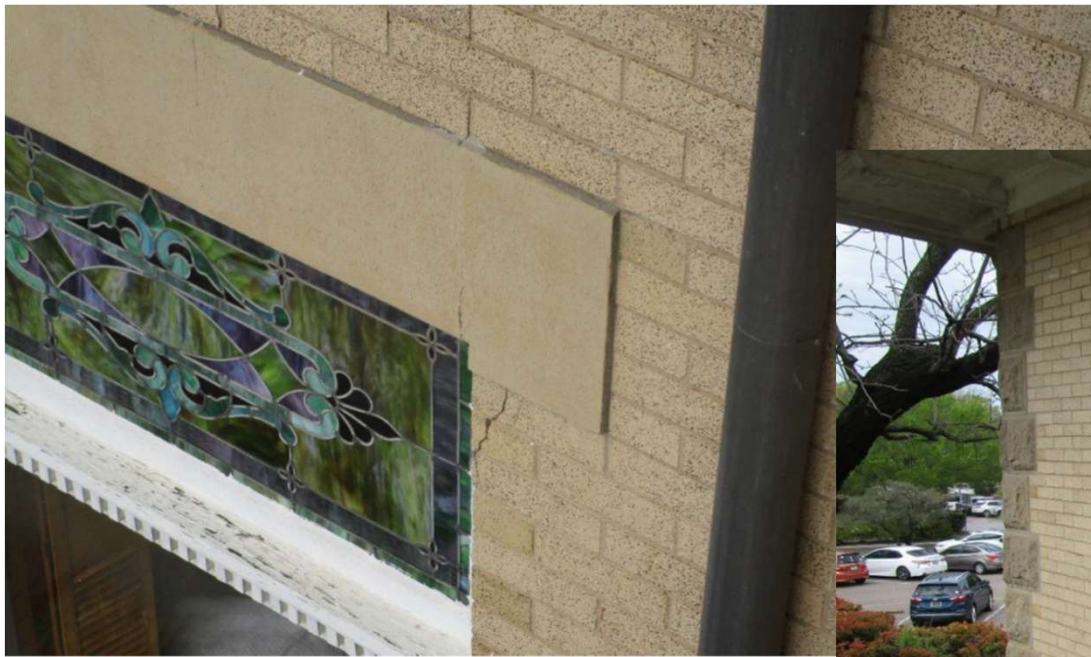
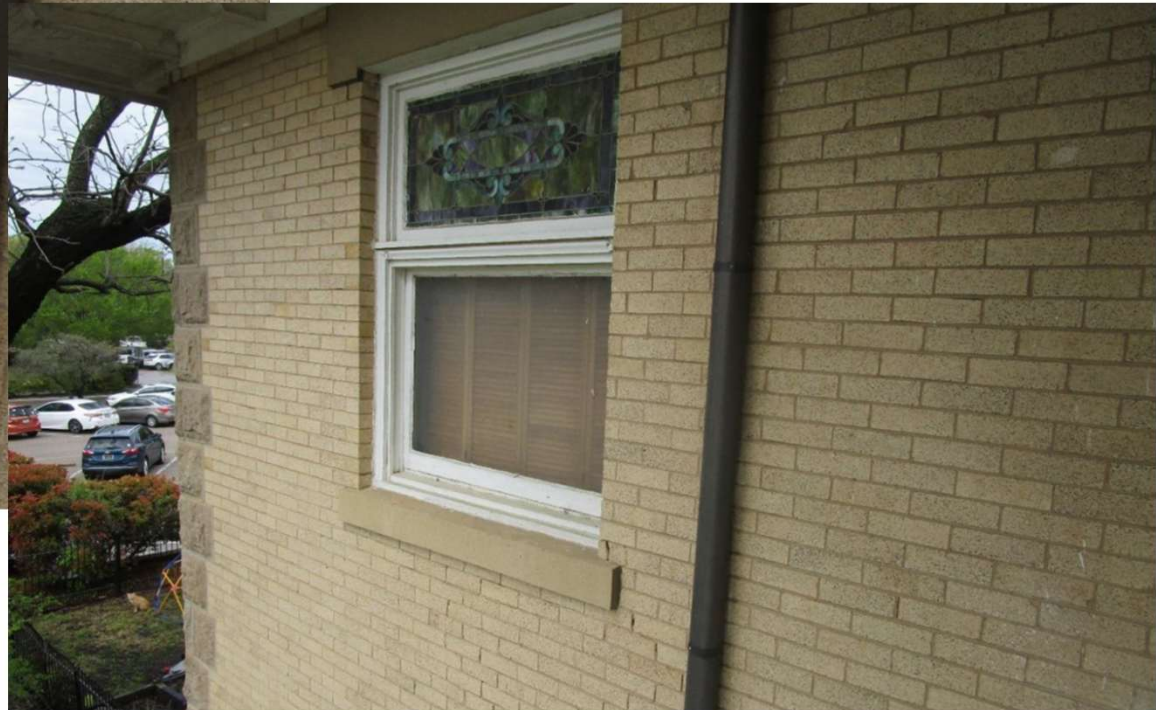
Façade damage on northside (porch)

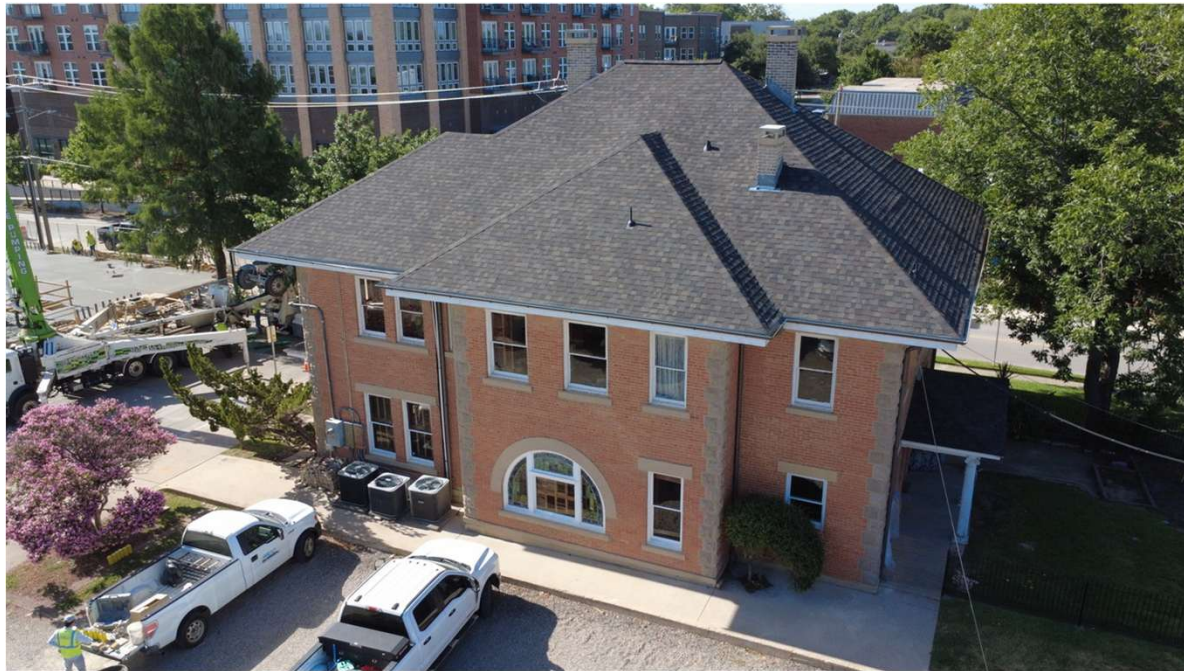
Updated façade and chimneys

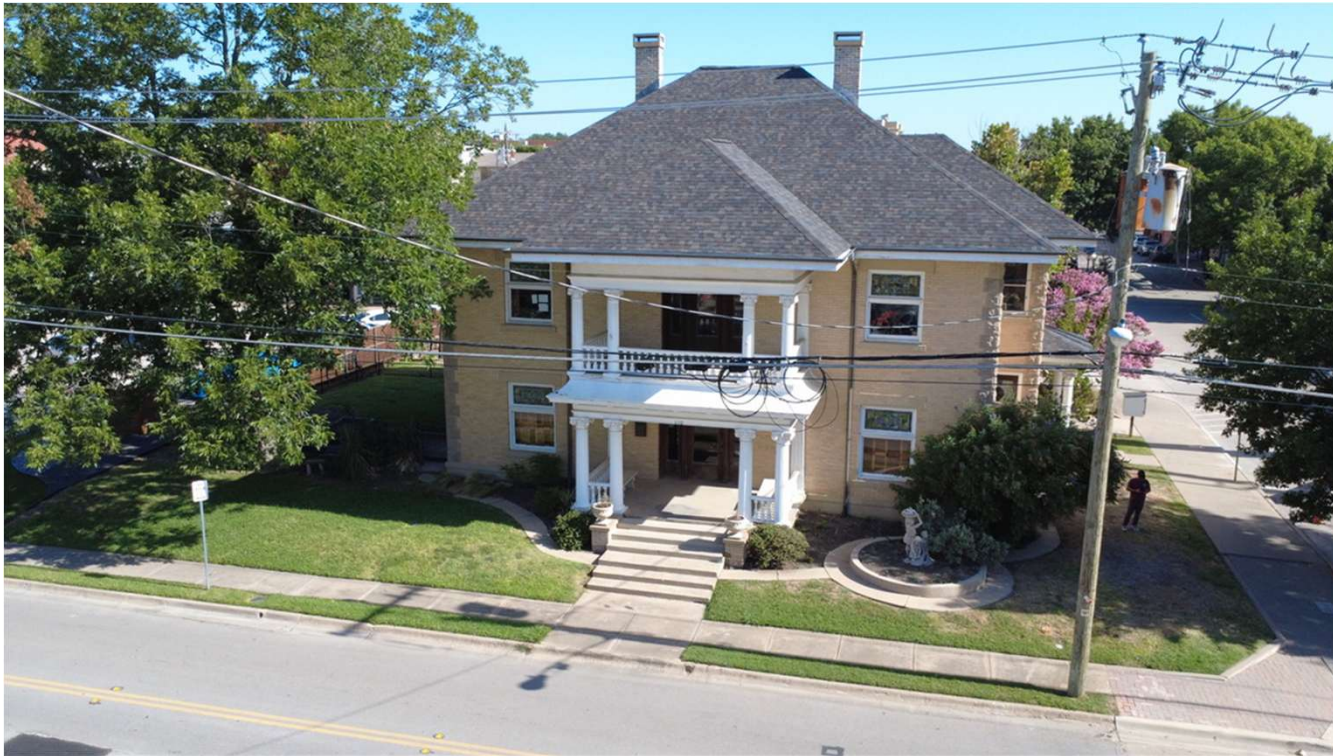
Updated façade and chimney.
