# PROPERTY INSPECTION REPORT

**110 E Davis St**  
**Inspection Prepared For: The Parks Church**  
**Agent:**

**Date of Inspection: 3/11/2024**  
**Age of House: 110 Years, Size: 4,400 SF**  
**Weather: Cloudy/Rain, 50-60 Degrees**

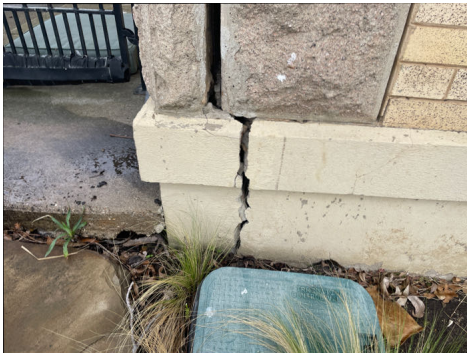
Cracks/damage located at foundation corners noted. Evaluation and repair of this area is needed.

Foundation corner damage

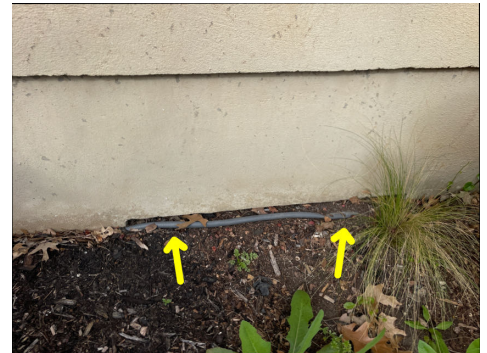
Crawlspace: Ventilation of the crawl space is insufficient. Proper ventilation will help to control humidity and reduce the potential for rot. Improvements recommended.

East Exterior: Possible crawlspace vent covered

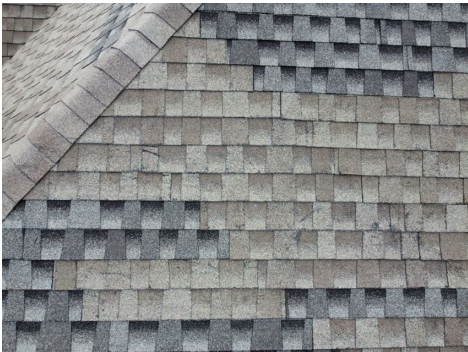
Previous repairs to roofing materials and/or flashings noted in one or more locations.

Previous repairs to roofing materials

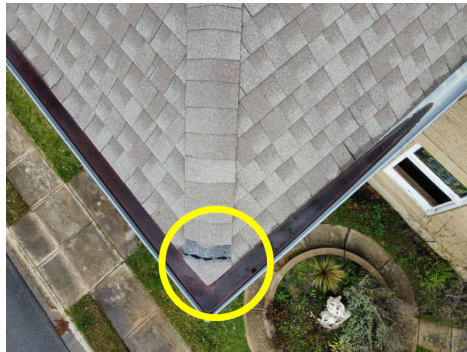
Damaged or missing shingles were noted at the time of the inspection. Repairs needed.

Shingle damage

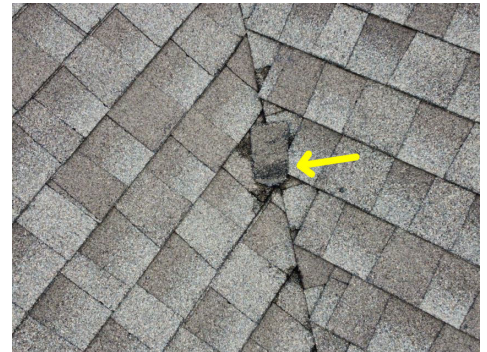
Shingle damage (possible source of water stain in southeast office ceiling)

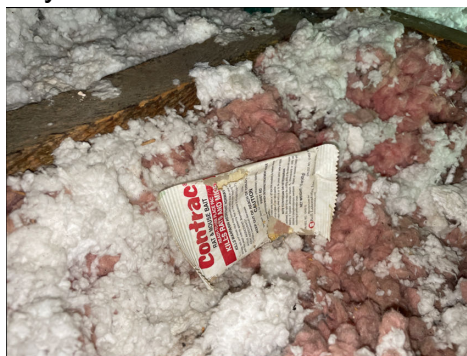
Evidence of rodent/pest activity noted in the attic. Further evaluation of any damage and droppings by a pest control specialist recommended.

Rodent activity example

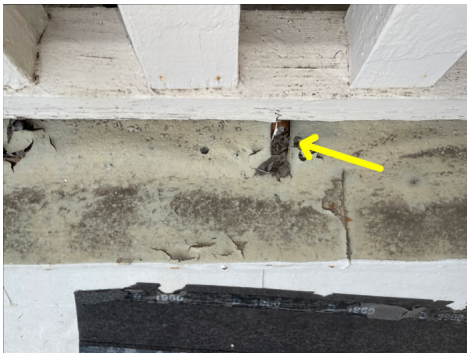
Front porch: Peeling paint and corrosion on the metal covers was noted. Repair needed.

Front porch peeling paint

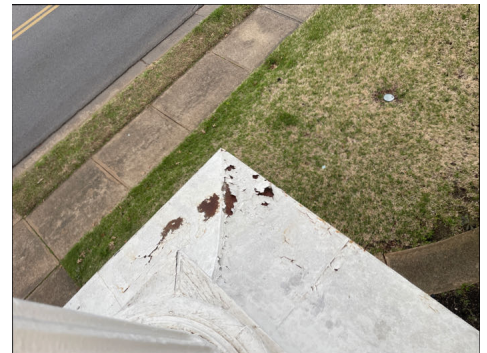
Front porch peeling paint

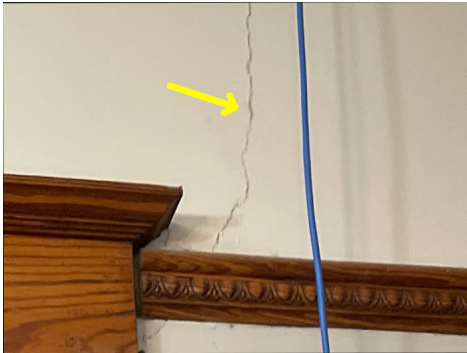
Multiple Locations: Cracks on interior wall surfaces were noted. This condition is likely associated with the age of building and typical structural movement. Monitor and repair as needed.

Upstairs south west bedroom:  
Interior wall crack

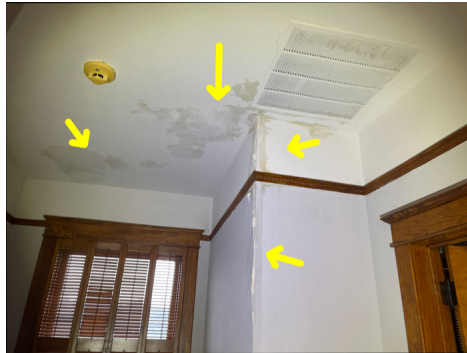
Top of west stairs: Water damage on interior wall surfaces noted. The cause and remedy should be further evaluated and corrected as necessary. Any related damage behind the finished surface should also be assessed and repaired.

Top of west stairs: Water  
damage

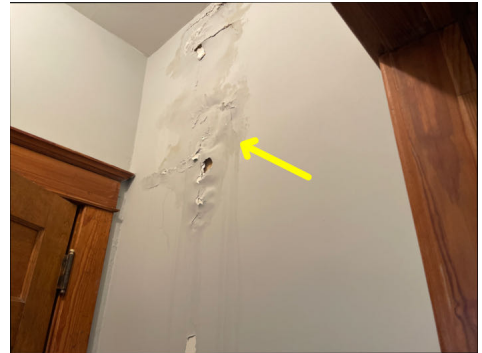
Upstairs south of office: Water  
damage

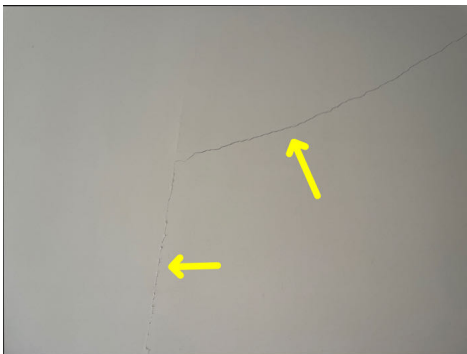
East Stairway: Interior Wall  
Crack

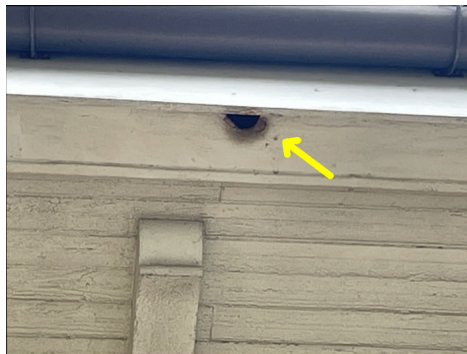
Front Exterior: Damage to exterior siding or surface caused by rodents should be repaired. If the unwanted pests are still present, removal/extermination will be needed.

Front exterior soffit: Rodent  
damage/entry point

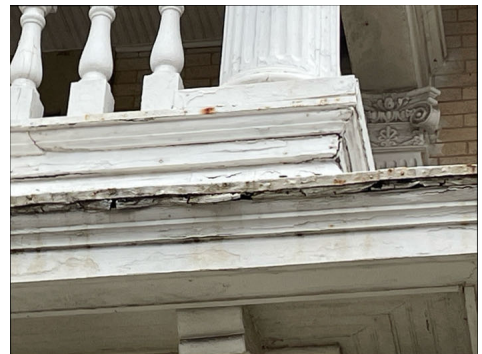
Patio/balcony damage

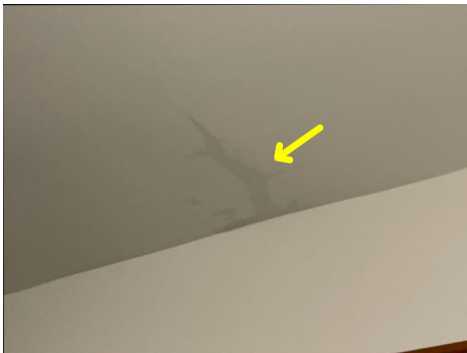
Various Locations: Water staining was noted. The source of the water should be identified and corrected as necessary. All repairs to the structure should be made if needed.

Upstairs Hall: Ceiling Water Stains

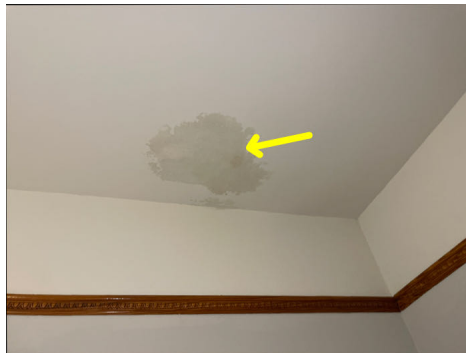
Upstairs southeast office: A water stain/active leak was noted. This could be related to a possible roof issue. Full evaluation and repairs are needed.

Upstairs south east office: water stains

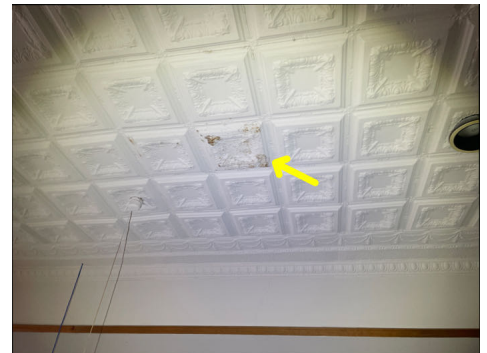
Upstairs North Office: Ceiling Water Stains

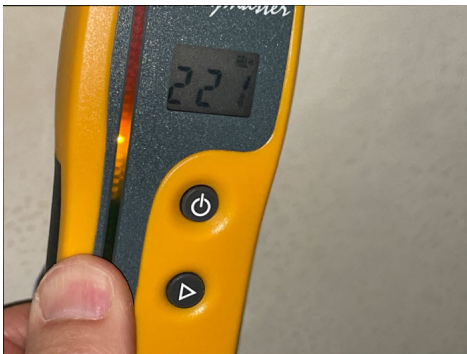
Upstairs Southeast Office Ceiling: High Moisture at Water Stain

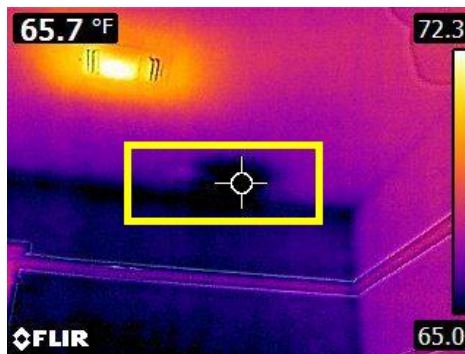
Upstairs southeast office: Thermal image of water stain

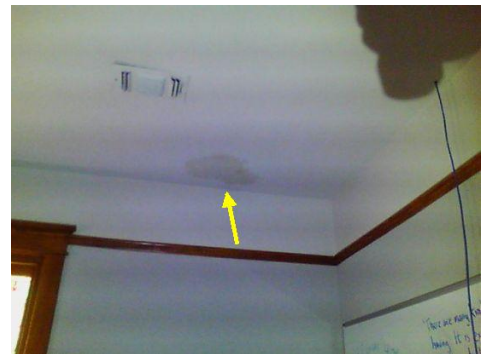
Upstairs southeast office: water stain

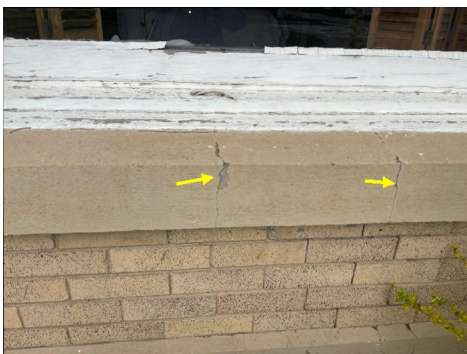
Multiple windows: Damage to the exterior cast stone windowsills was noted. Repair as needed.

Exterior window sill damage

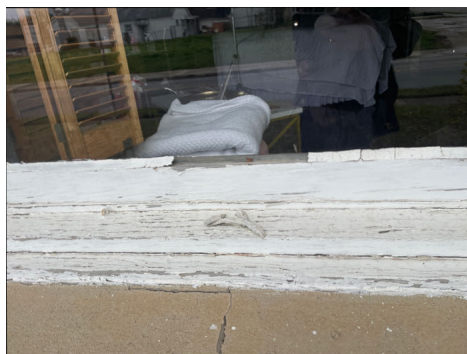
Multiple windows: Water damage, peeling paint, and deteriorating glazing noted.

Window paint, caulk, and glazing deterioration

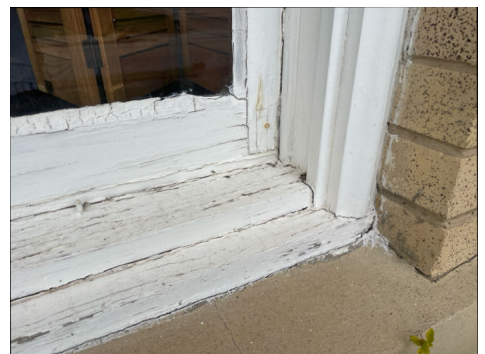
Window paint, caulk, and glazing deterioration

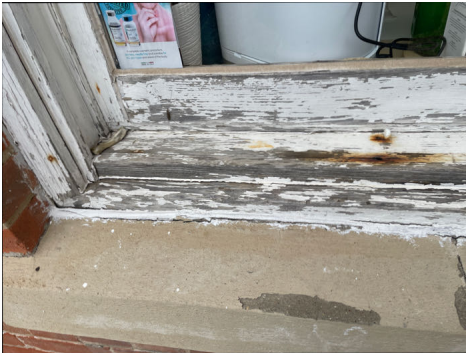
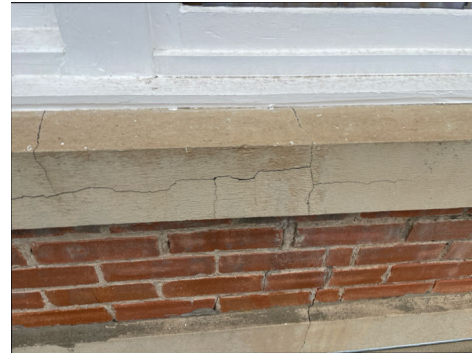
Peeling paint

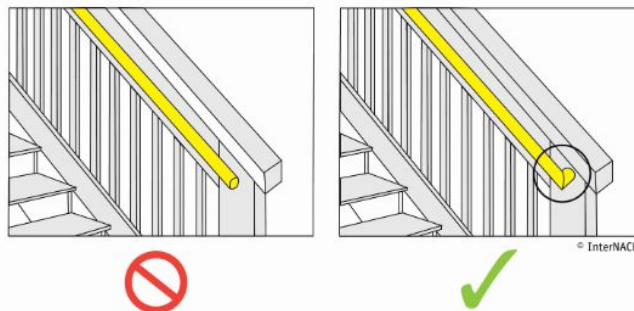
Current building standards require the end of the handrail to return to the wall. Handrail termination is important so clothes or equipment do not get stuck on the end of the handrail. Improve as needed.

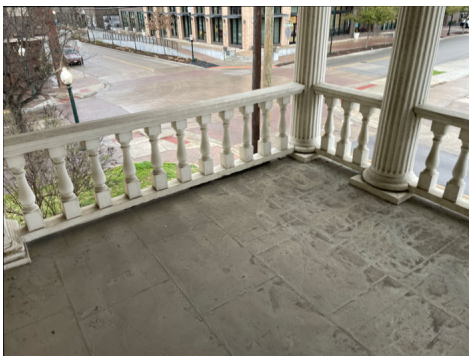
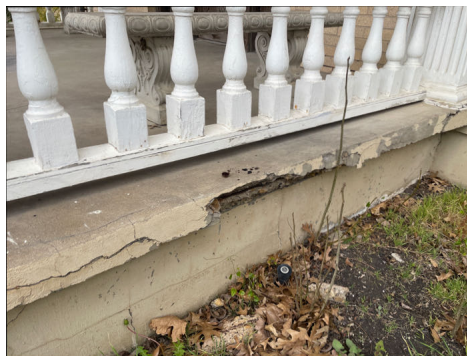
Extensive damage to concrete, spindles, and columns on the front and side porches was noted. Full evaluation and repairs are needed.

Front Porch Damage

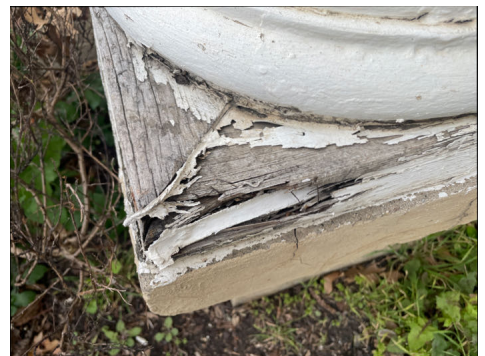
Front Porch Damage

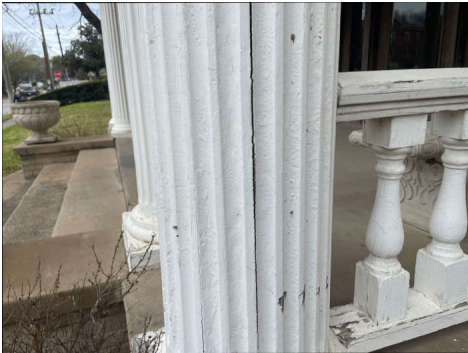
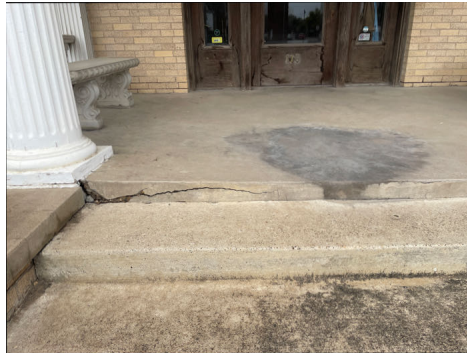
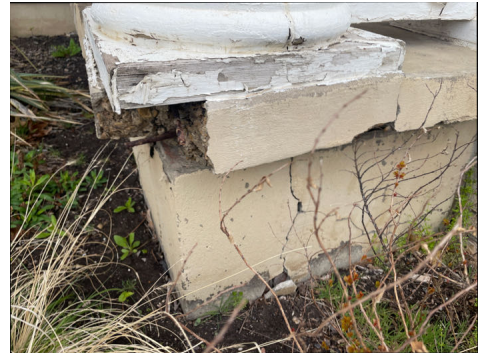
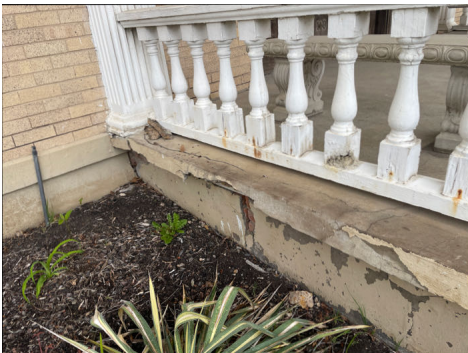
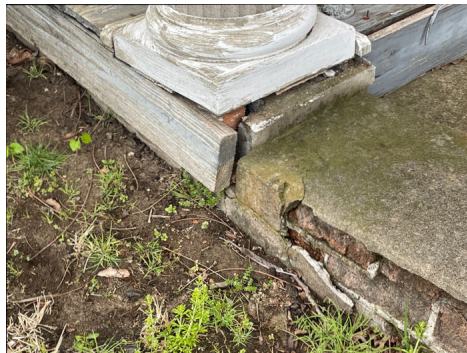
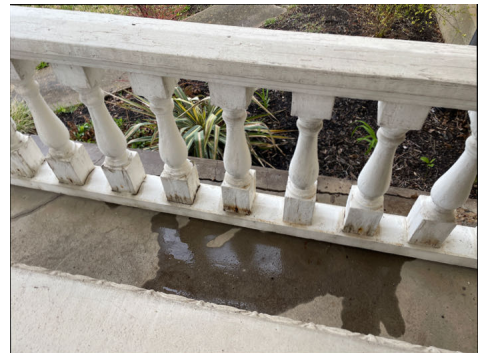
Side patio damage

Patio railing damage

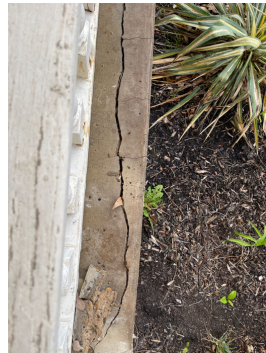
Patio damage

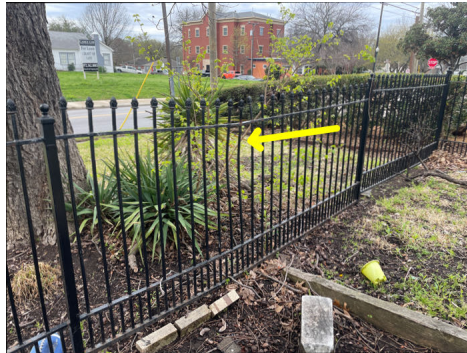
Damaged fence sections and/or pickets noted. Repair as needed.

Minor fence damage

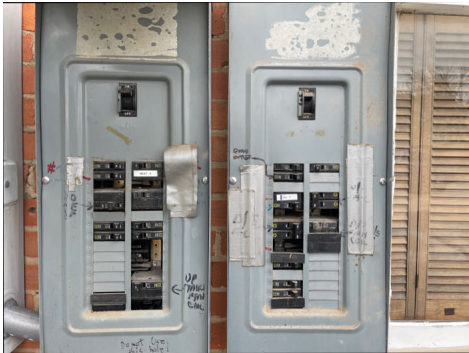
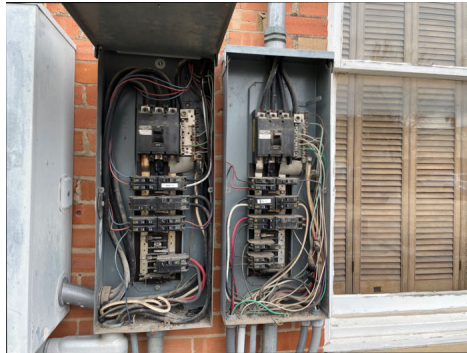
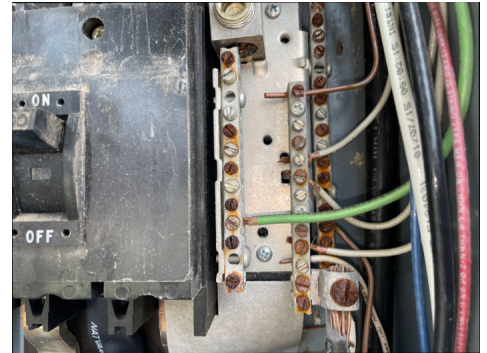
Evidence of rusting within the main distribution panel. Evaluate and repair as needed.

Corroded screws in panel

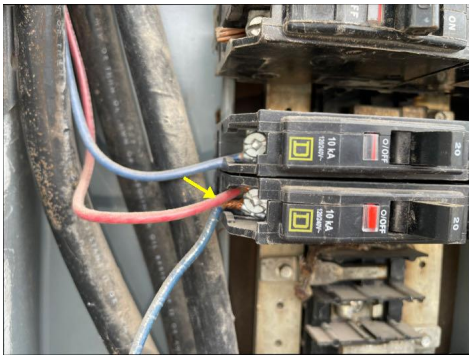
One or more of the breakers in the panel box was observed to be double wired. The breakers that are in place are not listed or labeled for this type of installation. Evaluation and repairs needed.

Double lugged breaker

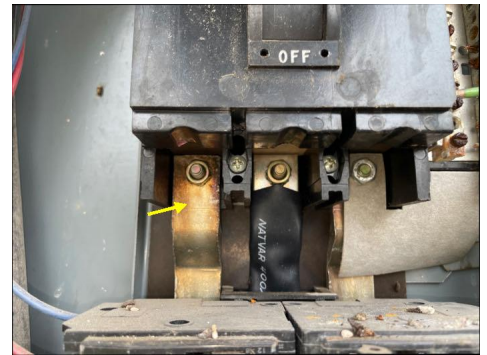
Discolored bus bar

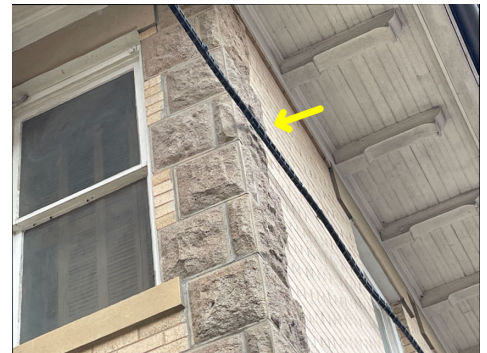
There is insufficient clearance between the building and the main service drop at the east side. Repairs are recommended.

East exterior: service wires too close

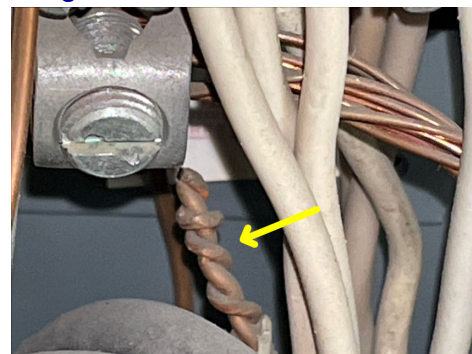
Sub Panel: Missing wire nut on a neutral connection noted. Repairs needed.

Sub Panel: neutral connection missing wire nut

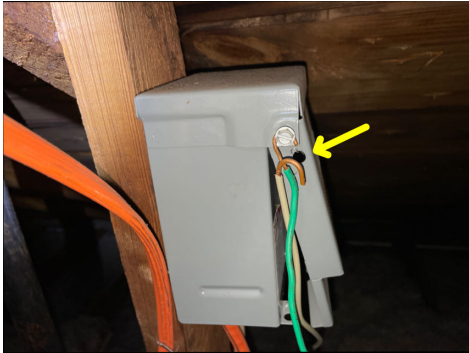
Attic: Loose and incorrect location grounding at the water heater disconnect. Improvements needed.

Attic water heater:  
Loose/improper grounds

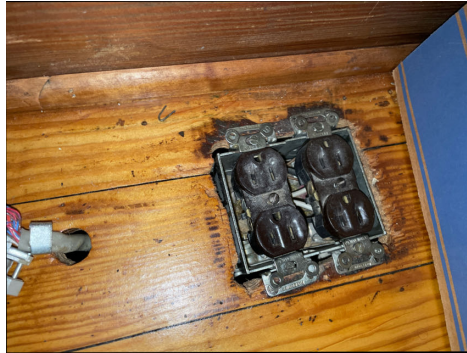
Multiple Locations: Missing covers noted. Repairs needed.

Upstairs NE corner: Floor outlet  
missing cover

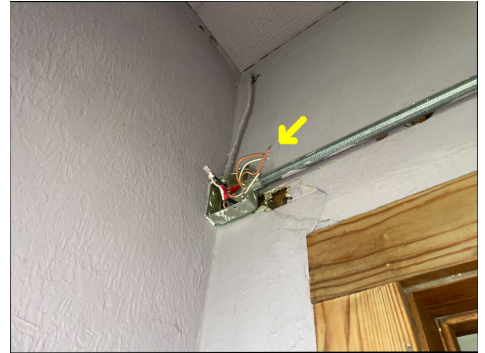
Downstairs 132 space: Electrical connections made outside of junction boxes noted. Repair needed.

Downstairs Suite 132 Closet:  
Connection not in Junction Box

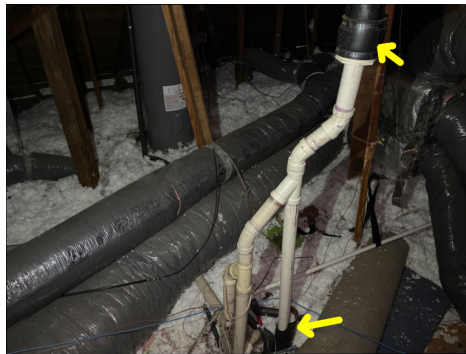
Attic: The cast iron vent stack visible inside the attic has been modified with additional PVC materials. The lower connection is open/not sealed properly. Further evaluation by a qualified plumber and repairs are recommended.

Attic: Cast iron vent conversion to pvc

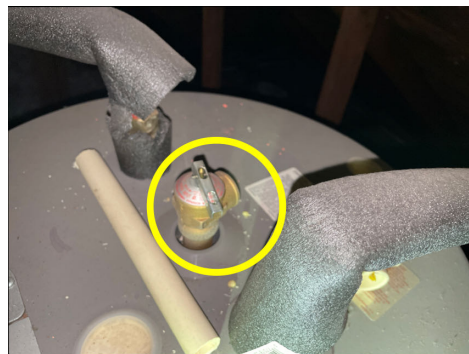
**Attic: Discharge piping for the Temperature and Pressure Relief (TPR) Valve on the water heater was not present. Installation needed.**

Attic: TPR discharge line missing

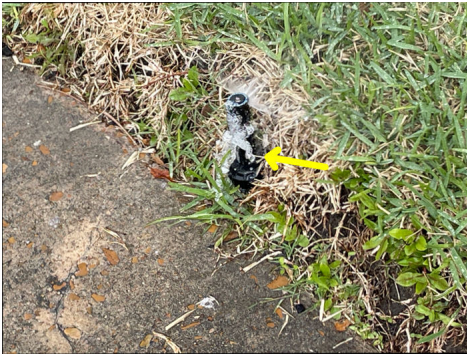
zone 4: Damaged sprinkler heads should be replaced or repaired as necessary.

Sprinkler head damage

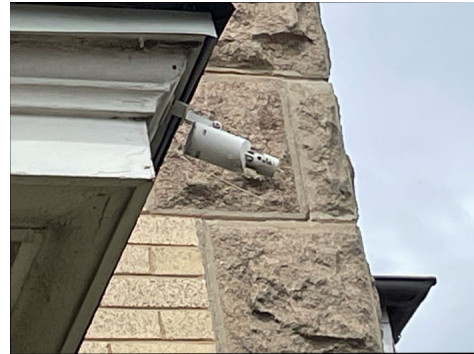
Rain Sensor Not Installed Vertical
