HPAB Meeting August 2025

401 N Bradley St

Sanborn Maps & Photos of Historic Homes in McKinney with Dormers

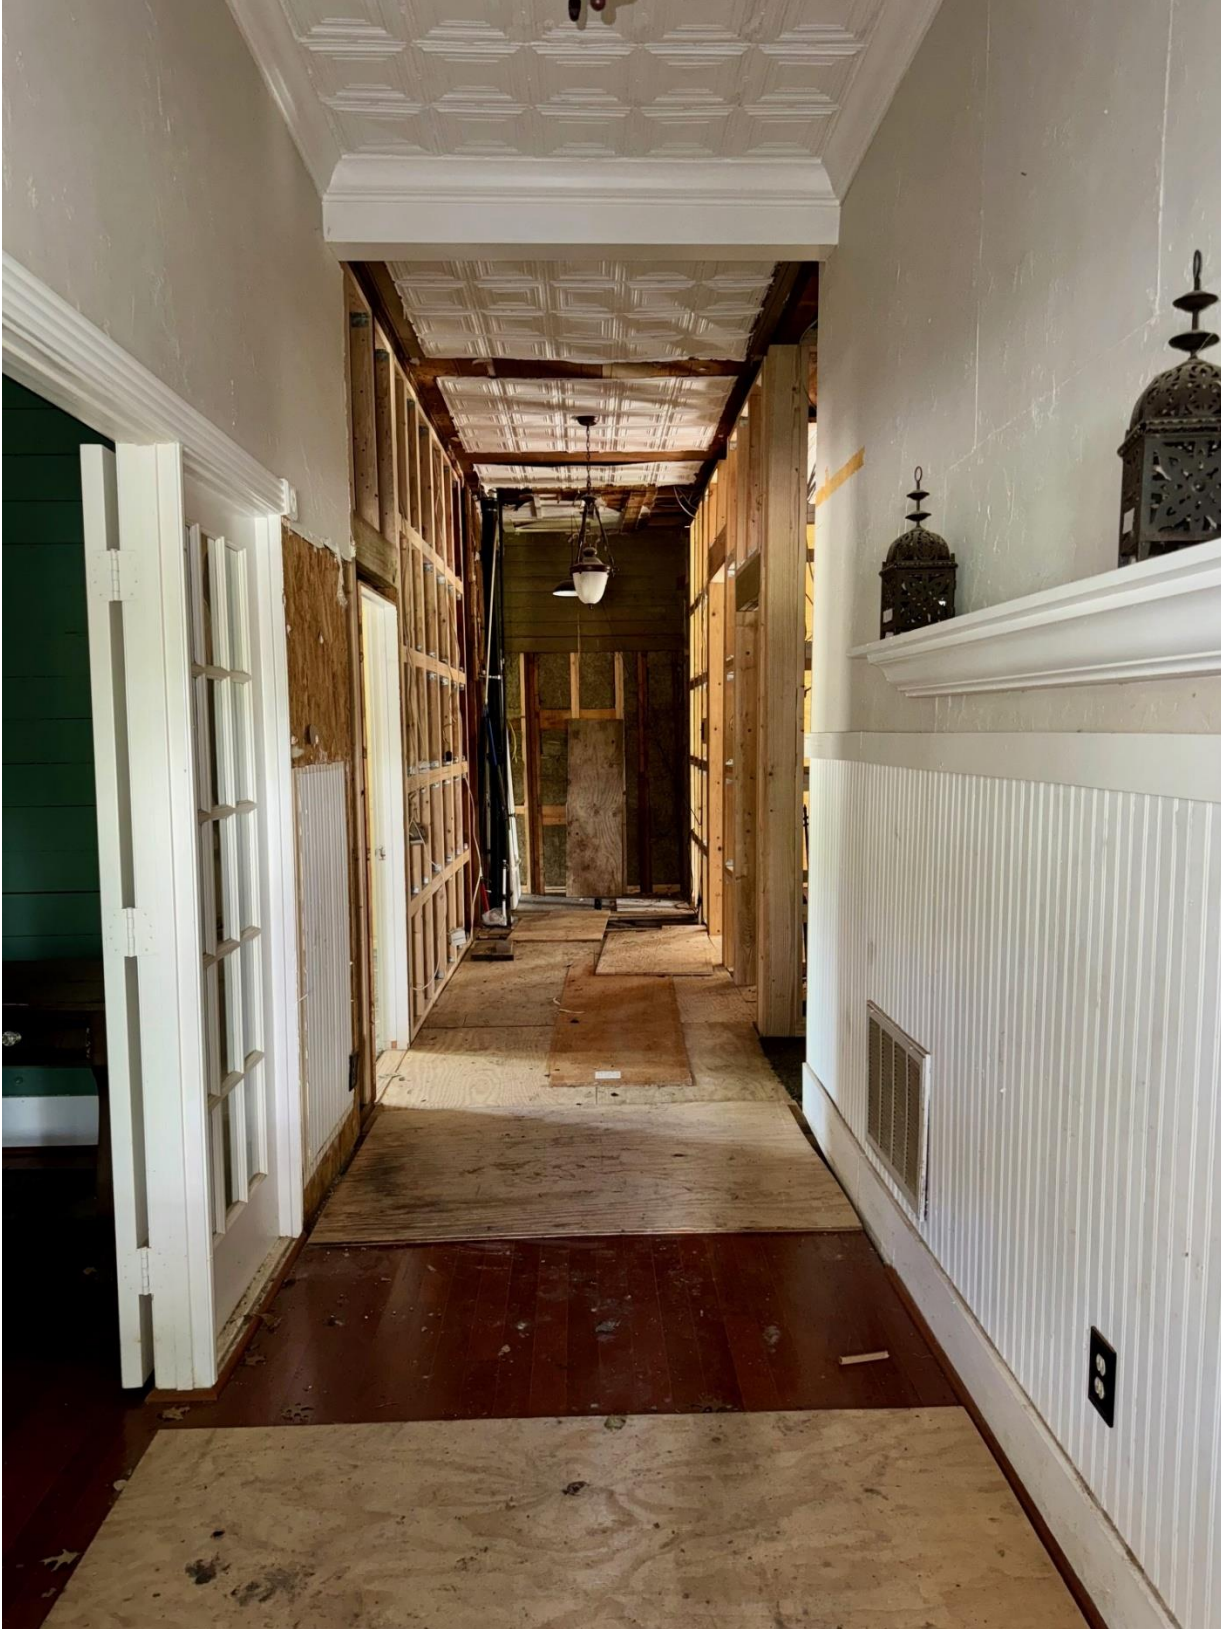
View upon front door entry

These photos reflect the state in which the property was purchased and currently remains, highlighting the extensive work that is required to make it livable.

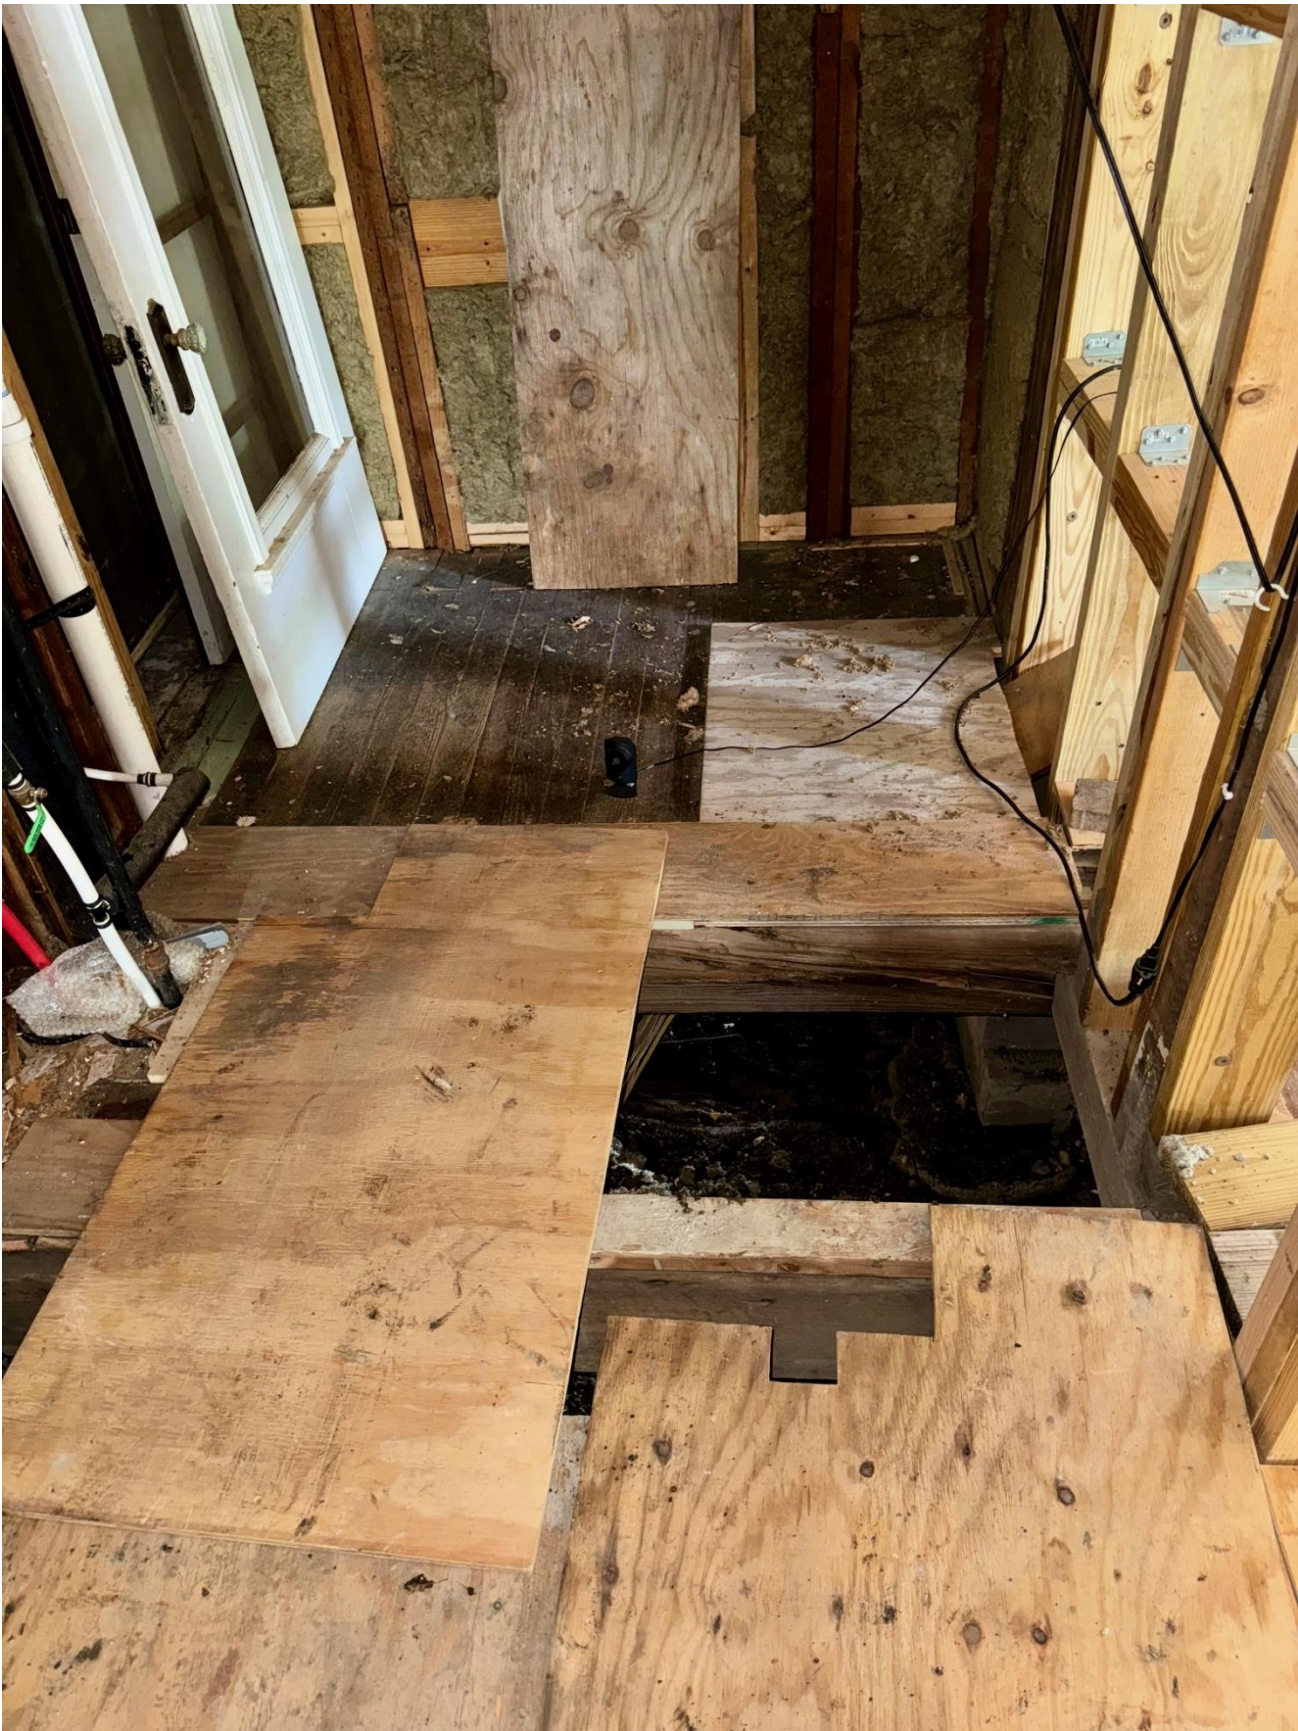
End of main hallway. Holes in the floor, most areas covered by plywood due to missing subfloor

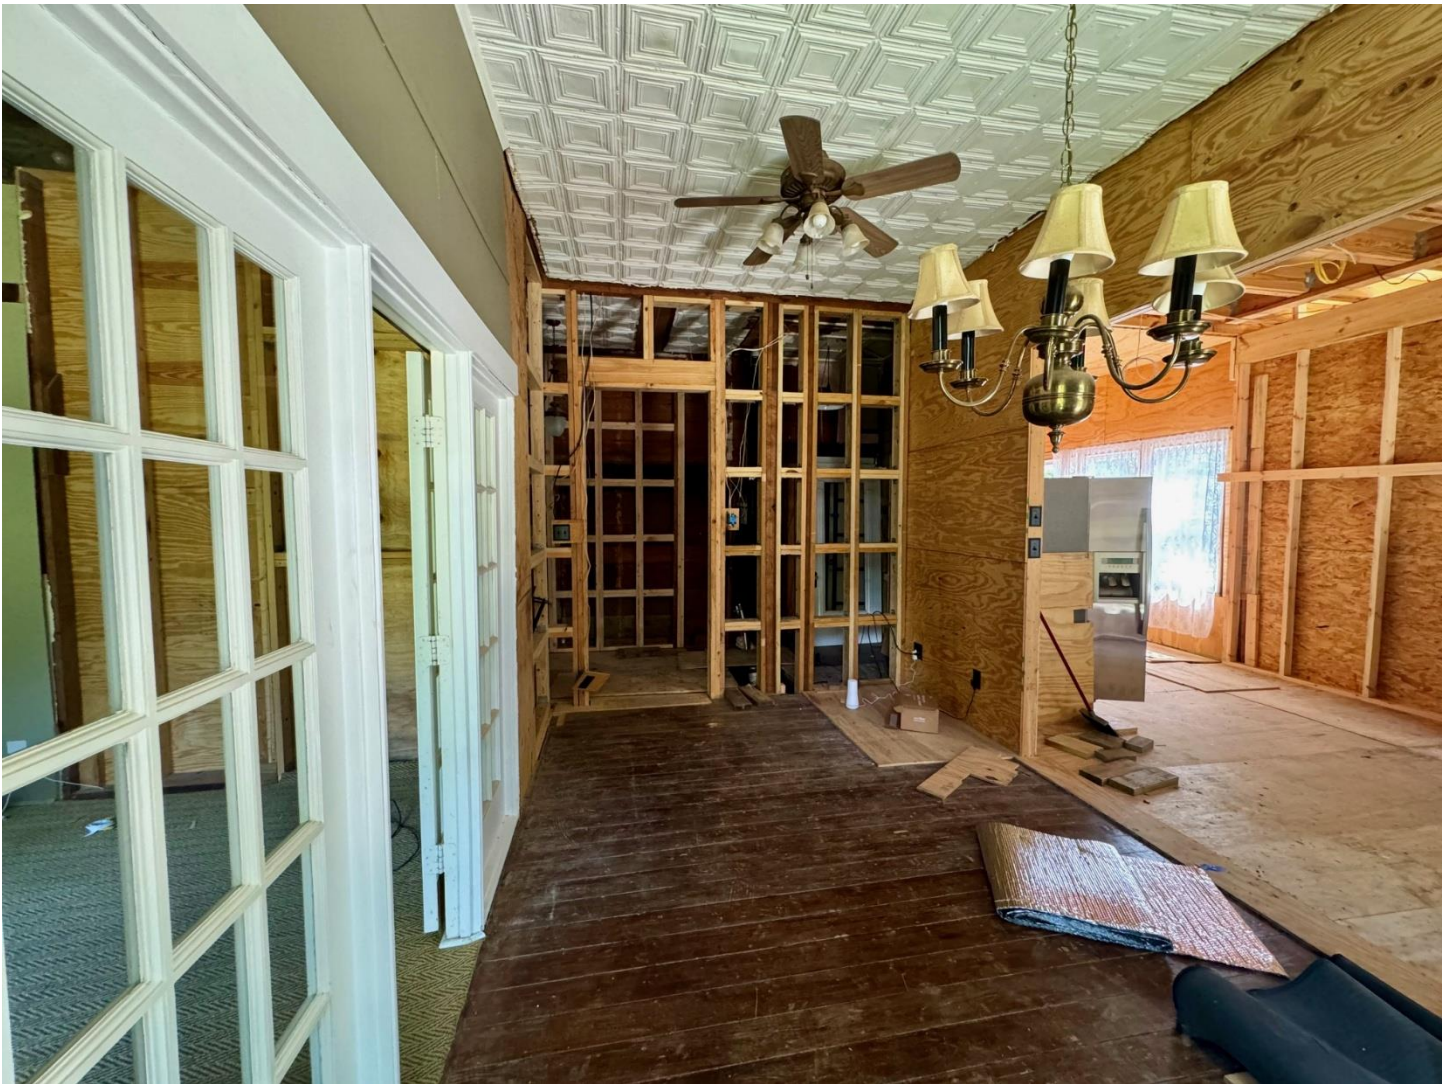
Dining area view, with visibility to office/study (left) and potential kitchen area (right). (currently no actual kitchen)

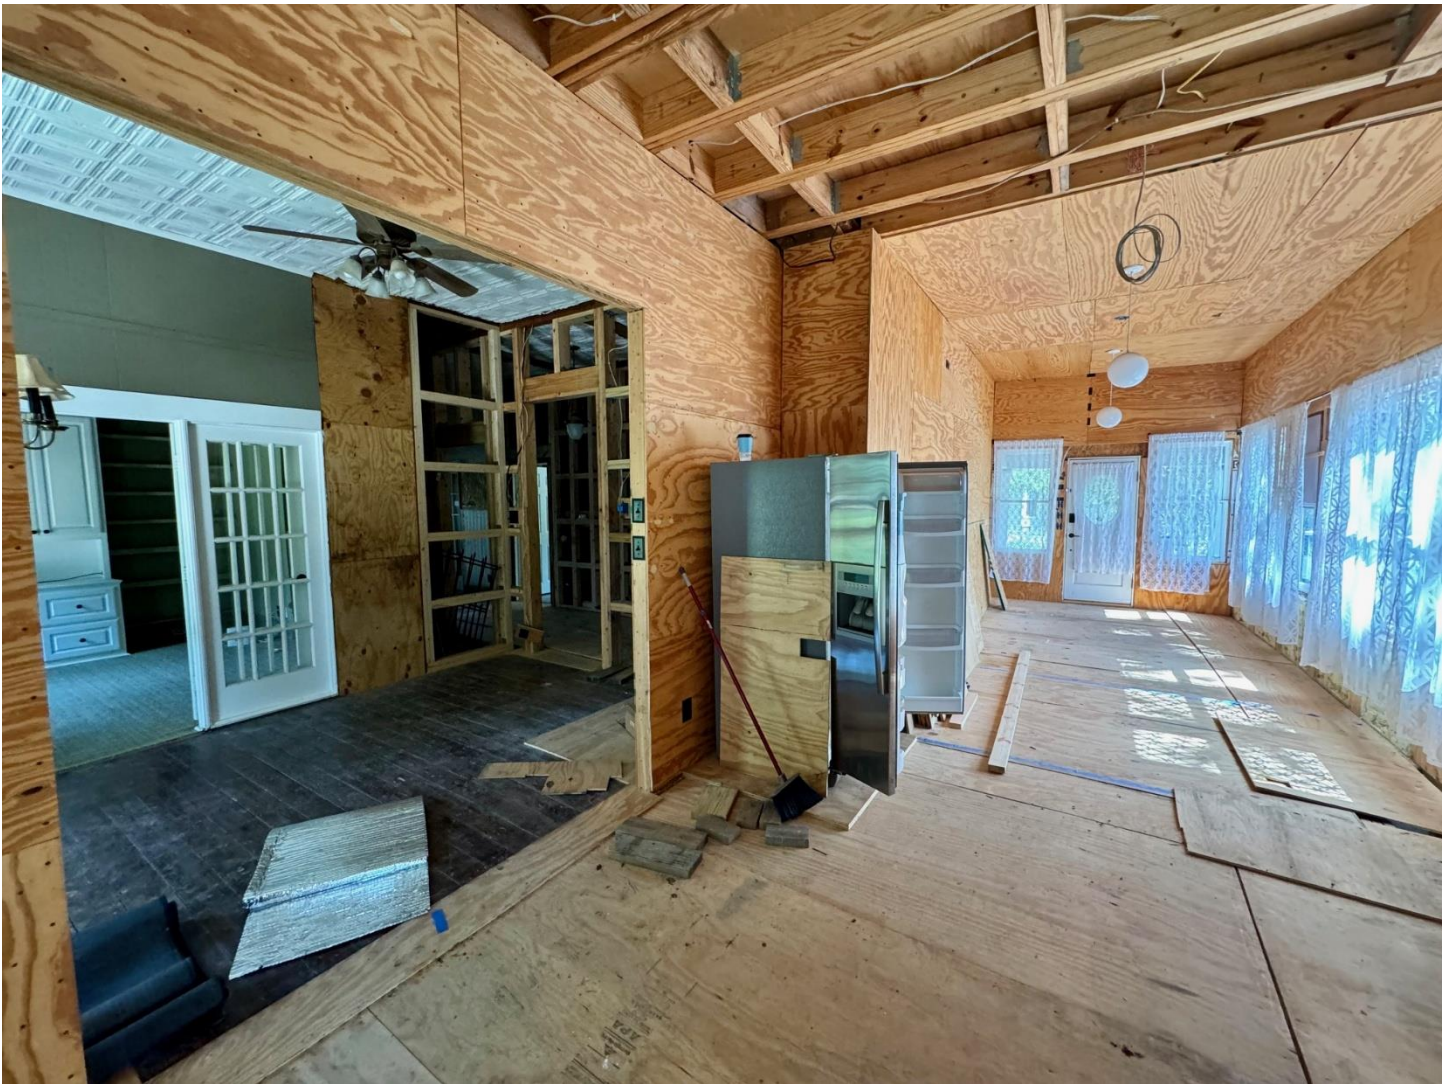
View of area previous owner used as a kitchen with views of dining area and office/study

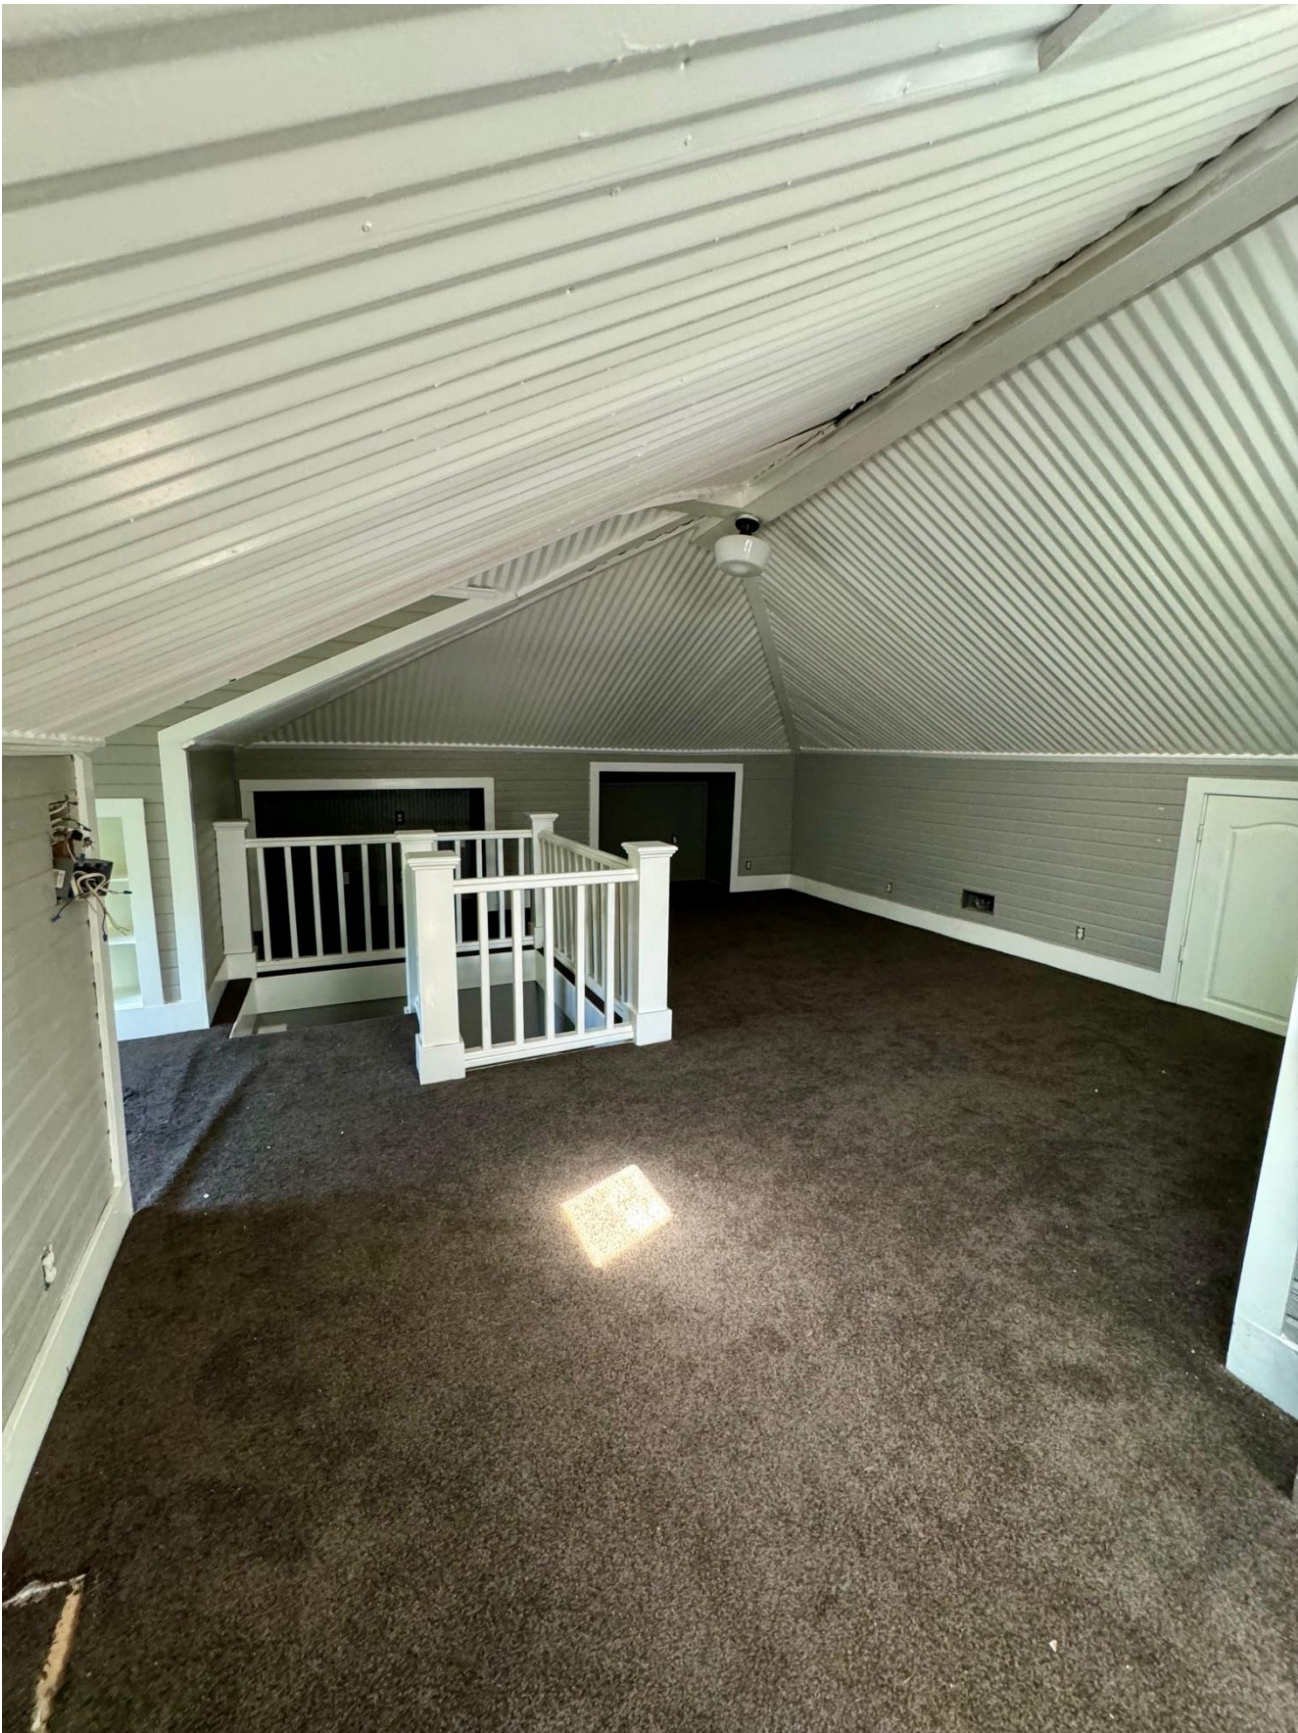
Upstairs open area. Exterior wall heights do not exceed 3 ft.

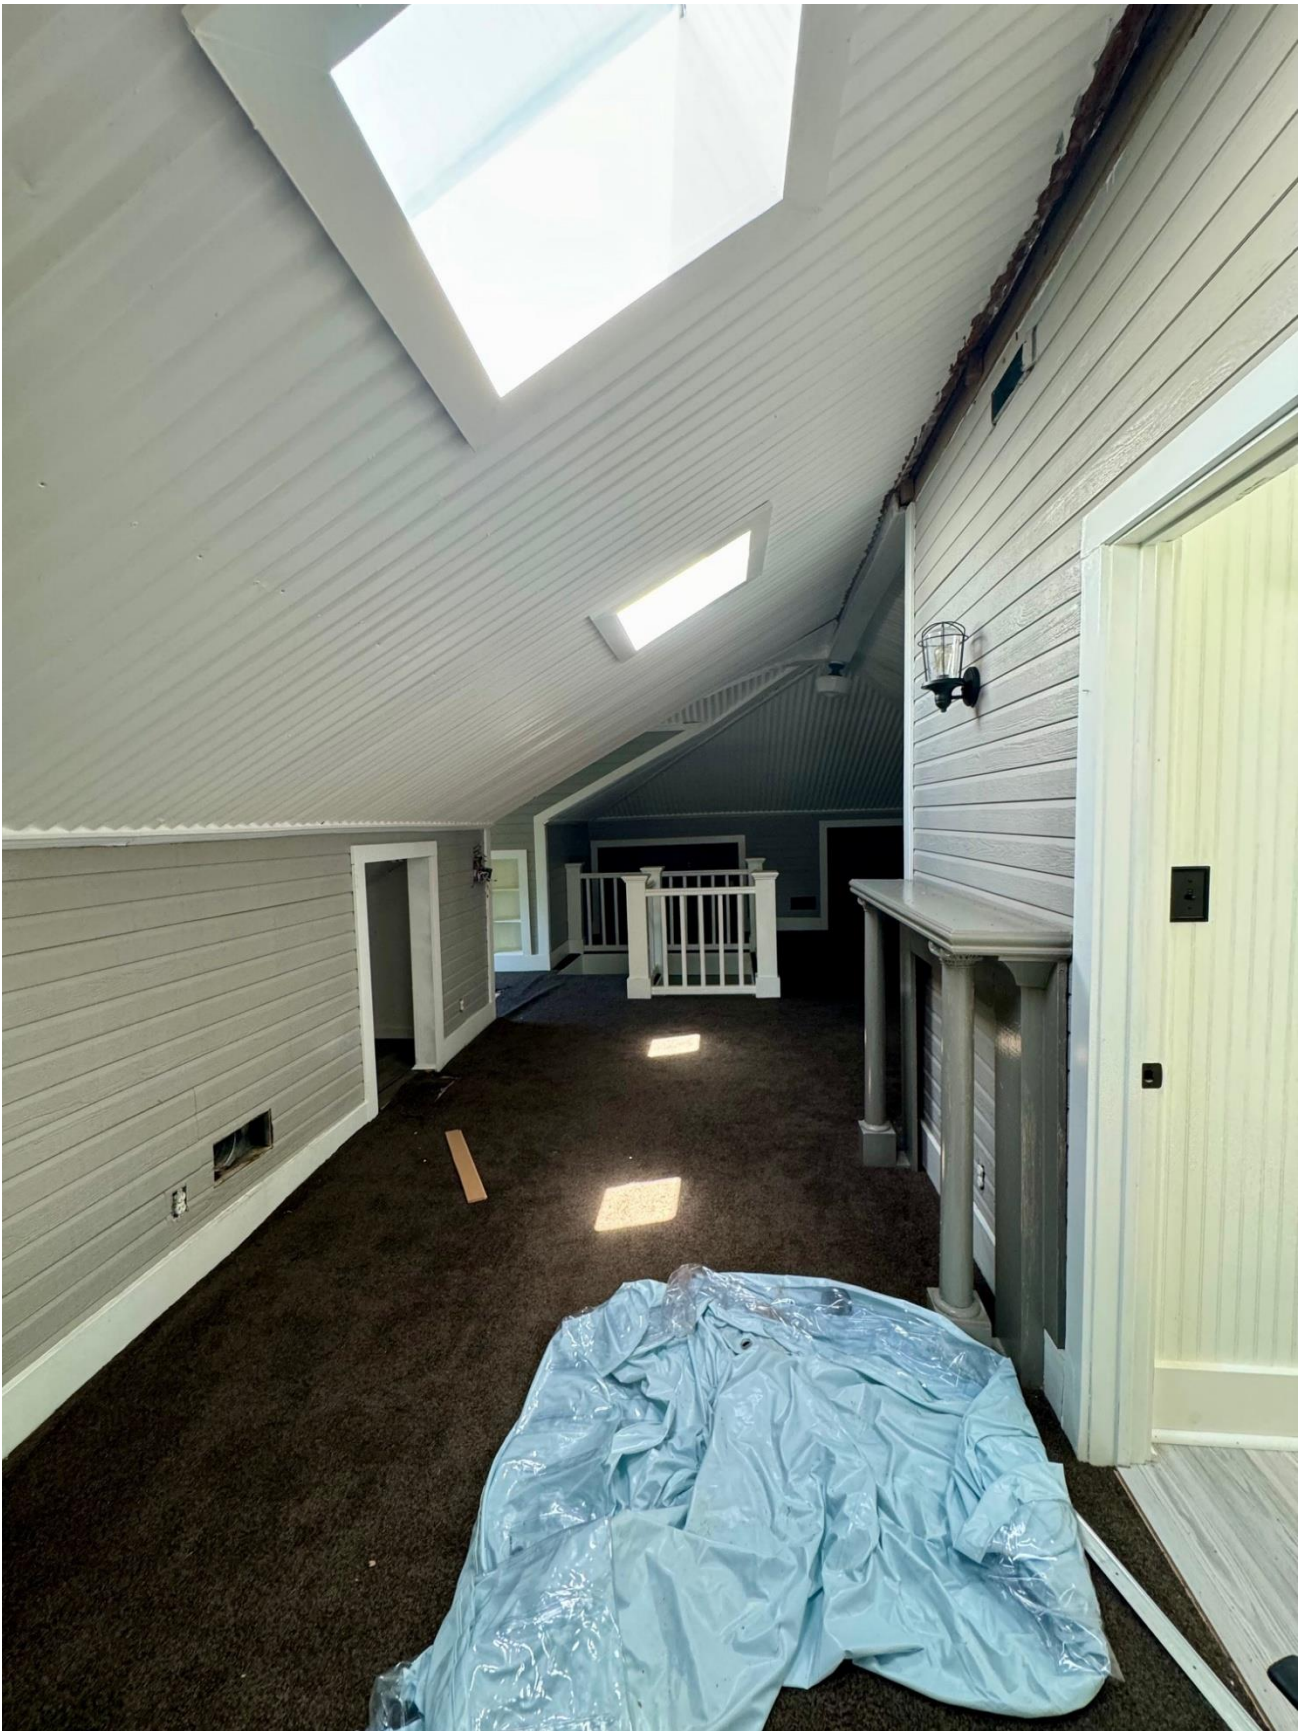
Secondary view of upstairs open area with period incorrect skylights. Tarp required to catch rain that comes through the roof.

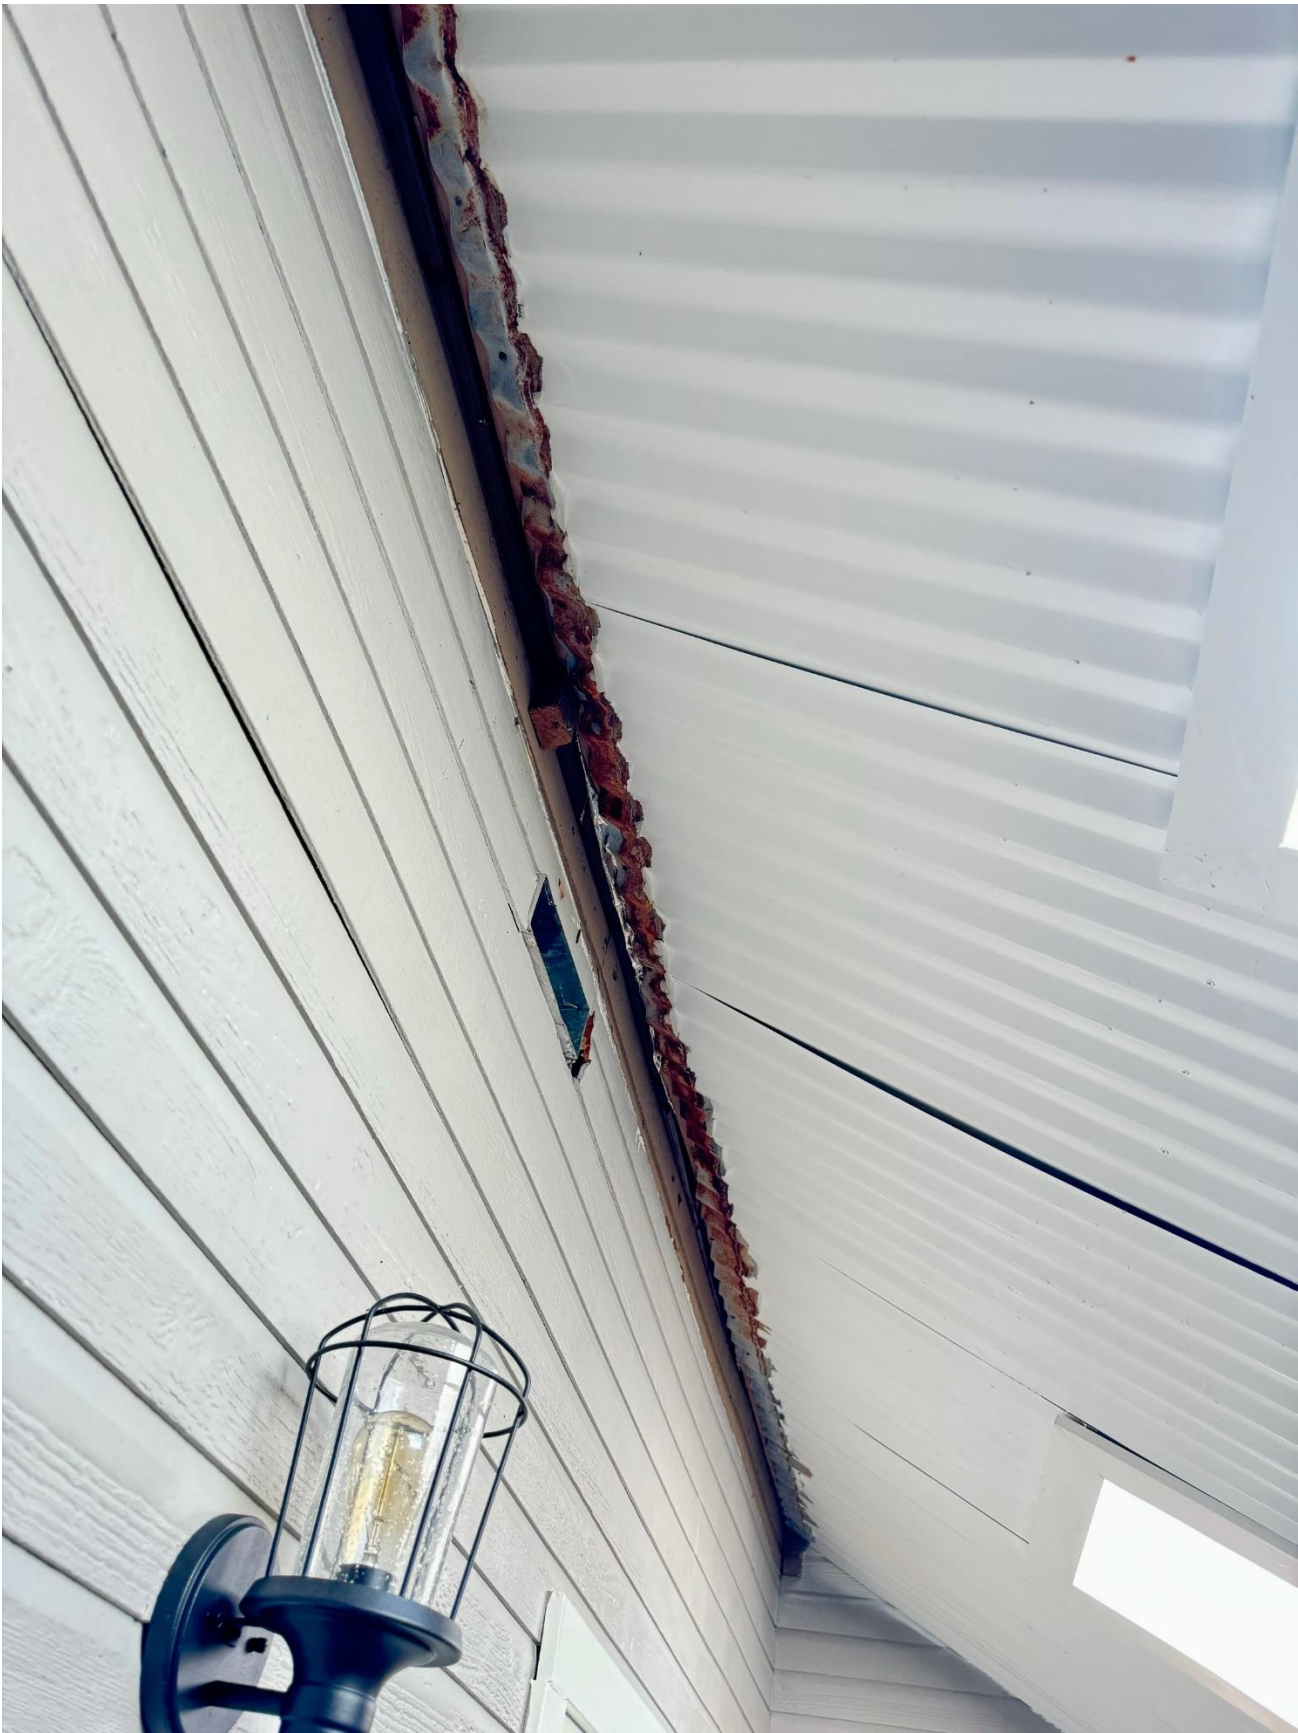
View of upstairs ceiling condition and continuing water damage due to failing roof

Note: there is not a single area of this property that would be considered complete or without damage
