Project Summary

Letter of explanation: 312 E. Cloyd St McKinney Tx

Proposed work: Demolition of existing front and rear perimeter fencing and patio cover, New Construction patio concrete and cover, new front and rear perimeter fencing.

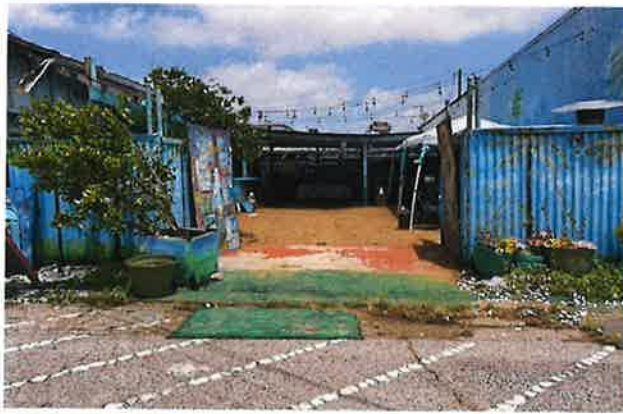
The property has existing front fencing that is 6ft tall composed of painted corrugated metal panels with painted wood affixed at entrance onto gates. This existing front fence is currently in violation of City of McKinney ordinance due to currently having no sight lines into the patio area. See photos provided below

Existing front fence and gates

- A. New fencing to be erected on same footprint of existing fencing of front and rear perimeter.
- B. Rear fence height will be **6ft 8 inches**, The fence materials will be treated wood boards for supports and slats with wood cap and Metal poles
- C. Front fence height will be **6ft**, Fence materials will be **Wrought Iron** for fence and gates
- D. Front gates material will be Wrought Iron measuring **6ft tall x 4ft wide**, manual operation, slide to open. See example photo of Wrought Iron Material and Gate

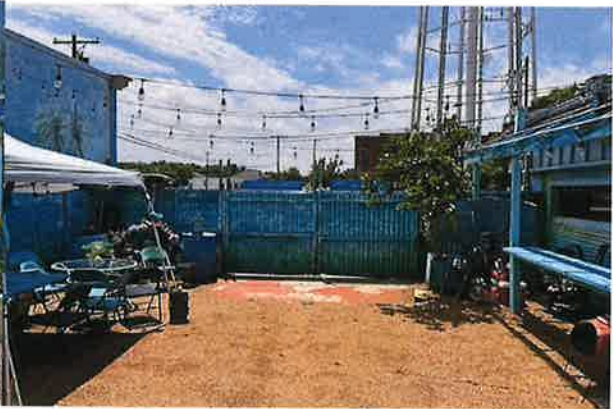
Current Total Patio area 47.5ft x 27.5ft is a pebble gravel floor surface with a non-functioning French drain that allows for water build up into puddles into several areas and eventually directs water to the interior during rain

Inside current gravel patio facing parking lot

- A. New 47.5ft x 27.5ft 4-inch concrete patio floor to be installed sloped to the parking lot to direct water away from patio area
- B. New Patio Cover will be built in the same footprint of the existing patio cover only wider to cover more of the patio space. The new patio cover will connect to existing structure (Kelly's art shack) in the same manner as the existing patio cover. The new patio cover will have one slope shed roof extending very close (6 inch) to the adjacent existing building which has approximately 16-foot-tall wall creating the exterior perimeter on the south side. This is where the new 4-inch

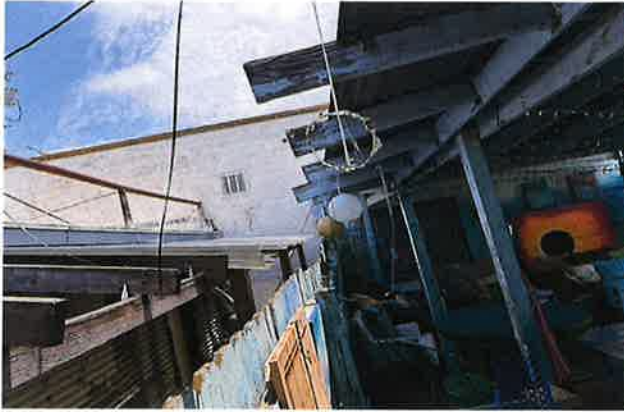
The property currently has a 6ft tall rear wooden painted fence that is in very dilapidated condition with several areas of rotten slats and supports that are collapsing. See photos provided below.

Existing rear fence and Rotten wood from patio cover rafters

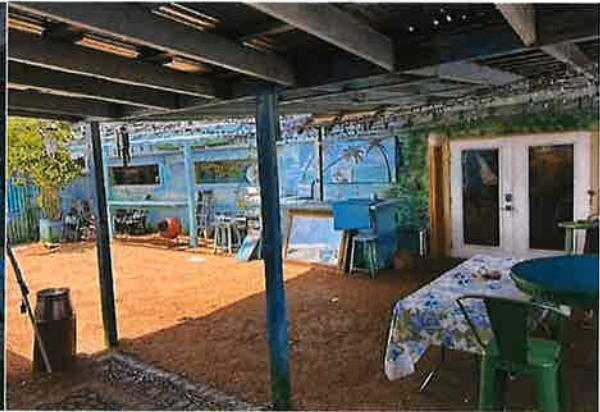
The property has an existing patio cover in very dilapidated condition with painted rotten wood throughout. The current roof of the patio cover is made of corrugated metal and leaks across many areas and is sloped towards the middle of the roof creating many drainage issues and puddling of water below. 27.5ft x 18ft is the current footprint of existing patio cover, see photos provided below.

Existing patio cover double sloped to center Rotten wood

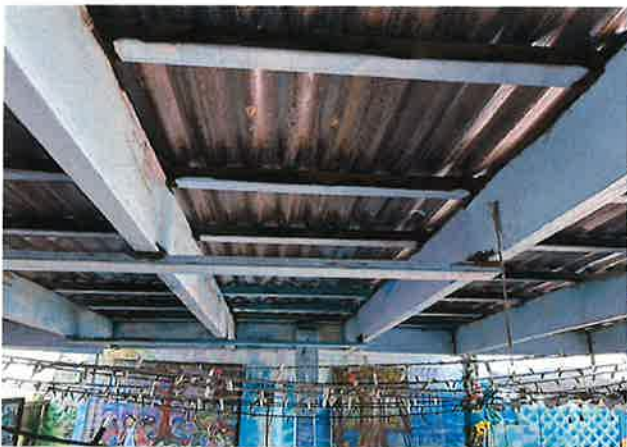
Rotten painted wood on rafters and rear fence

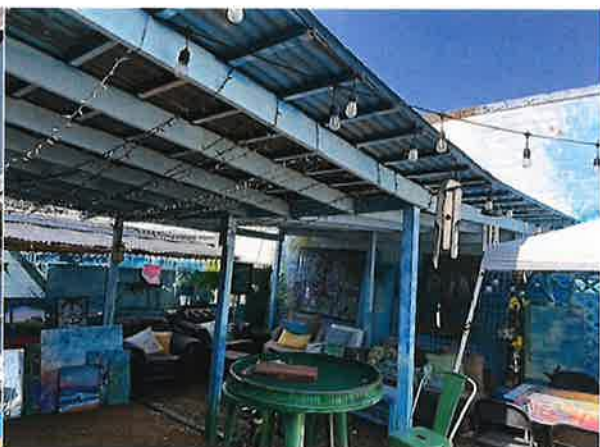
Water currently puddles and floods into the building during moderate rains and makes it impossible to use outdoor patio area due to leaky and mis sloped roof of current patio cover.

Existing patio cover slopes to center of patio space

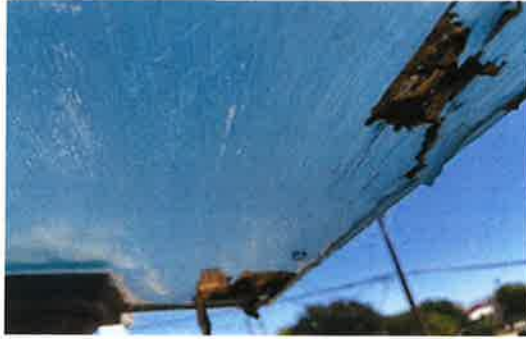
Unsupported existing covered porch

5. Project was delayed 2 weeks to fix extreme safety hazard at front entrance. Owner noticed that one of the support columns from the covered front entry areas was missing and that caused the roof structure to sag on one side. The owner requested that the column be replaced. Morgan Star attempted to install the missing column and noted that all of the soffit, fascia, and trim were completely rotten as well as the wood frame supporting the entire roof area. In order to make the entrance area safe from a roof collapse Morgan Star demolished, reframed in place all rotten support members, installed new siding, trim, soffit, and 2 new matching support columns properly supporting the covered porch area. (added cost of \$2,645)

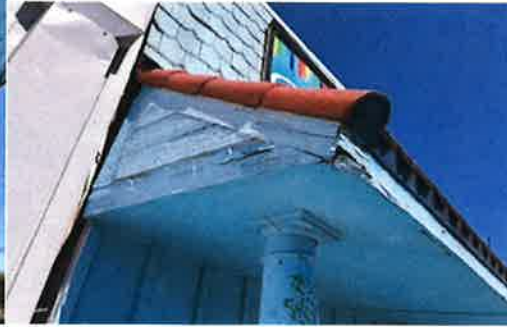
Existing covered porch area rotten wood siding

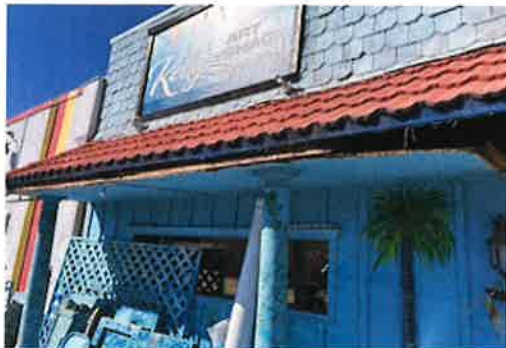
Rotten soffit, trim

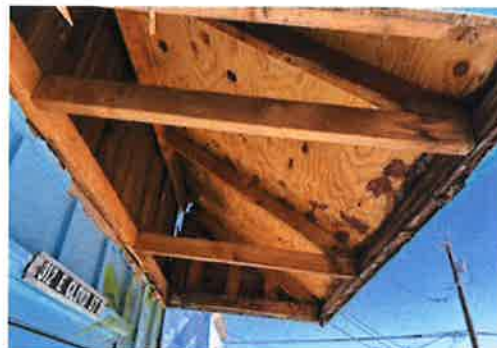
Rotten wood framing/structure

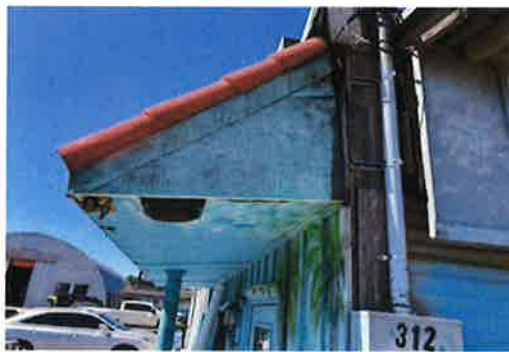
Missing column leaning covered porch area before
Existing metal siding with rotten wood replaced

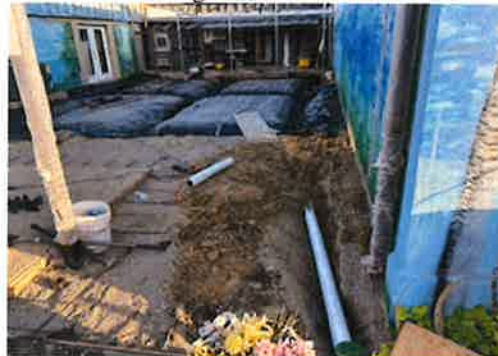
Relocate and extend wastewater drain from neighbor

1. Neighboring property wastewater drainage across the patio issue. City of McKinney wastewater department informed Morgan Star of requirement to relocate and extend the wastewater from the neighboring business in order to get building permit approval. Project was delayed 2 weeks in order to gain approval for wastewater plan. Morgan Star created drawings to relocate and extend the wastewater from the neighboring property across the new patio area due to being grandfathered in pre 1999 era. Plan drawings were approved by city wastewater

department before permit issued. One existing underground drain and one above ground roof gutter from neighboring business required to be rerouted at our project cost and installed per approved plan. (Added cost to project \$2,185)
