Hope Hardware Building

214 EAST LOUISIANA STREET

A NARRATIVE SUMMARY TOWARD THE COMPLETED PROJECT

Hope Hardware Building Renovation Project

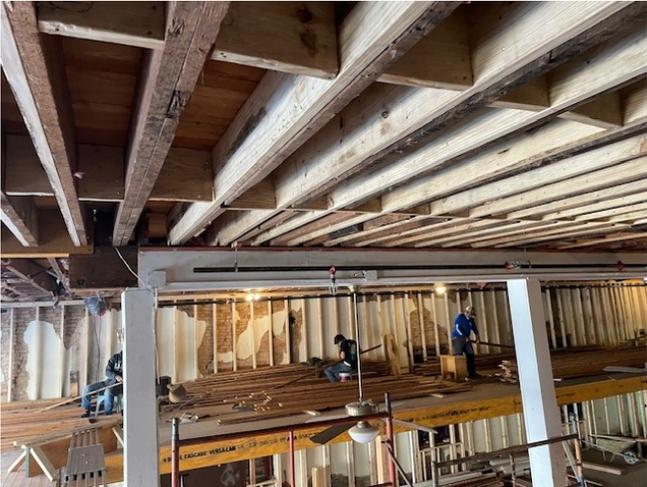
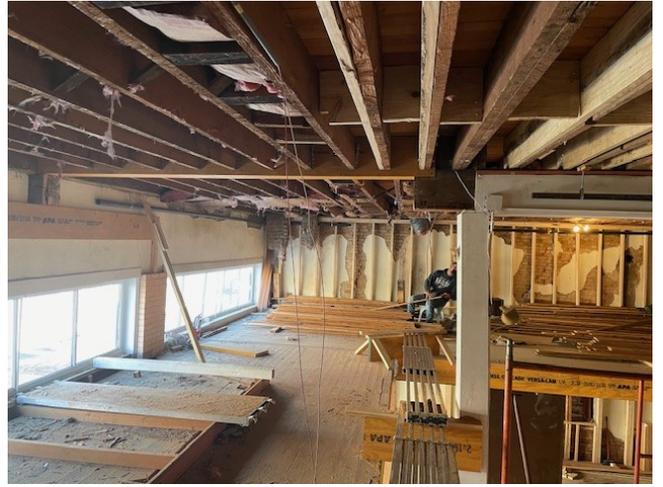
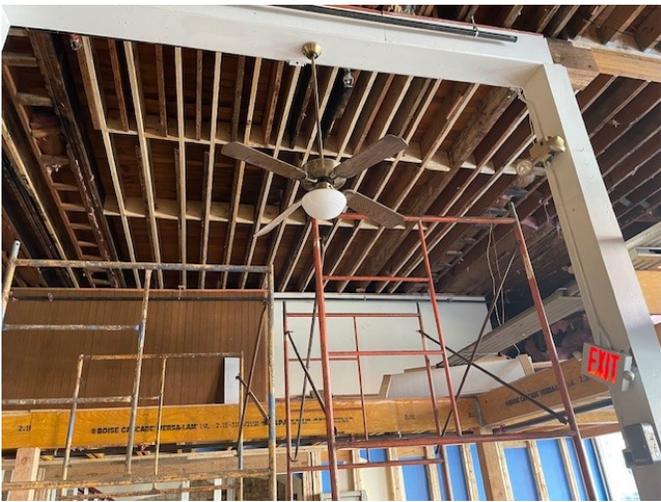
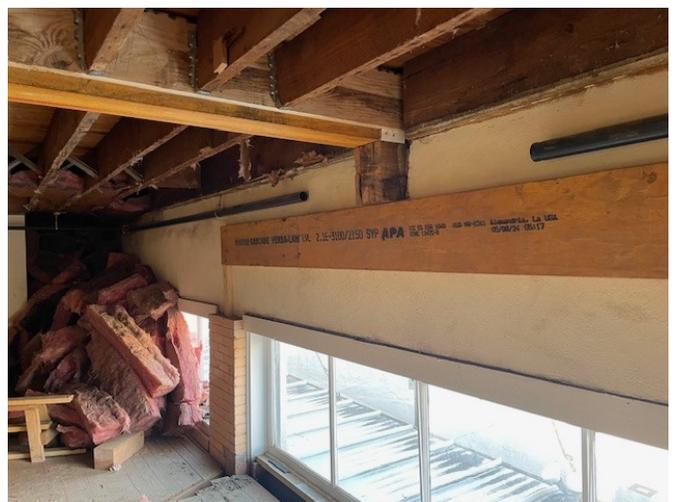
Damaged Joists

As mentioned previously, the history of the current building at 214 East Louisiana started around 1880. During that time heating with stoves in the central areas of the building occurred. Whether by extreme heat in the exhaust flue(s) or from some other problem, structural second floor framing was damaged. In our efforts to clear the first floor of the obstacles presented by a two story braced frame at the front entry our contractor and structural engineer followed up their search for damage to the framing by removing the wood ceiling below the second Floor exposing the original damaged second floor joists. This 117 car siding was salvaged for future reinstallation on the ceiling. By the use of steel scaffolding (photographs A and B) to brace the second floor, new joists were introduced to sister new joists to the damaged joists allowing the original clear span to be restored and the early braced frame removal.

The exploration of damage explains how the original fire damage began on the first floor near the front of the building damaging the second floor framing so seriously that the mid span framework had to be erected to support the burned joists in the first two bays to the building. Moreover, the framework was extended to the second floor roof framing to give added bracing to the repairs below.

Upon removing the entire ceiling in search of this original damage to the first two structural bays, new full span joists were added to brace the Second Floor framing to ensure safe use of the building on all floors (photographs C through J).

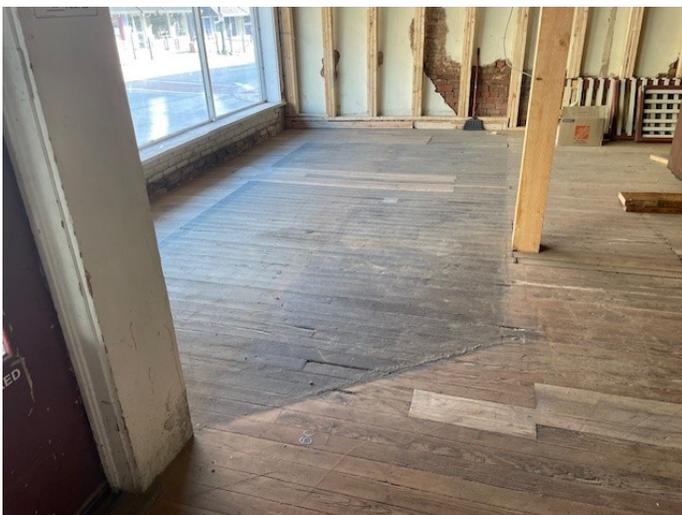
Repair of Damaged Floor

Earlier discoveries of fire damage and debris hidden below the first floor framing was discovered during the historic floor repair and was brought to light and more than six tons of burned debris was taken from below the first floor where there was clearly damage to the building in the early years of use.

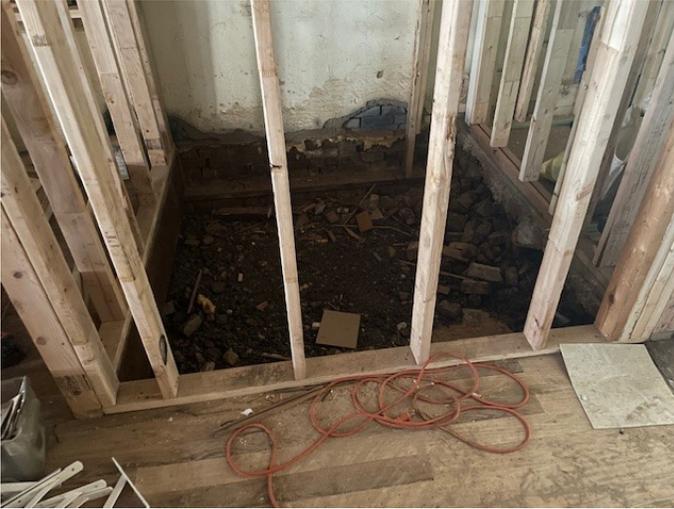
Fire Riser Room: Framing completed, Fire System installed. Waiting for Tenant's plan to complete the concrete floor, side door access, drywall and electric)

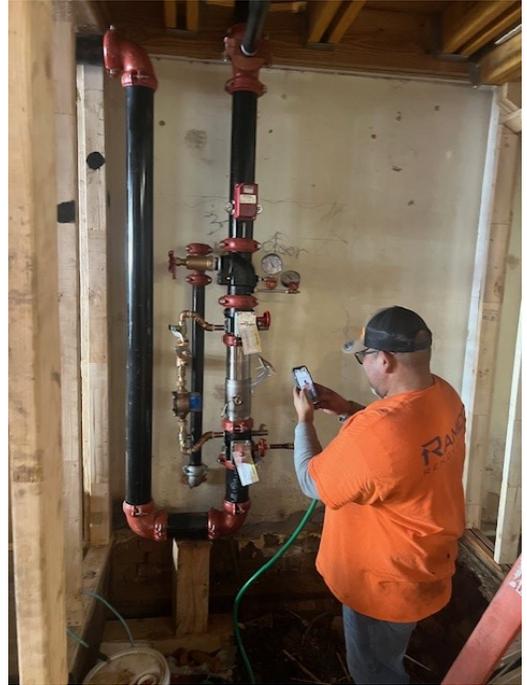
System Testing

Work above was the most important part of the project that was completed and inspected by the City of McKinney successfully on 12/20/2024.

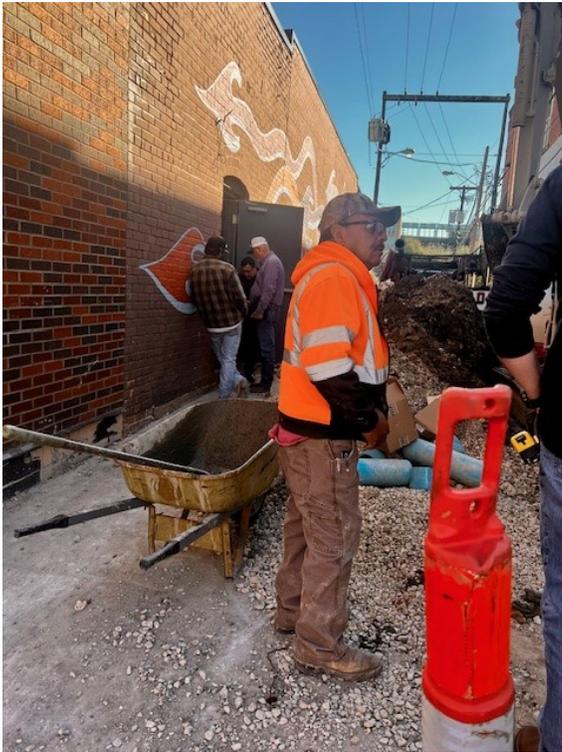
City Inspector water pressure test
