# Certificate of Appropriateness - Demolition

1505 W  
Louisiana

Historic Preservation  
Advisory Board Meeting  
November 6, 2025  
5:30 pm

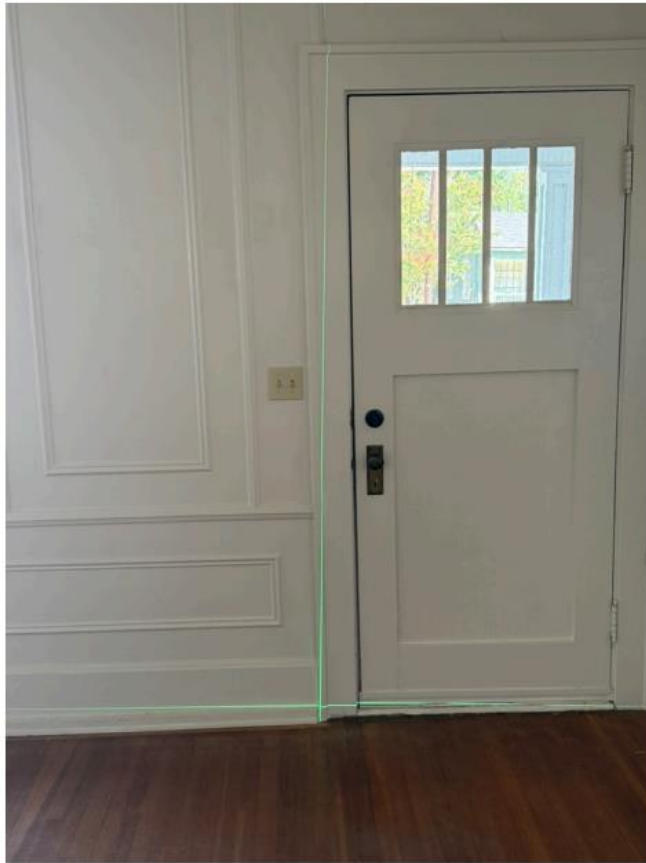
- Walls out of plumb on average 1 1/2" – 2 1/2", largest deviation 4 1/4" out of plumb
- Floors out of level on average 2" – 3", largest deviation 6 3/4" out of level
- Above condition not allowing any windows to operate (NO FIRE EGRESS)
- Floors spongy in several areas with foot traffic, will not properly support motorized wheelchair
- Many doors not wide enough for wheelchair access
- Rafters are 2" x 4", not supporting HVAC properly
- Exposed Romax wiring in several interior and exterior locations
- Evidence of "Leveling and Shoring up" efforts by previous contractor, uncertain as to why home is still significantly out of level and out of plumb
- Laboratory testing confirmed elevated mold spore concentrations throughout the interior
- Aspergillus/Penicillium-like spores were recorded in excess of 3,400 spores/m<sup>3</sup>
- Epicoccum spores were also present indoors

Above: Walls out of plumb.

- Staff recommends approval of this request for the demolition of the house
- Foundation, wall, floor, and roof connections have been compromised
- Previous foundation repairs (2022), including adding steel plates, to prevent further shifting and damage to walls, floors, joists, ceiling, roof, etc. have proved unsuccessful
- Continued attempts to re-level the foundation will most likely cause more damage
- Elevated levels of mold throughout the interior indicate that effective remediation cannot be achieved without full-scale reconstruction

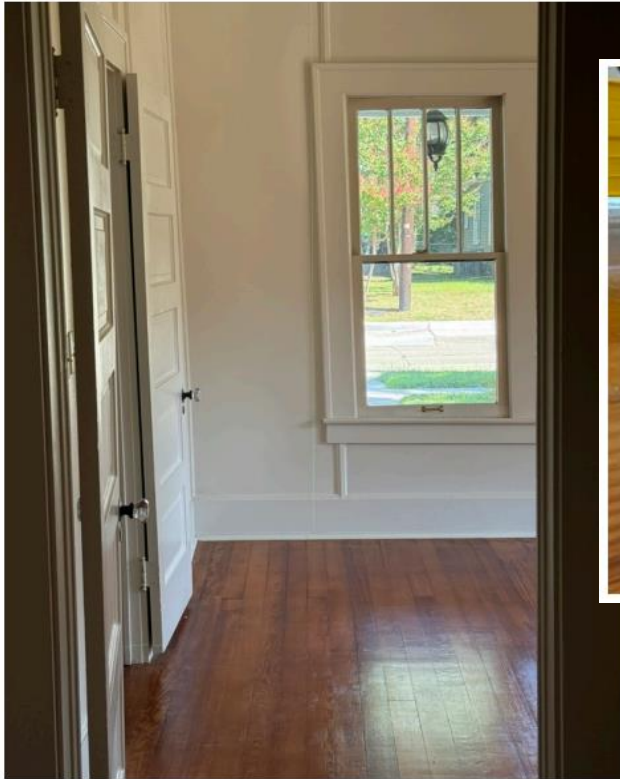
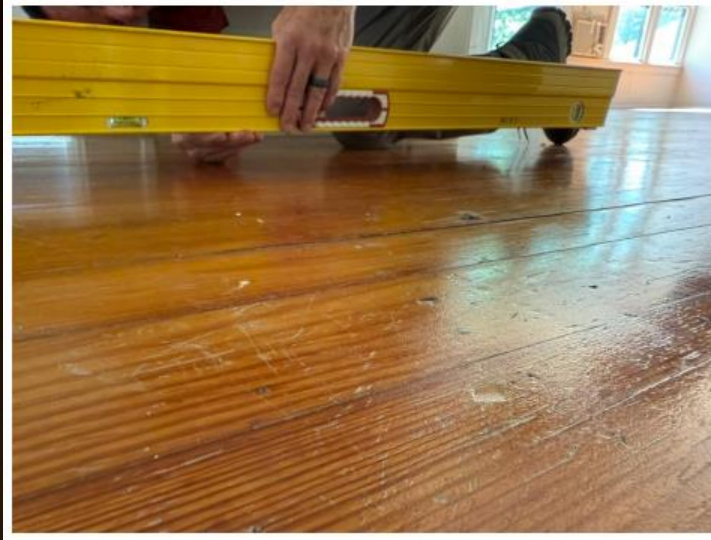
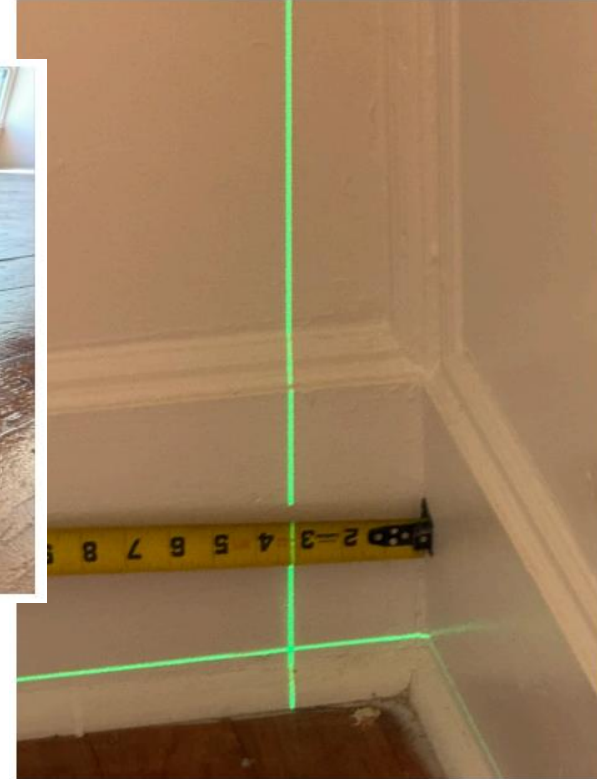
Walls being out of plumb and floor being out of level 2-3" prevents windows from opening
