Building Due Diligence

110 Davis Street
McKinney, TX

Prepared for: Parks Church

RE: 110 Davis Street, McKinney Tx 75069

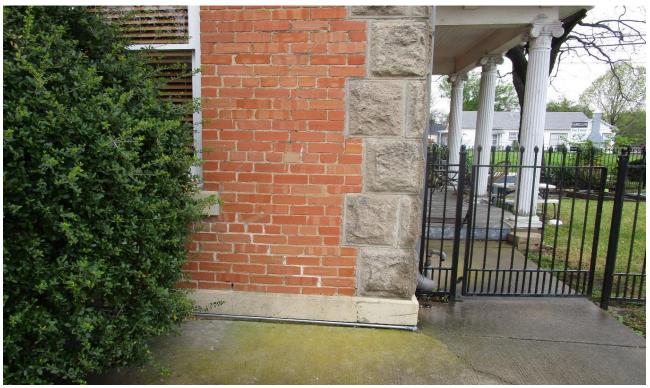
Photo #2 Northwest corner of the north side of the building. the corner of the building has experienced some foundation movement in the past.

- There is a crack in the brick at the northwest corner of the building that
 has been previously repaired. The crack is likely due to the downspout
 discharging next to the foundation and causing foundation movement.
 Recommendation: Downspout should be connected to an
 underground line and discharged in the parking lot.
- Some of the brick on the north side at the northwest corner has numerous small holes and two of the bricks are missing the finish surface due to water penetrating the ice and freezing.
 Recommendation: The damaged bricks and bricks with holes should be removed and replaced.

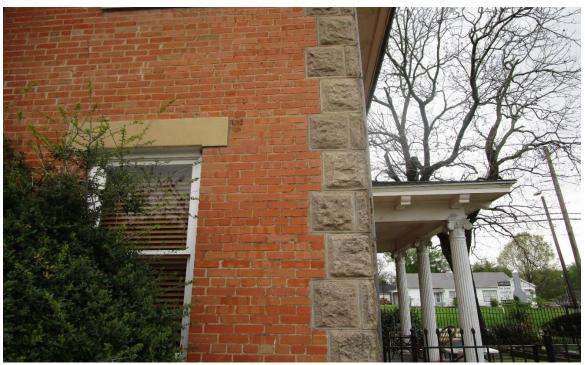
Photo #3 Some damage to the brick on the northwest corner of the building is present.

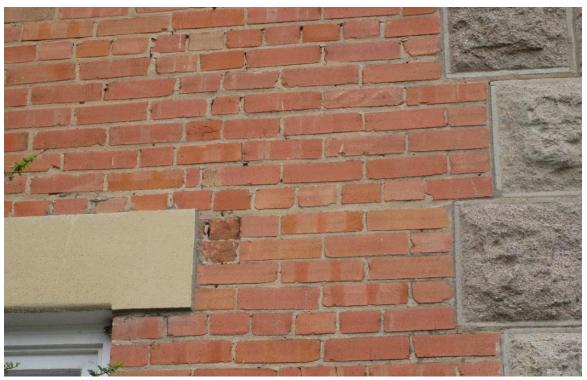
Photo #4 Close up of some of the damaged brick on the northwest corner of the building. This area needs to be tuck pointed to keep water out of the walls.

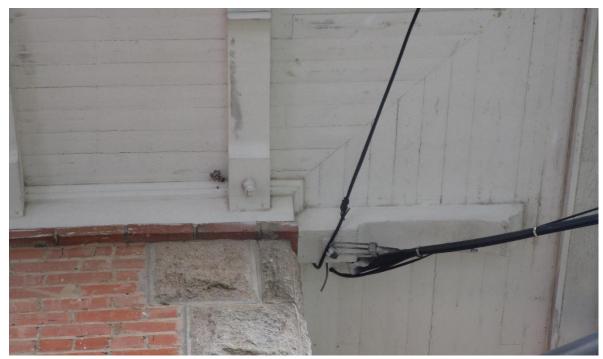
Photo #5 Clouse up of roof soffit at the northwest corner of building. The utility lines do not appear to have damaged the soffit structure.

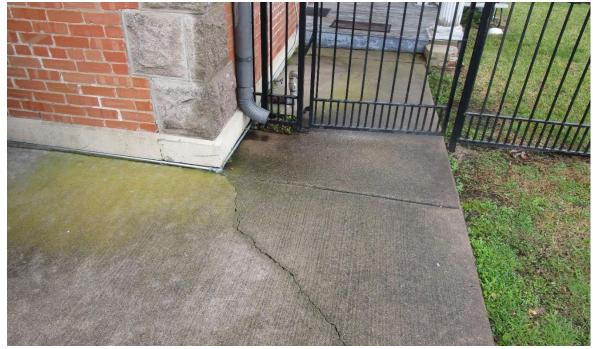
Photo #8 Downspout discharging next the building. Large crack in the sidewalk and the cracks in the brick are likely due to the water from the downspout being discharged next to the foundation.

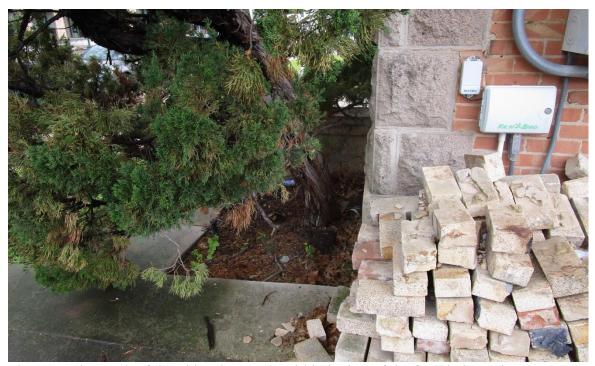
Photo #9 The trunk of the old cedar tree is within inches of the foundation. The tree should be removed.

- A large cedar tree is within inches of the foundation at the northeast corner of the building. Recommendation: This tree should be removed.
- The stucco covered brick column supports on the east covered patio are cracking and shifting. Recommendation: All stucco should be removed, bricks repaired and stucco replaced.

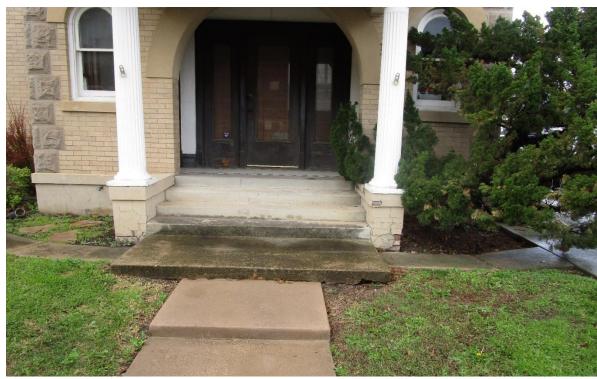
Photo #12 East entrance to the building. The stucco on the short brick walls is falling off. The steps appear to be bowing upwards in the middle, likely due to some heaving of the soil.

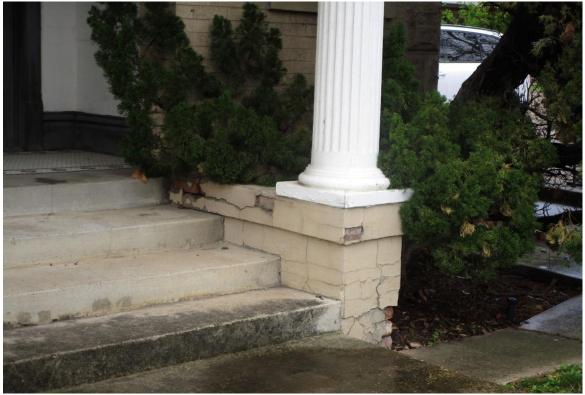
Photo #13 Another view of the damaged brick wall on the north side of the covered porch entrance.

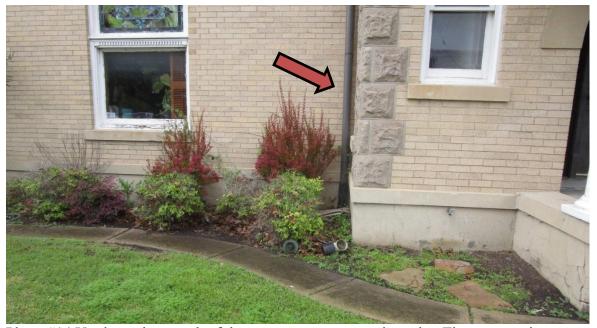
Photo #14 Yard area just south of the east entrance covered porch. The arrow points to a downspout nestled in the corner. This should be tied to an underground drain that discharges at the curb.

- Downspout on the southside of the east patio appears to be tied to an underground drain that discharges a few feet away. Recommendation: The downspout should be connected to an underground drain that discharges at the curb.

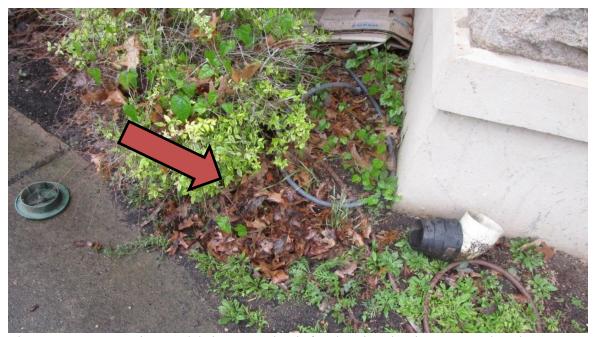
Photo #16 Arrow points to debris covered exit for the pipe that is connected to the downspout. No water is flowing out from the pipe shortly after a rain event. This should be tied to an underground drain that discharges at the curb.

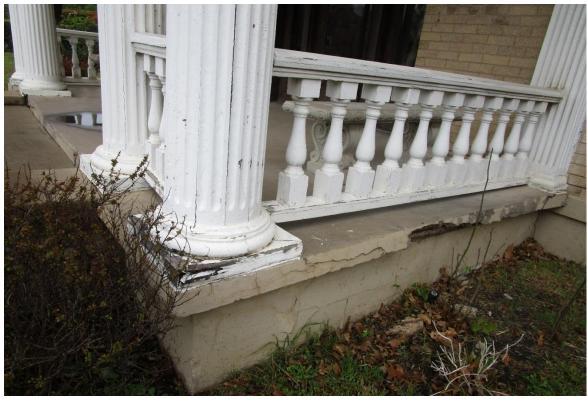
Photo #19 The column base and concrete have severe water damage.

- The concrete slab for the south covered patio is severely cracked.
 Some of the concrete on the sides of the slab have spalled off and the exposed rebar is heavily rusted. Recommendation: All loose and delaminated concrete should be removed, the rusted rebar treated and the concrete replaced. Option, remove and replace the concrete slab in its entirety.

- Wood column bases for the fluted columns on the south covered patio are rotted. Recommendation: The rotted wood bases need to be removed and replaced.

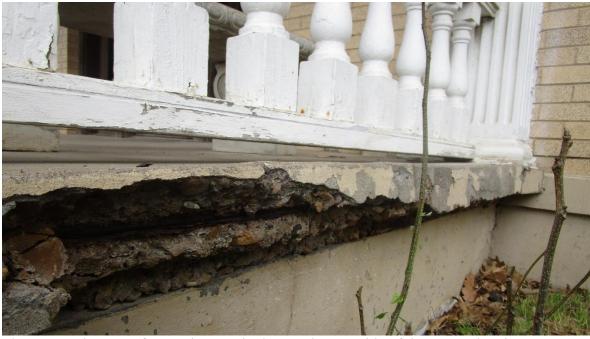
Photo #20 Close up of severely rusted rebar on the east side of the covered patio.

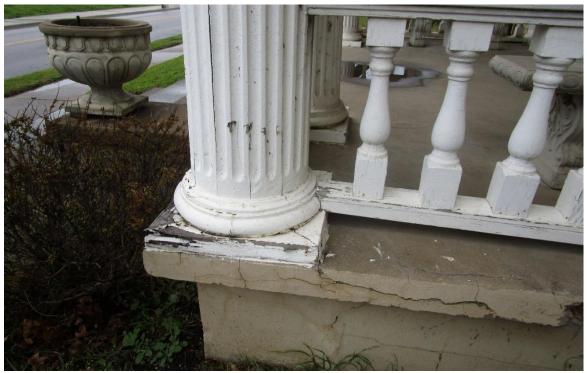
Photo #21 The wood column base has severe water damage and needs to be replaced.

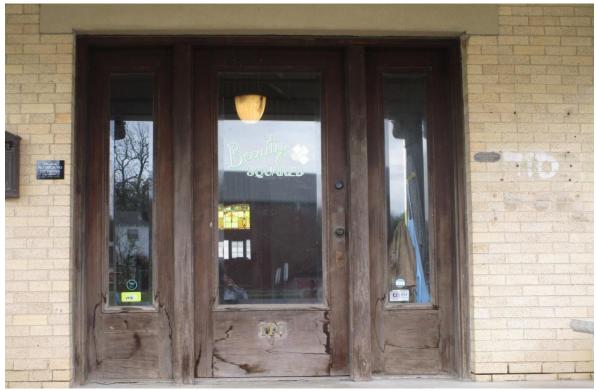
Photo #23 South entrance doors are heavily weathered. It may be possible to refurbish the doors.

- The wood doors and sidelights for the main south entrance have significant UV damage but the wood does not appear to be rotted.
 Recommendation: Refinish the doors and sidelights.

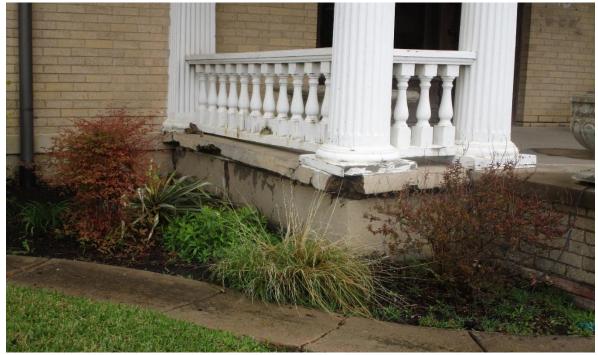
Photo #24 West side of the south covered entrance patio. This side has concrete damage and wood column base damage.

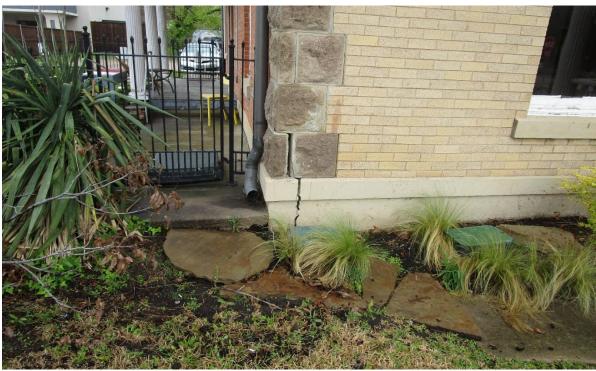
- There is a large vertical crack in the foundation and first stone quoin at
 the southwest corner of the building. Analysis: The crack is likely due
 the downspout discharging water next to the foundation and/or the roots
 of the large tree about 12 feet to the west of the building corner.
 Recommendation: Connect downspout to an underground pipe and
 discharge thru the curb at the street. Add a root barrier between the tree
 and the southwest corner of the building. Repair the concrete
 foundation and tuck point damaged stone quoin.

Photo #26 Large crack in the foundation and stone quoin at the southwest corner of the building. The crack is likely due to the downspout discharging water next to the foundation and/or the nearby large tree.

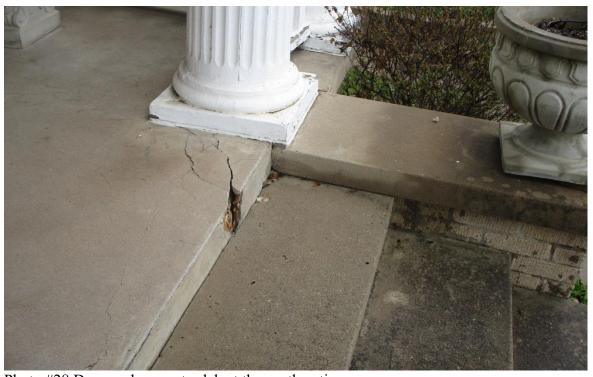
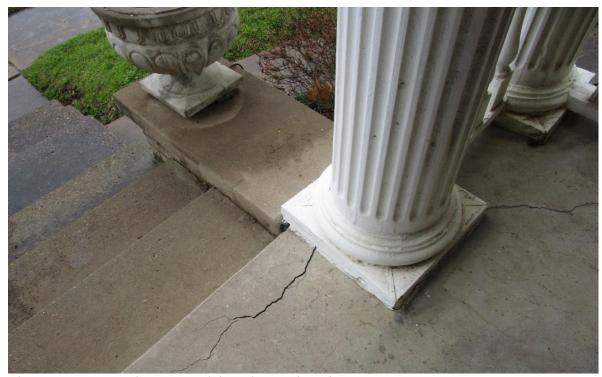
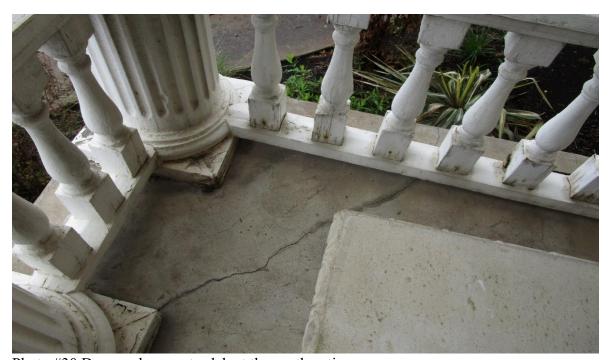
Photo #28 Damaged concrete slab at the south patio.

Photo #29 Damaged concrete slab at the south patio.

Photo #30 Damaged concrete slab at the south patio.

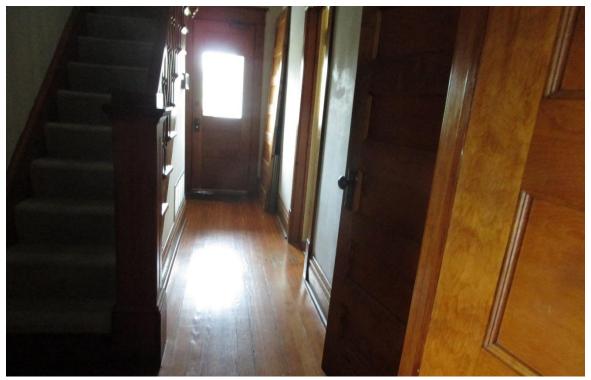
Photo #31 View of main hallway on first floor looking towards the west. Note some ripples in the hardwood floor.

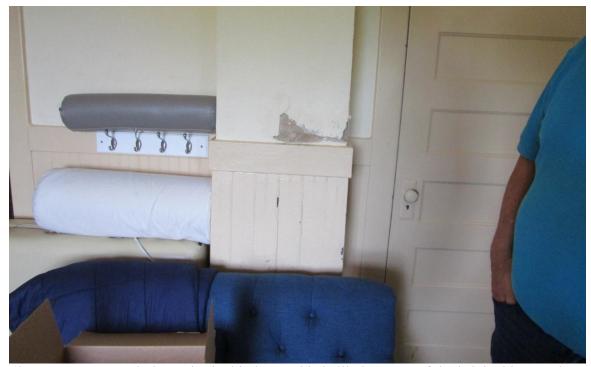
- The plaster around a "bump out" in the kitchen on the first floor has water damage. The "bump out" is likely due to water leaking in at the roof chimney intersection. Recommendation: Repair roof to chimney connection. Paint the brick chimney above the roof line or wrap in sheet metal and inspect and repair/replace chimney caps. If the chimney is no longer functional, remove portion of chimney above the roof and roof over the opening. This is the best option.

Photo #33 Damaged plaster in the kitchen. This is likely a part of the brick chimney that has water coming around the roof penetration.

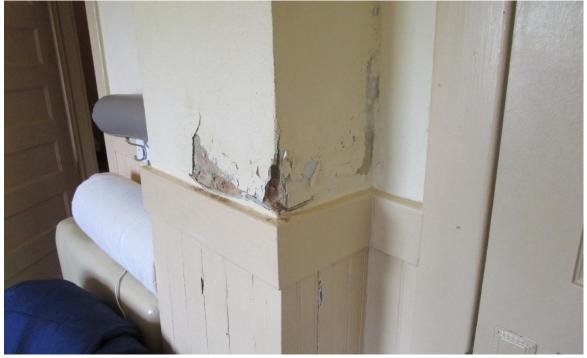
Photo #34 Another view of the damaged plaster in the kitchen.

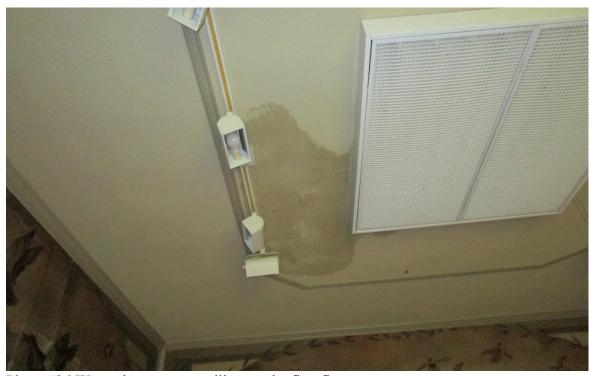
Photo #36 Water damage to a ceiling on the first floor.

- There are numerous areas on the first floor ceiling and wall murals with water damage. Recommendation: The roof likely needs replacing and any roof penetrations as previously described.

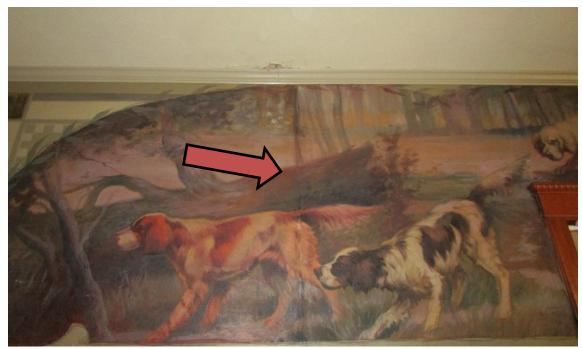
Photo #37 The arrow points to a crack in the wall mural. The crack is likely due to water from a roof leak.

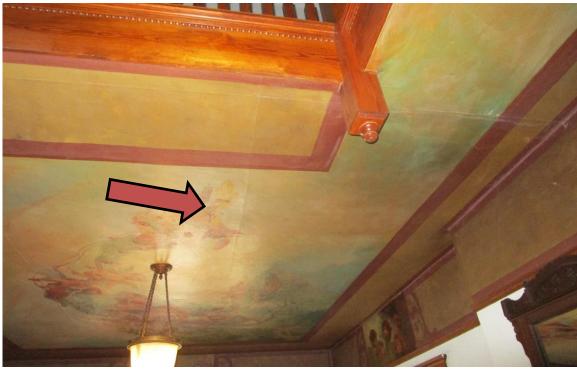
Photo #38 The arrow points to a crack in the ceiling mural. The crack is likely due to water from a roof leak.

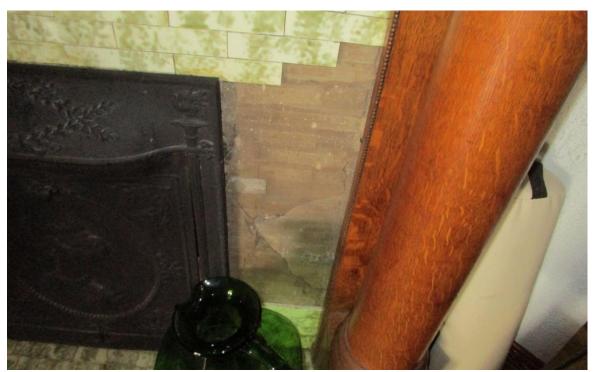
Photo #40 Tile missing from the right side of the fireplace surround. This may be due to a water leak or an overheating of the fire brick that is now exposed and cracked.

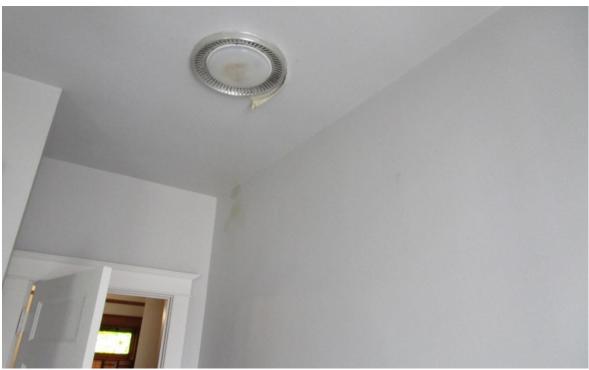
Photo #42 Some water damage to the wall near the ceiling and to the wall paper around the ceiling light.

- There is other interior damage to plaster ceilings and walls on the second floor. **Recommendation:** Once the roof leaks have been rectified, repair and paint damaged plaster.

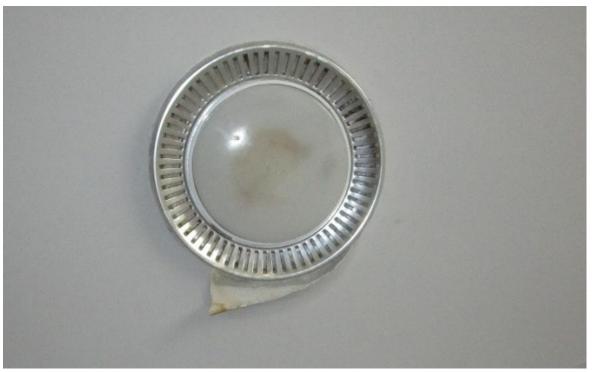
Photo #43 Close up of damaged wall paper around the ceiling light fixture. The fixture likely has water damage as well.

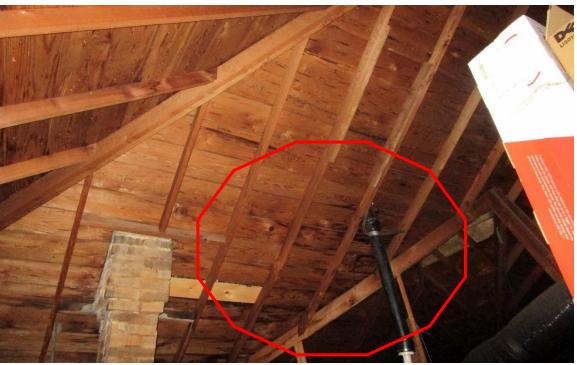
Photo #45w View of the underside of the north side of the roof. The circled area appears to have water damage. Two deck boards have been replaced. Some of the roof rafters have been repaired.

- The 1x6 wood roof decking has water staining on the underside in the attic in numerous locations throughout the attic. Recommendation: Install a new roof.

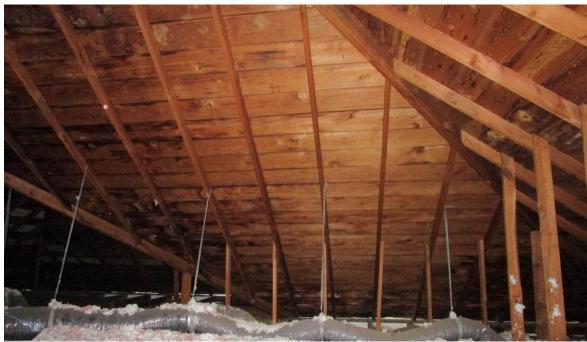
Photo #46 Underside of the west portion of the roof. The roof rafters are 2x4's at 24 inches on center and are spanning way beyond the code allowable spans. The decking on the left side of the photo has a lot of water staining.

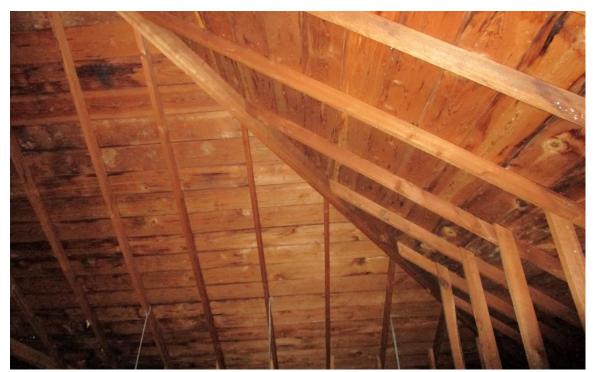
Photo #47 Southwest corner of the roof. Some water staining is visible on the roof deck on the left side of the photo.

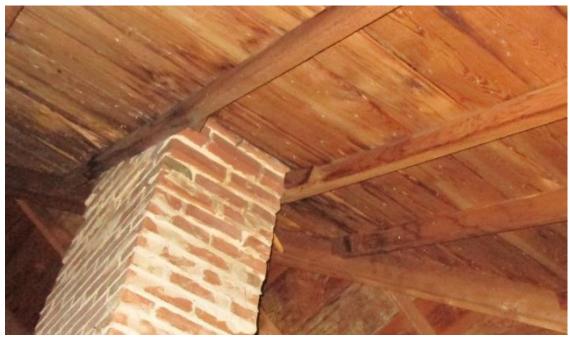
Photo #48 Close up view of the chimney – roof intersection. The decking has apparent water damage and some of it needs to be replaced.

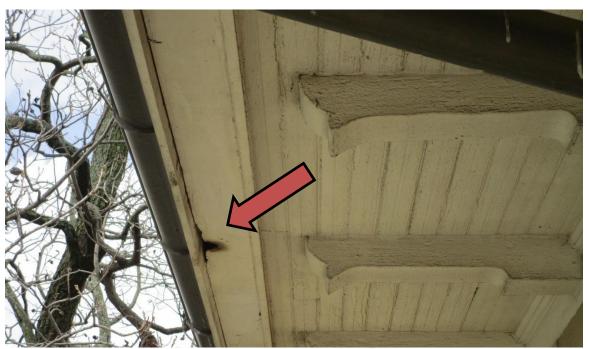
Photo #51 Arrow points to a hole in the roof soffit that is likely due to roof rats or squirrels. This hole should be filled. Note that rodents will chew thru wood to gain access to attics.

- A vermin hole is in the roof soffit on the south side of the building.
 Recommendation: Hire exterminator to rid building of pests. Fill hole with a metal plate and paint to match siding.

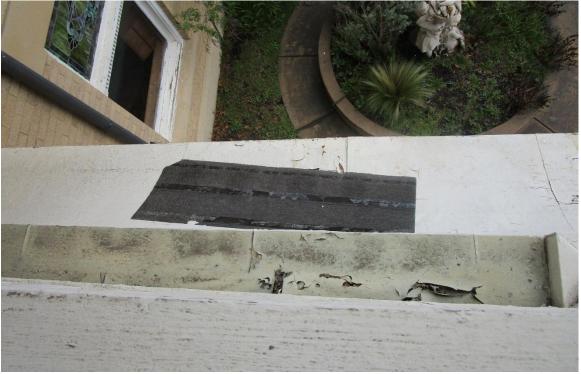
Photo #52 A roof shingle from upper roof that is laying on the east side of the lower roof for the south side entrance.

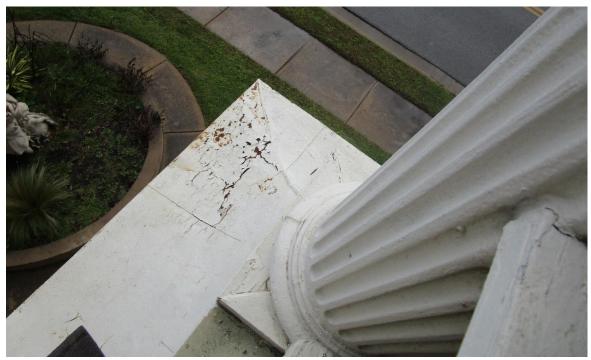
Photo #53 Crack paint on the lower roof southeast corner. It appears that the metal for the lower roof is rusting.

- The paint for the sheet metal "skirt" around second floor balcony is heavily cracked in some areas. Recommendation: Remove and replace paint.
- There is a crack in the brick at the upper right corner and of a first-floor window on the south side of the building. Recommendation: Remove broken brick and install a new one or seal crack in brick with a sealant that matches color of the brick.

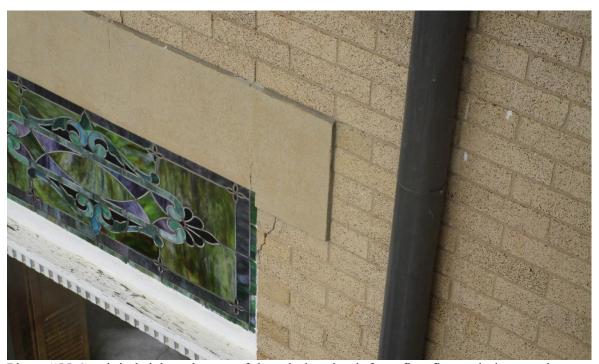
Photo #55 Crack in brick at the top of the window jamb for a first floor window on the south side of the building.

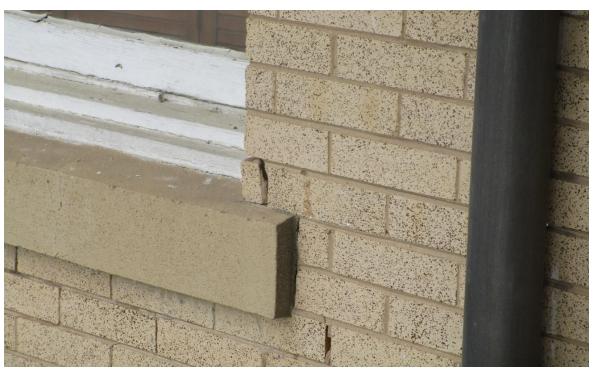
Photo #57 A small piece of brick has lost the mortar tying it to the remaining brick.

- There is a crack in the brick at the lower right corner and of a secondfloor window on the south side of the building. Recommendation: Remove broken brick and install a new one or seal crack in brick with a sealant that matches color of the brick.

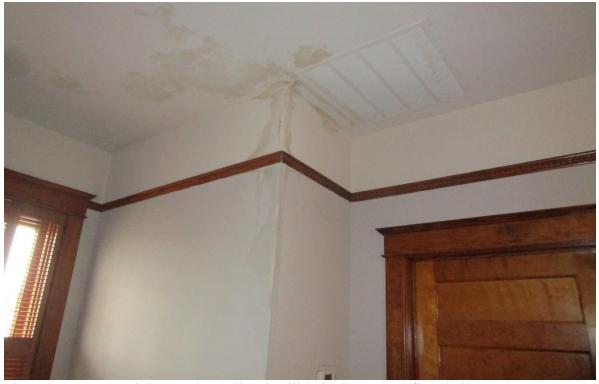
Photo #58 Water staining on the wall and ceiling in the second-floor hallway.

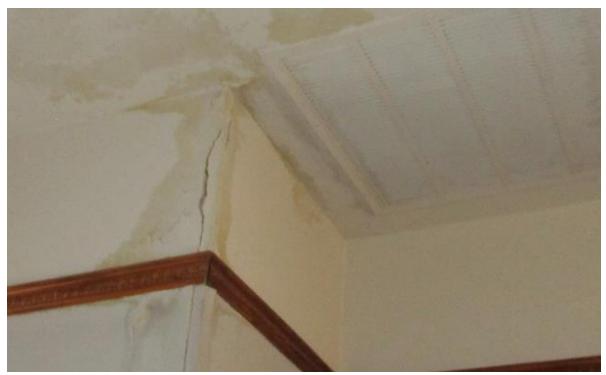
Photo #59 Close up of water damage at second floor ceiling. This is above the kitchen on the first floor where the plaster is damaged.

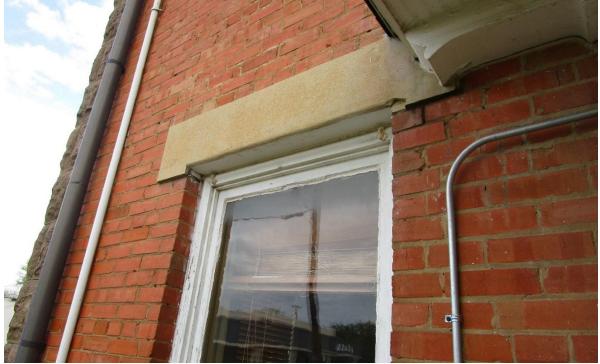
Photo #60 Window on the west side of the building has some water damage at the upper right-hand corner

- Many of the wood sills and wood frames have water damage and are likely rotted. Recommendation: Removed and replace damaged window frames.
- There is a crack in the brick on the north side of the building under the large window. Recommendation: Tuckpoint crack in the brick.

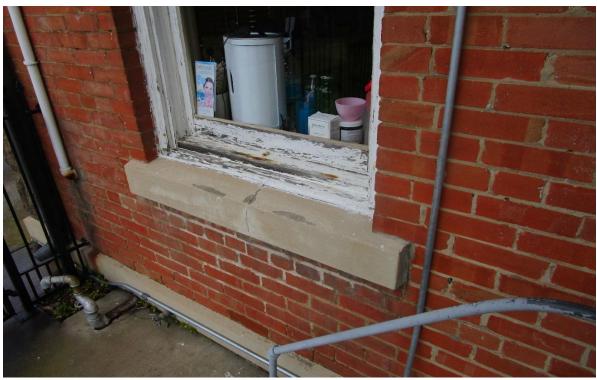
Photo #61 Windowsill on the west side of the building. The wood windowsill has severe water damage. The limestone sill has a crack in the middle.

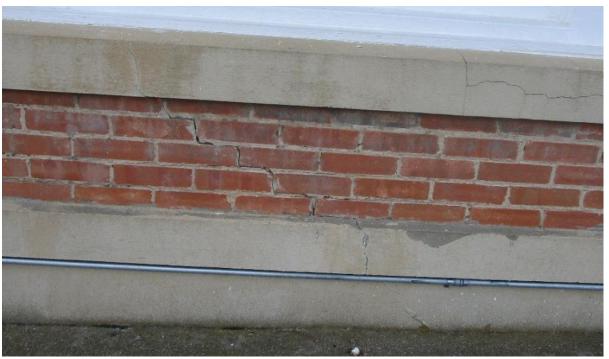
Photo #63 Crack in the brick and foundation under the window on the north side of the building.

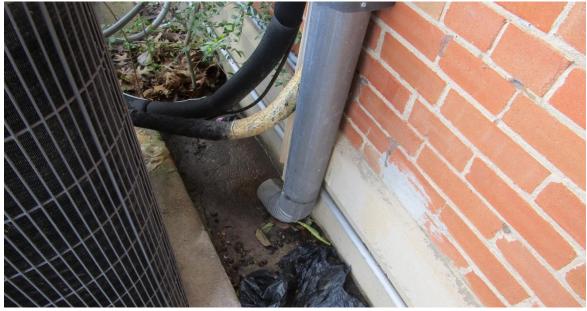
Photo #64 Downspout discharges water on the north side of the building behind the AC condensing unit. The AC condensate lines are discharging next the foundation as well. None of this water is directed away from the foundation.

- A downspout on the north side of the building discharges behind the AC units. There are AC condensate lines that discharge next to the downspout also. Recommendation: Downspout should be connected to an underground line and routed to discharge at the street or into the parking lot. AC condensates should be connected to a sewer line or discharged into the street or parking lot.
