## Building Due Diligence

110 Davis Street

McKinney, TX

Prepared for:  
**Parks Church**

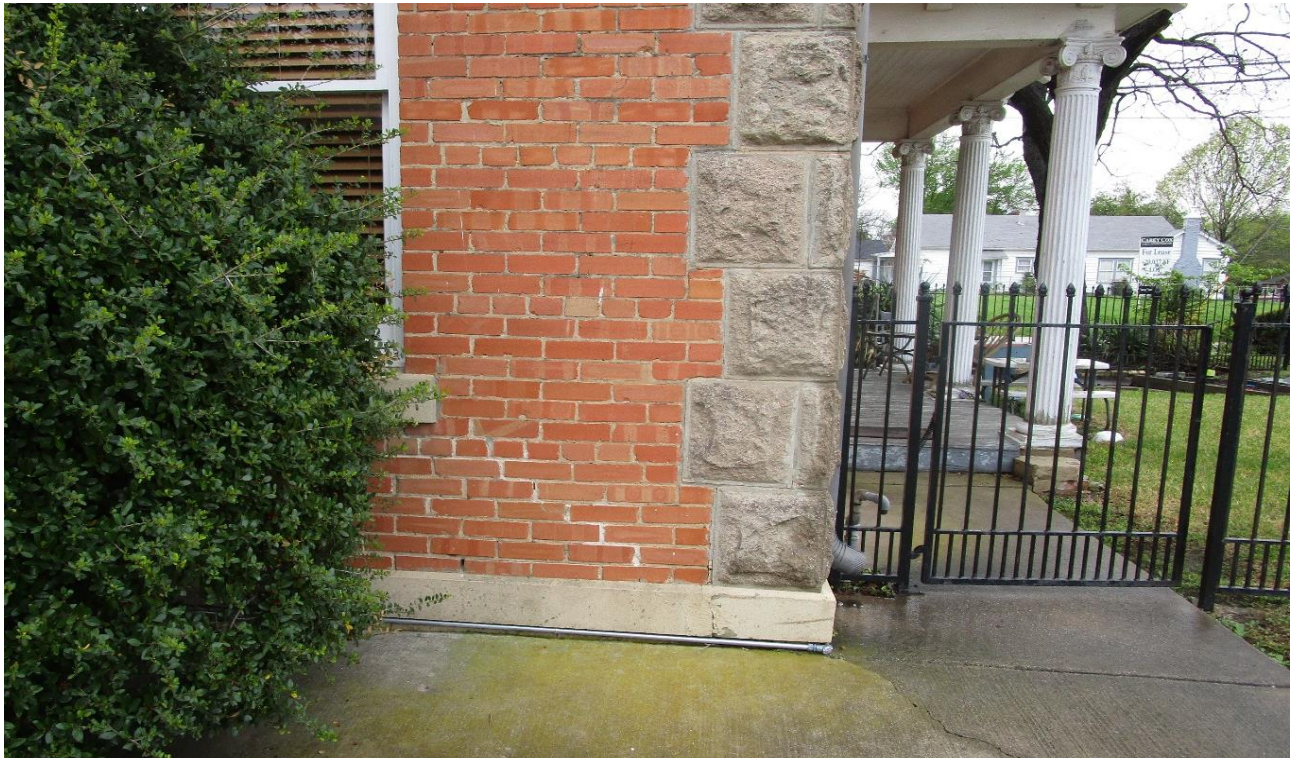
Photo #2 Northwest corner of the north side of the building. the corner of the building has experienced some foundation movement in the past.

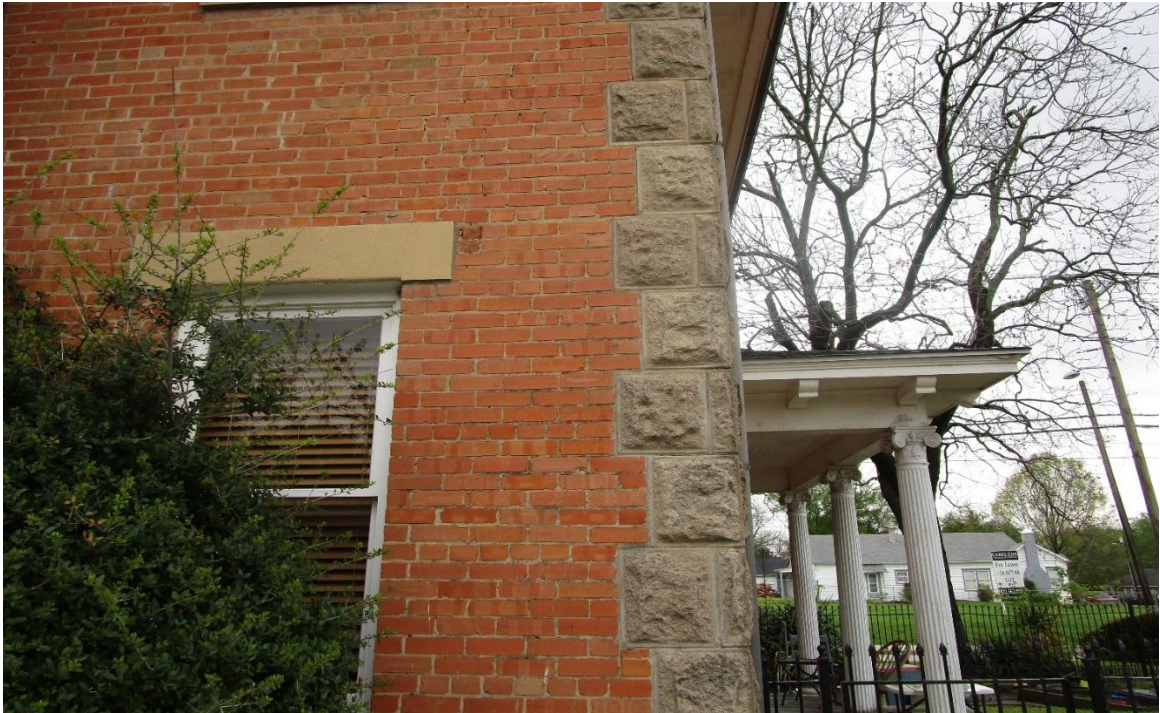
- Some of the brick on the north side at the northwest corner has numerous small holes and two of the bricks are missing the finish surface due to water penetrating the ice and freezing.

Photo #3 Some damage to the brick on the northwest corner of the building is present.

**Recommendation:** The damaged bricks and bricks with holes should be removed and replaced.

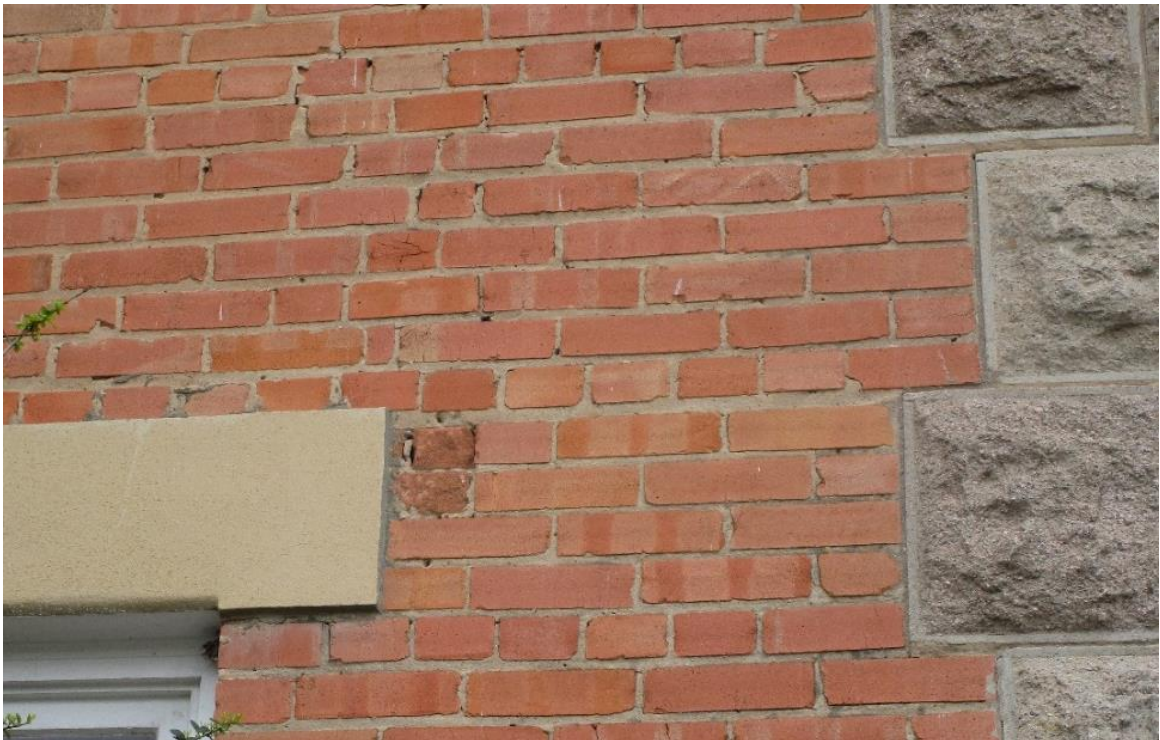
Photo #4 Close up of some of the damaged brick on the northwest corner of the building. This area needs to be tuck pointed to keep water out of the walls.

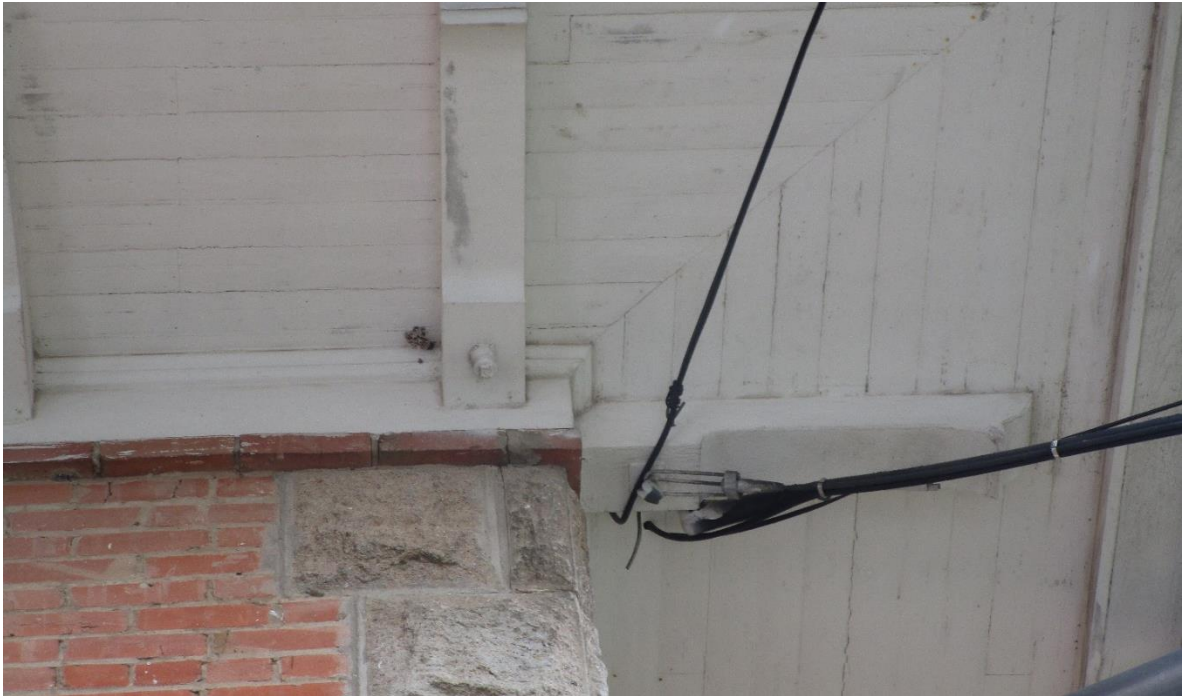
Photo #5 Close up of roof soffit at the northwest corner of building. The utility lines do not appear to have damaged the soffit structure.

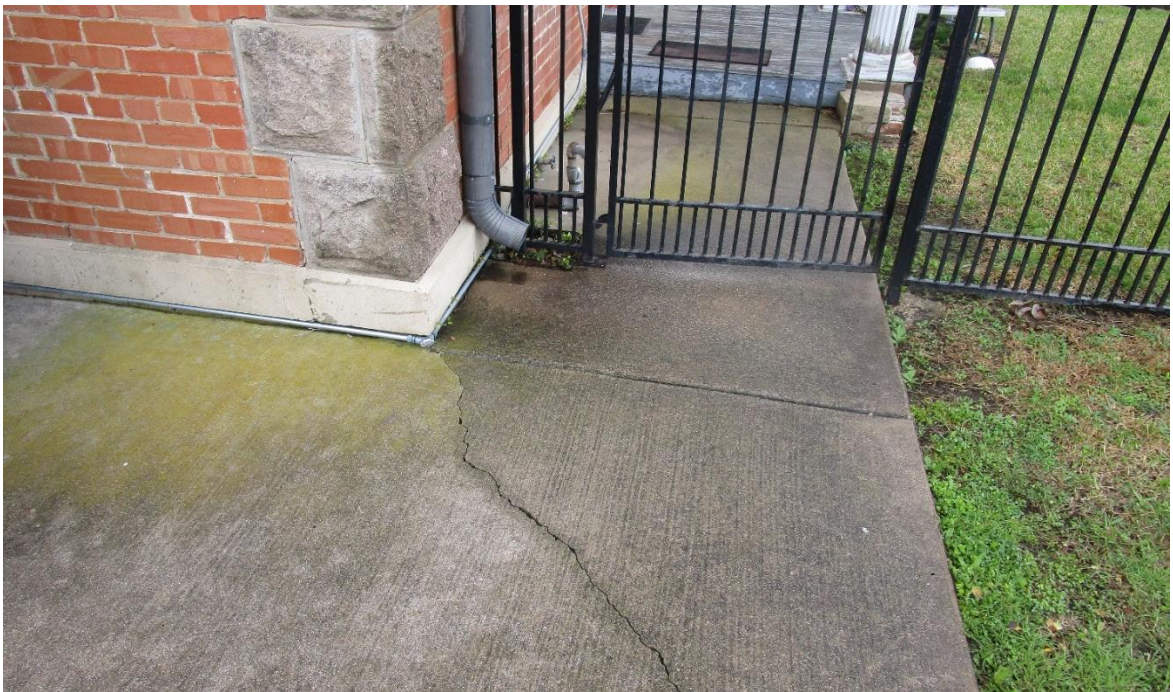
- There is a crack in the brick at the northwest corner of the building that has been previously repaired. The crack is likely due to the downspout discharging next to the foundation and causing foundation movement.

Photo #8 Downspout discharging next to the building. Large crack in the sidewalk and the cracks in the brick are likely due to the water from the downspout being discharged next to the foundation.

**Recommendation:** Downspout should be connected to an underground line and discharged in the parking lot.

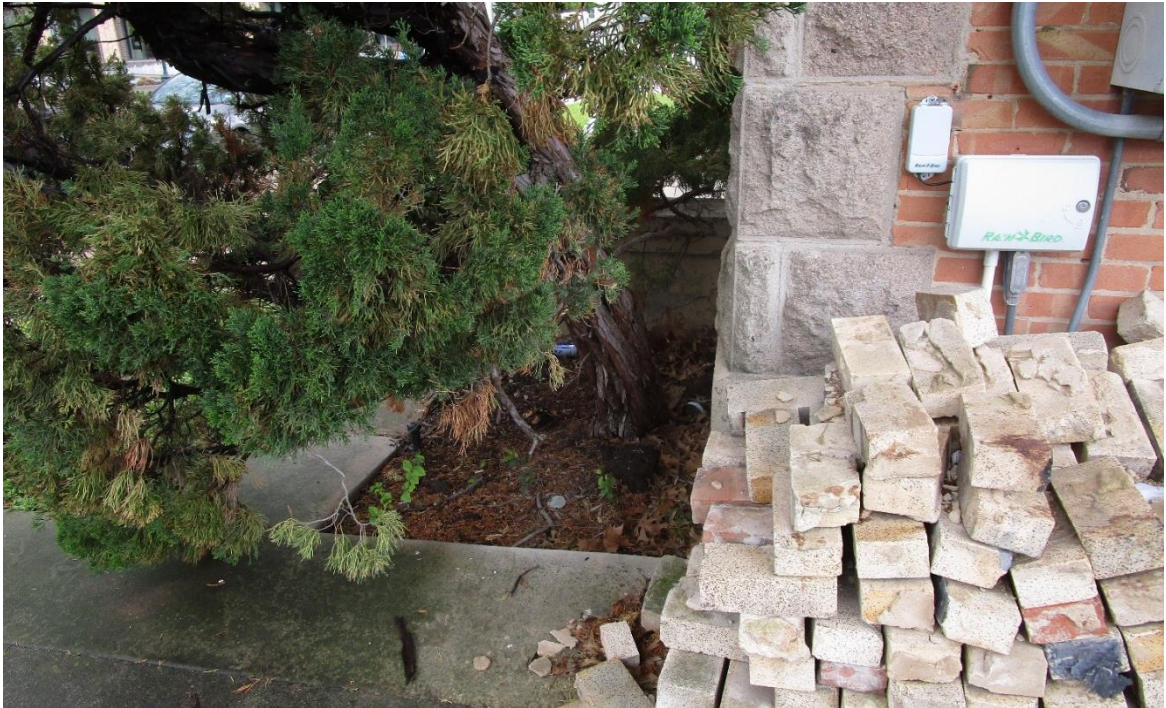
Photo #9 The trunk of the old cedar tree is within inches of the foundation. The tree should be removed.

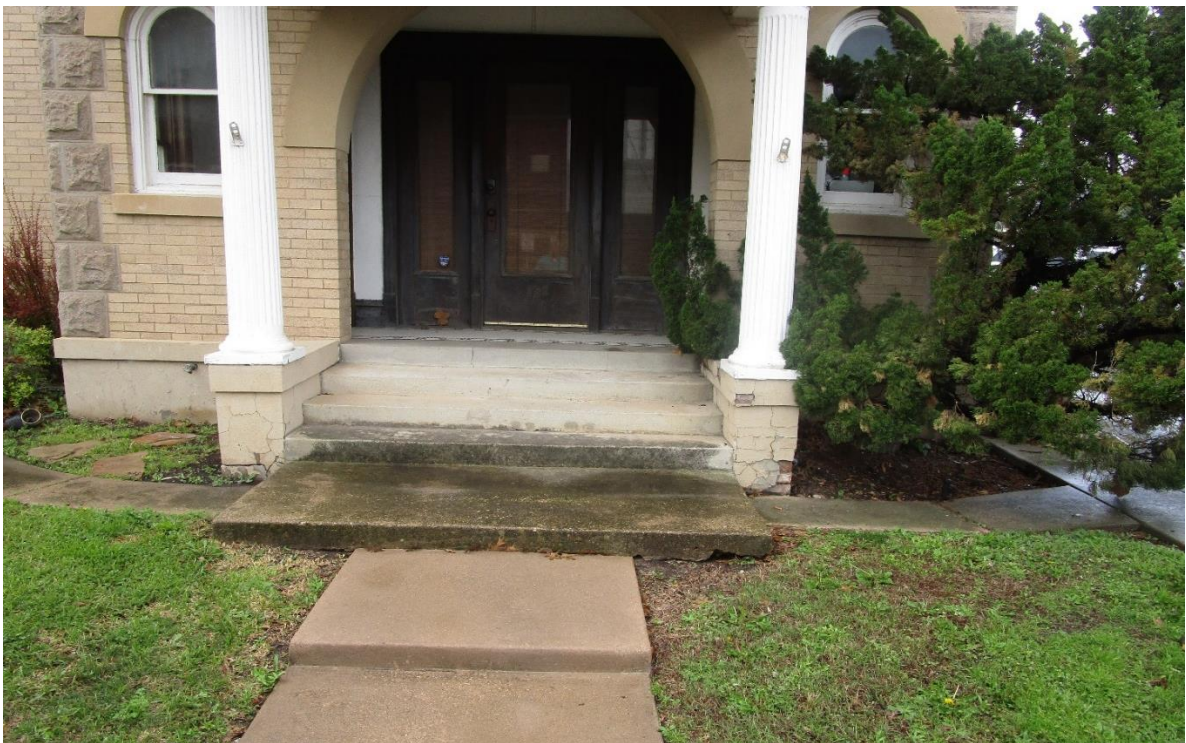
Photo #12 East entrance to the building. The stucco on the short brick walls is falling off. The steps appear to be bowing upwards in the middle, likely due to some heaving of the soil.

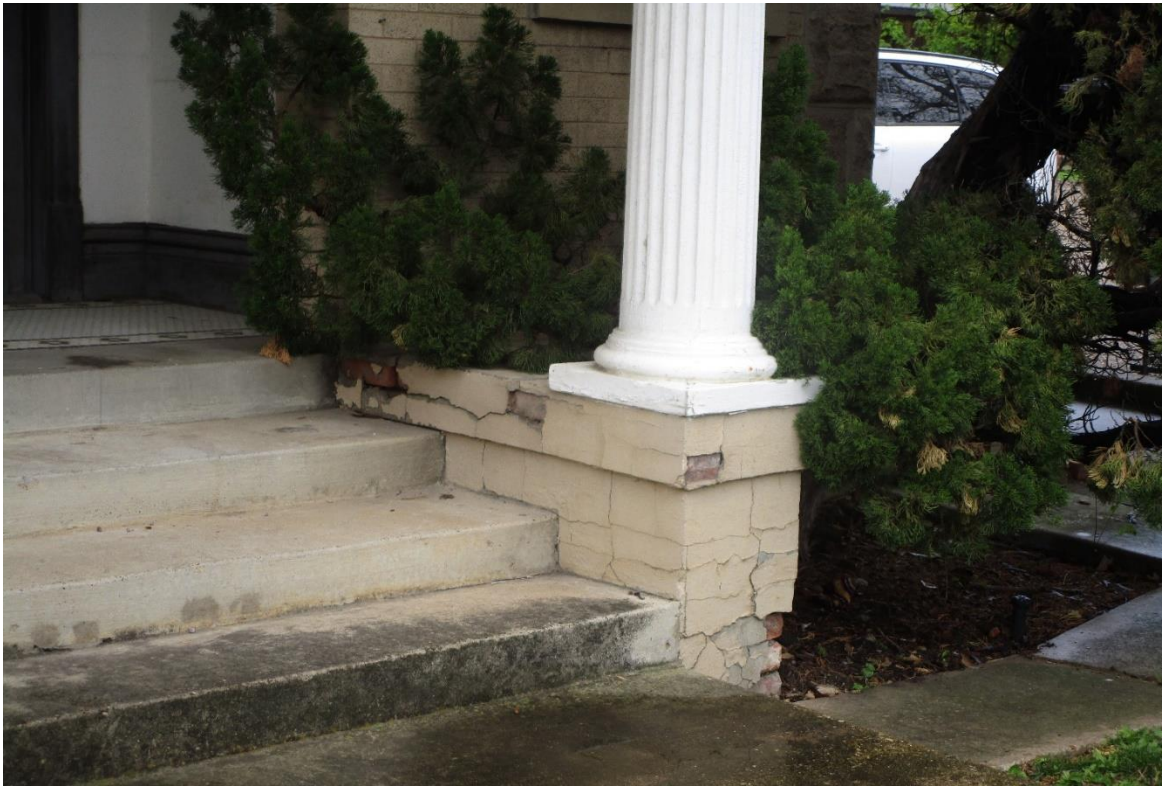
Photo #13 Another view of the damaged brick wall on the north side of the covered porch entrance.

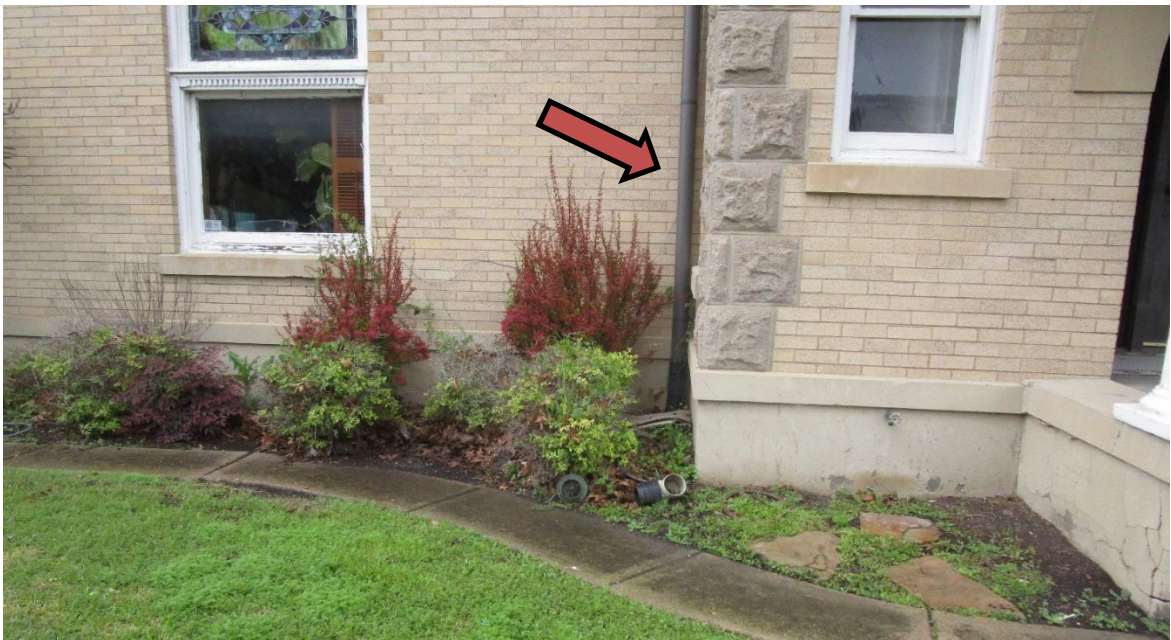
Photo #14 Yard area just south of the east entrance covered porch. The arrow points to a downspout nestled in the corner. This should be tied to an underground drain that discharges at the curb.

- Downspout on the southside of the east patio appears to be tied to an underground drain that discharges a few feet away. **Recommendation:** The downspout should be connected to an underground drain that discharges at the curb.

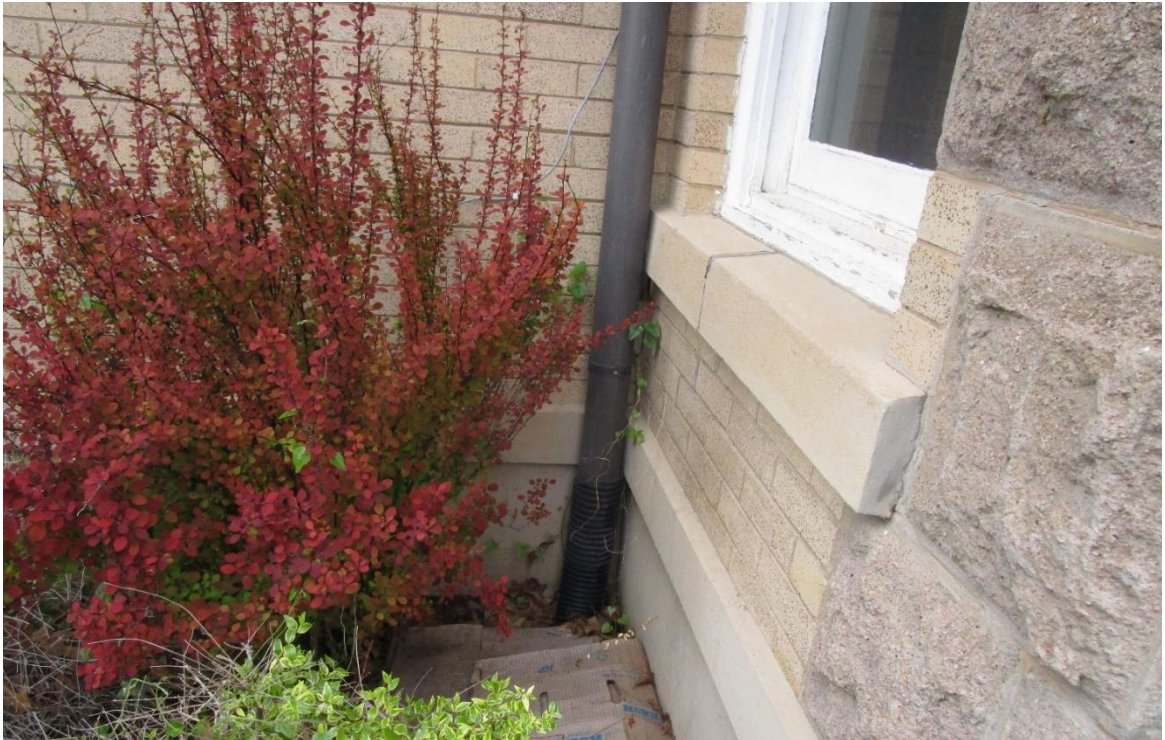
Photo #15 Downspout connects to underground pipe.

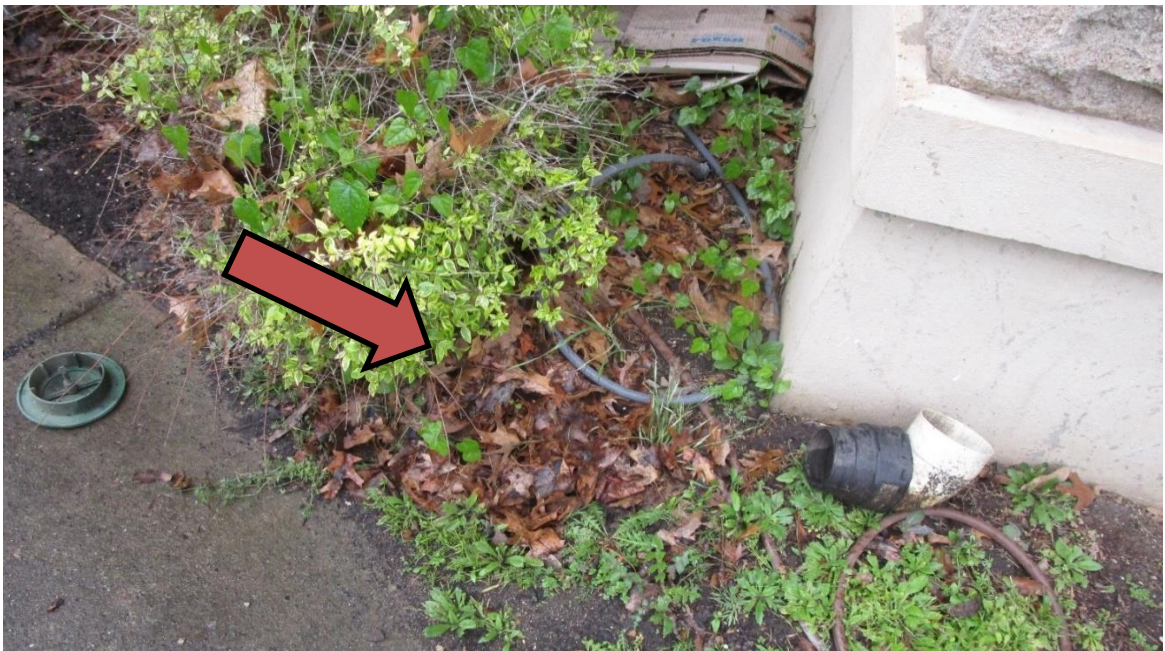
Photo #16 Arrow points to debris covered exit for the pipe that is connected to the downspout. No water is flowing out from the pipe shortly after a rain event. This should be tied to an underground drain that discharges at the curb.

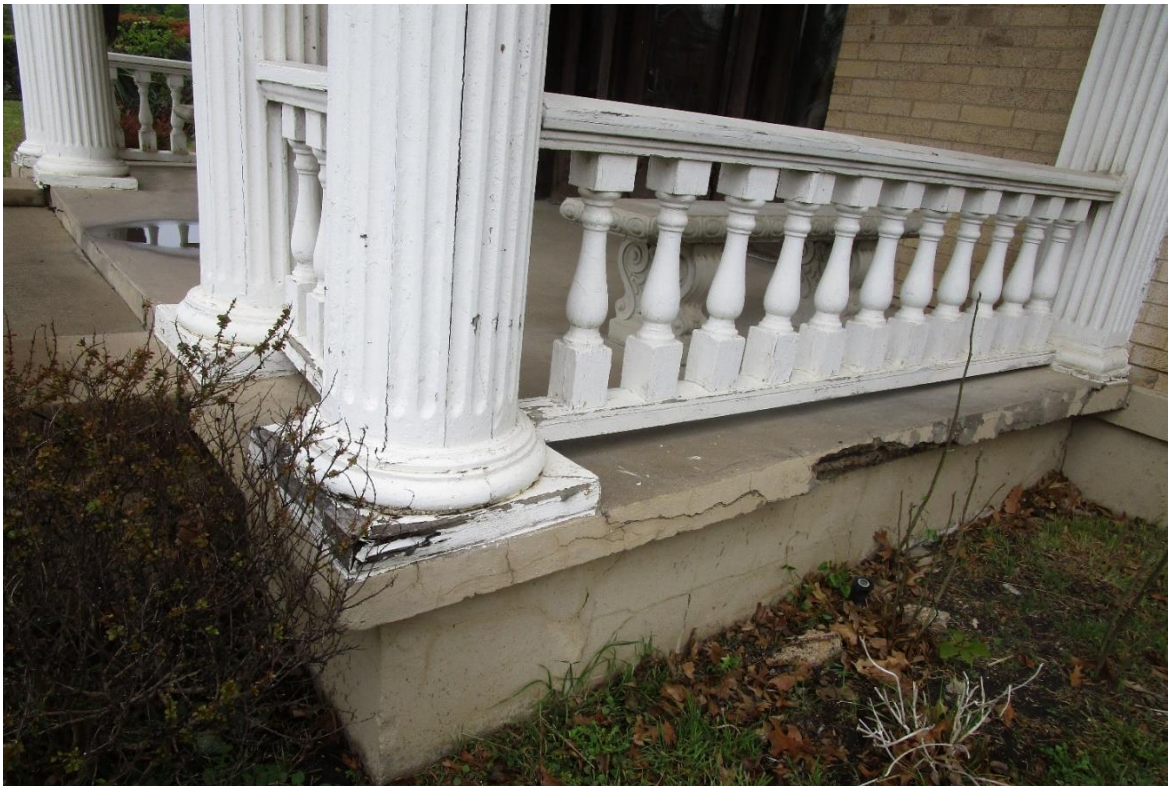
Photo #19 The column base and concrete have severe water damage.

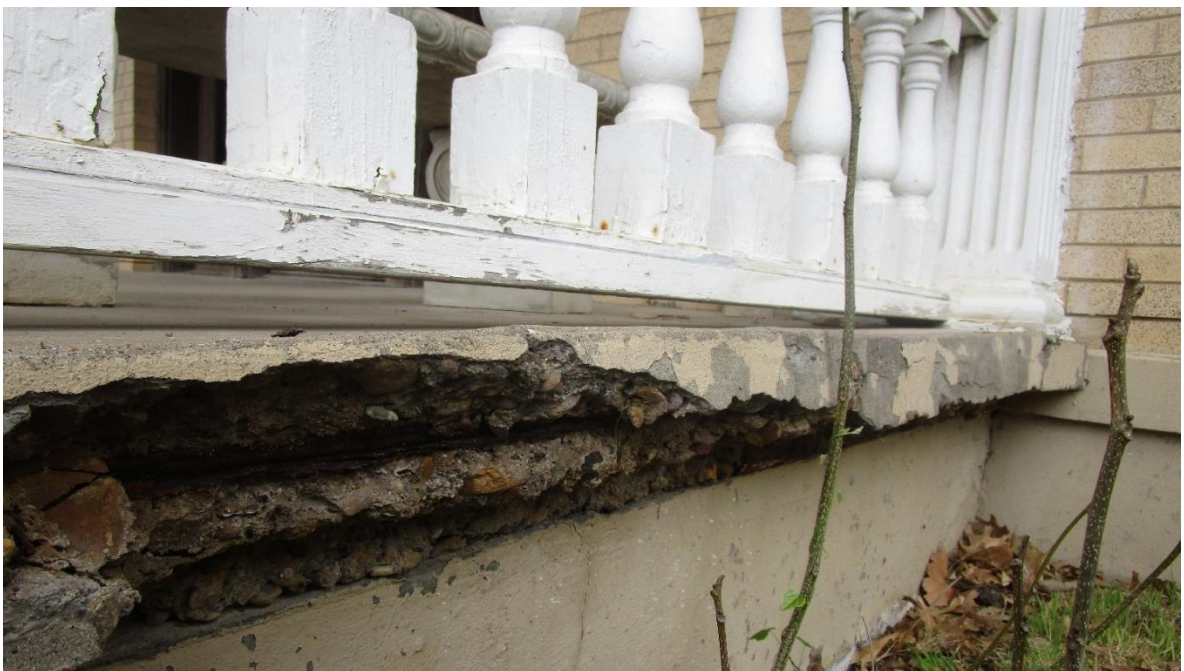
Photo #20 Close up of severely rusted rebar on the east side of the covered patio.

- The concrete slab for the south covered patio is severely cracked. Some of the concrete on the sides of the slab have spalled off and the exposed rebar is heavily rusted. **Recommendation:** All loose and delaminated concrete should be removed, the rusted rebar treated and the concrete replaced. Option, remove and replace the concrete slab in its entirety.

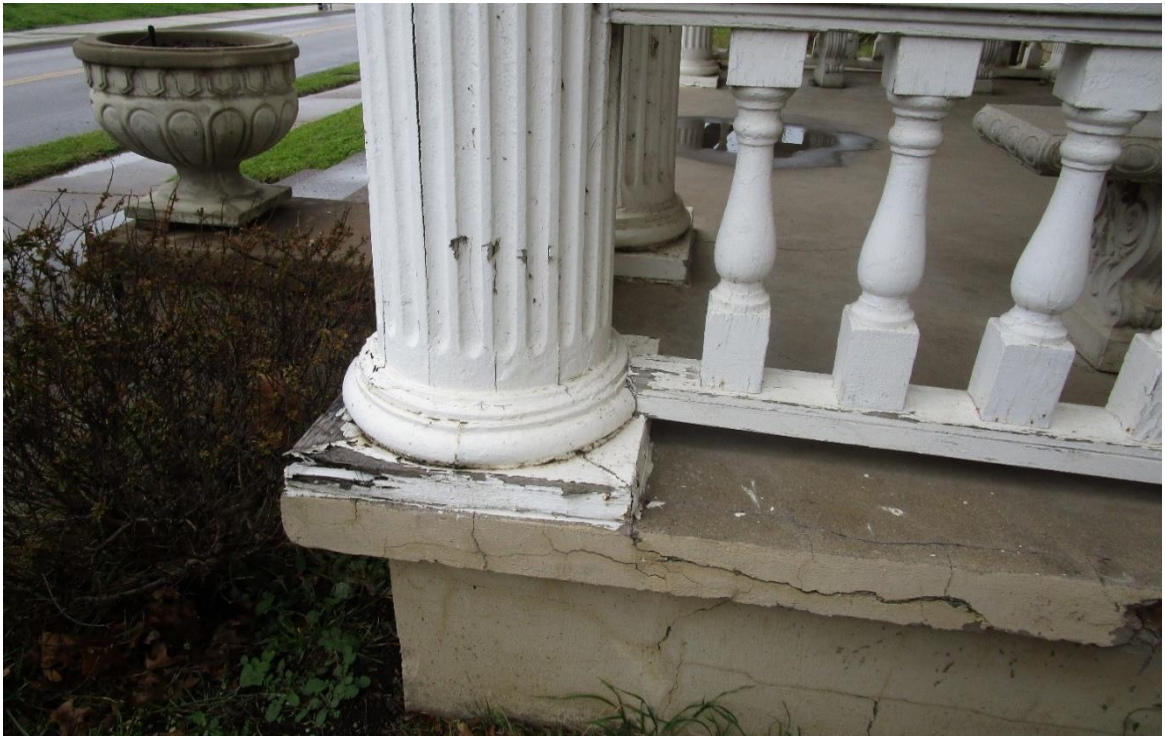
Photo #21 The wood column base has severe water damage and needs to be replaced.

- Wood column bases for the fluted columns on the south covered patio are rotted. **Recommendation:** The rotted wood bases need to be removed and replaced.

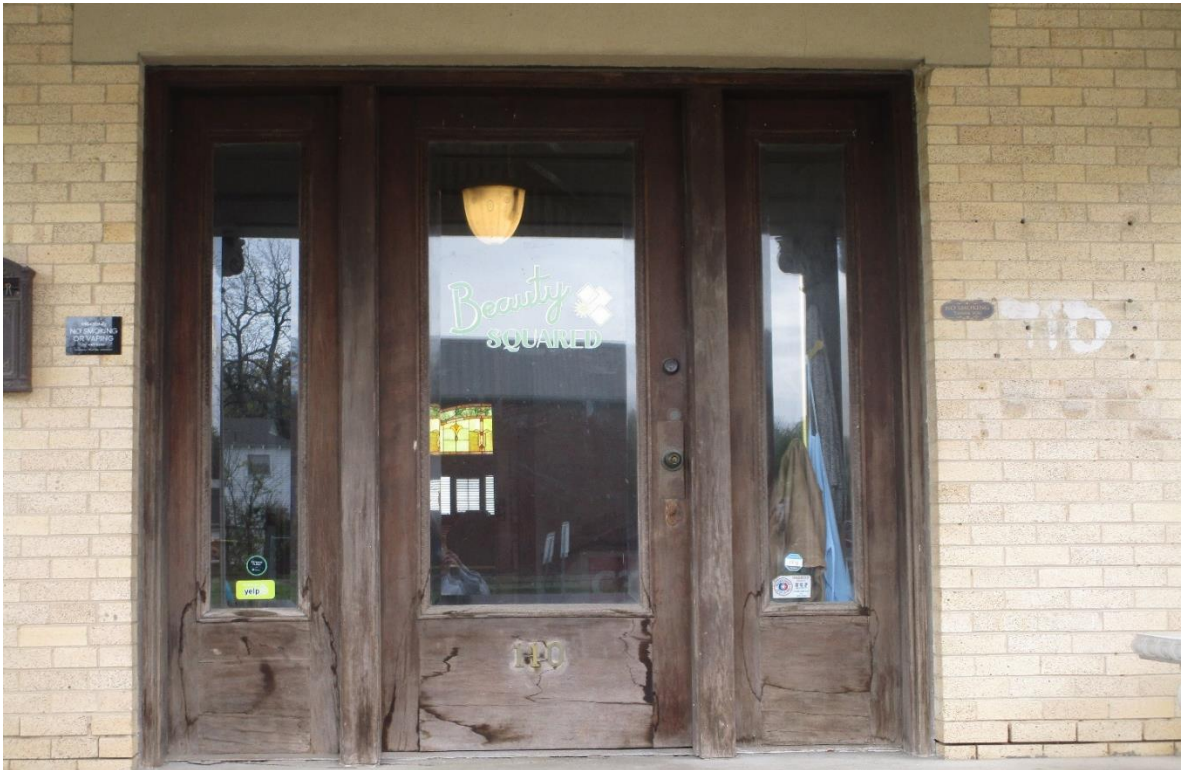
Photo #23 South entrance doors are heavily weathered. It may be possible to refurbish the doors.

- The wood doors and sidelights for the main south entrance have significant UV damage but the wood does not appear to be rotted. **Recommendation:** Refinish the doors and sidelights.

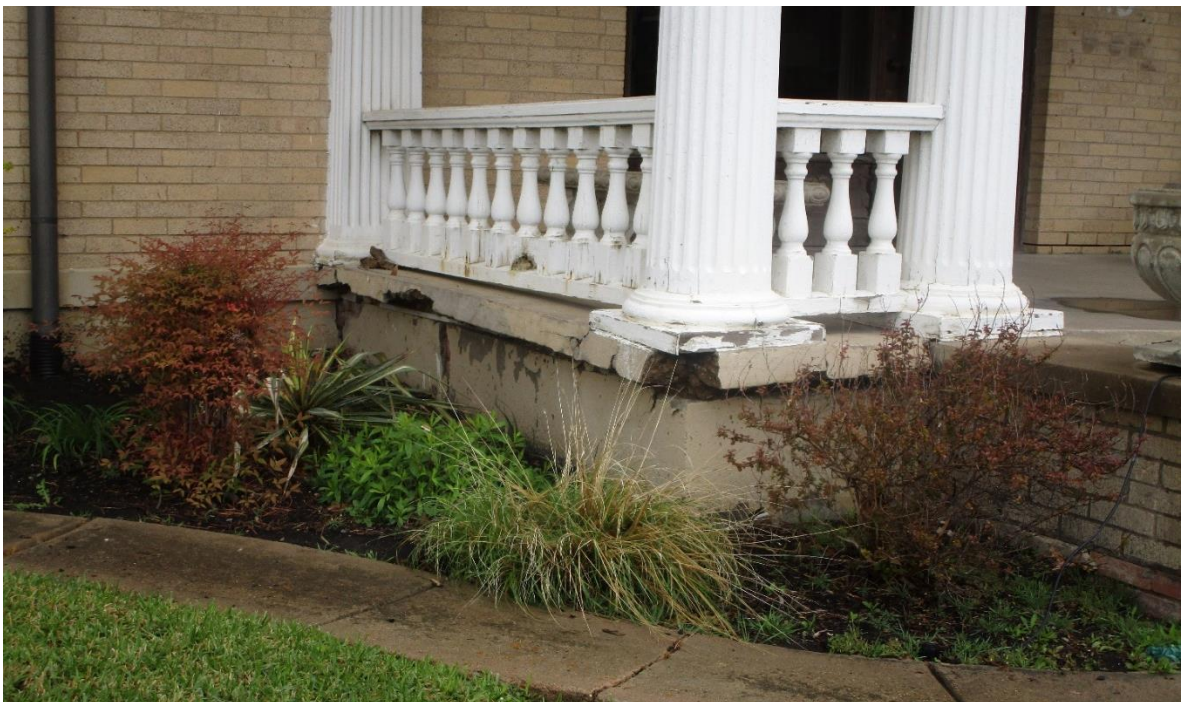
Photo #24 West side of the south covered entrance patio. This side has concrete damage and wood column base damage.

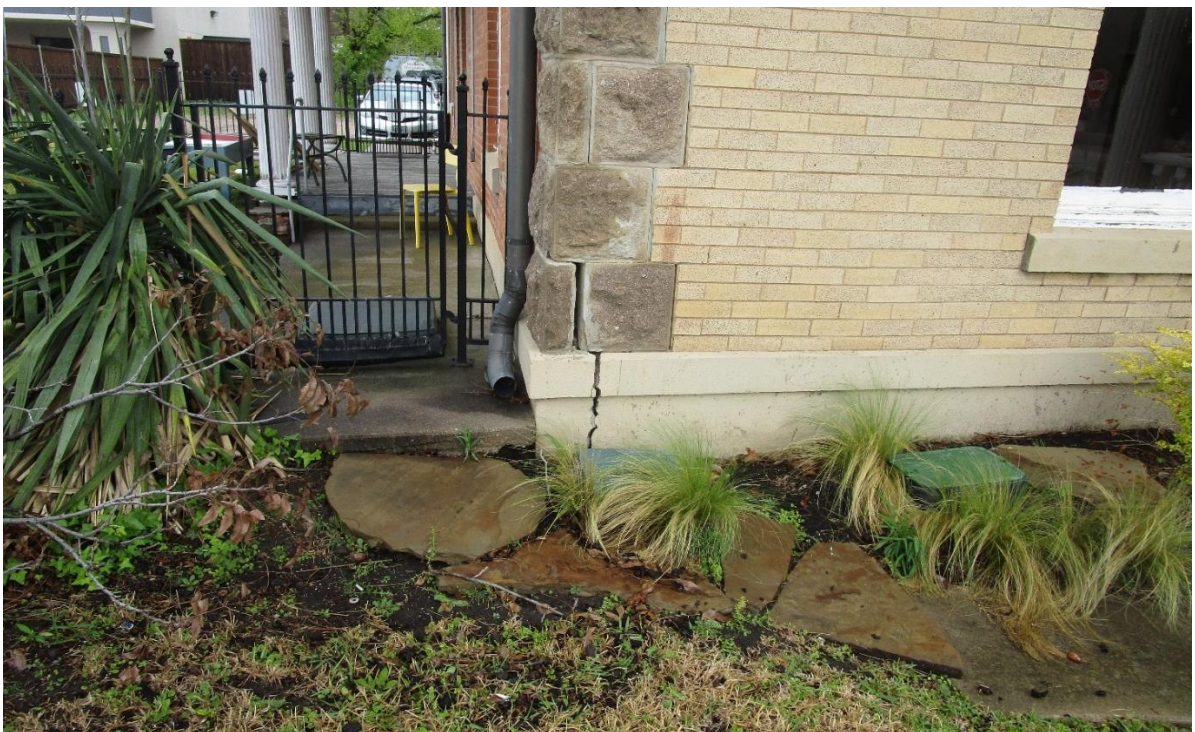
Photo #26 Large crack in the foundation and stone quoin at the southwest corner of the building. The crack is likely due to the downspout discharging water next to the foundation and/or the nearby large tree.

- There is a large vertical crack in the foundation and first stone quoin at the southwest corner of the building. **Analysis:** The crack is likely due the downspout discharging water next to the foundation and/or the roots of the large tree about 12 feet to the west of the building corner. **Recommendation:** Connect downspout to an underground pipe and discharge thru the curb at the street. Add a root barrier between the tree and the southwest corner of the building. Repair the concrete foundation and tuck point damaged stone quoin.

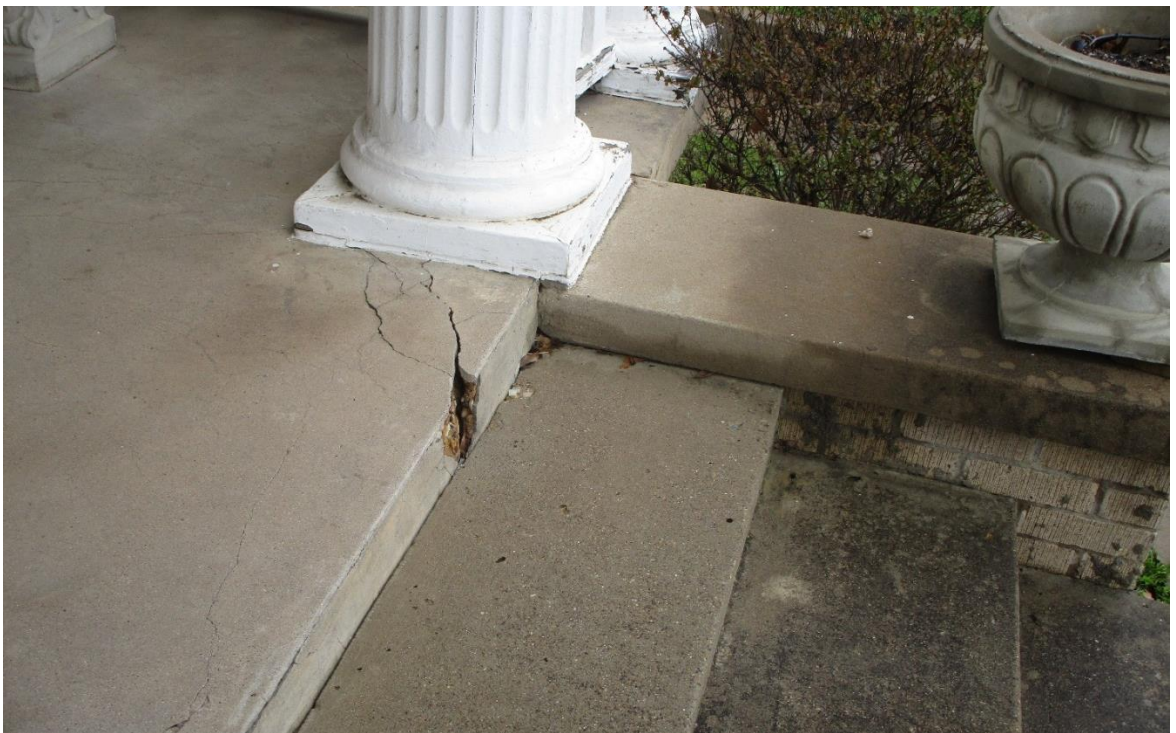
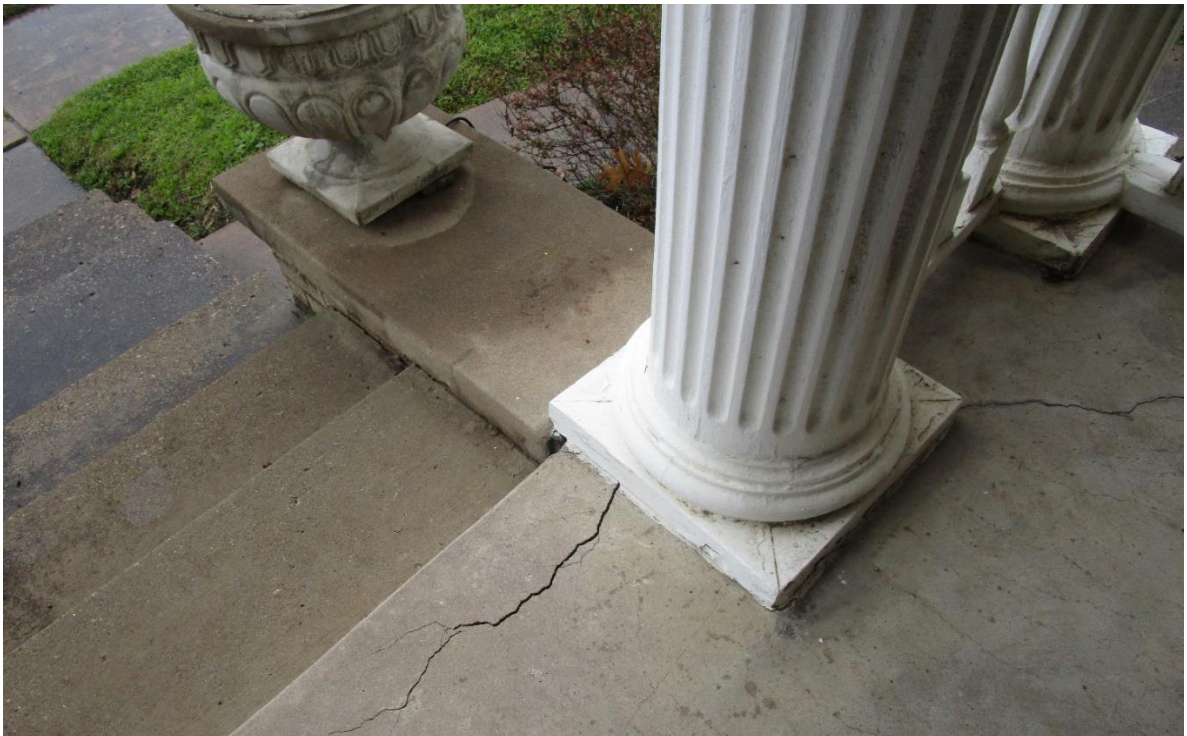
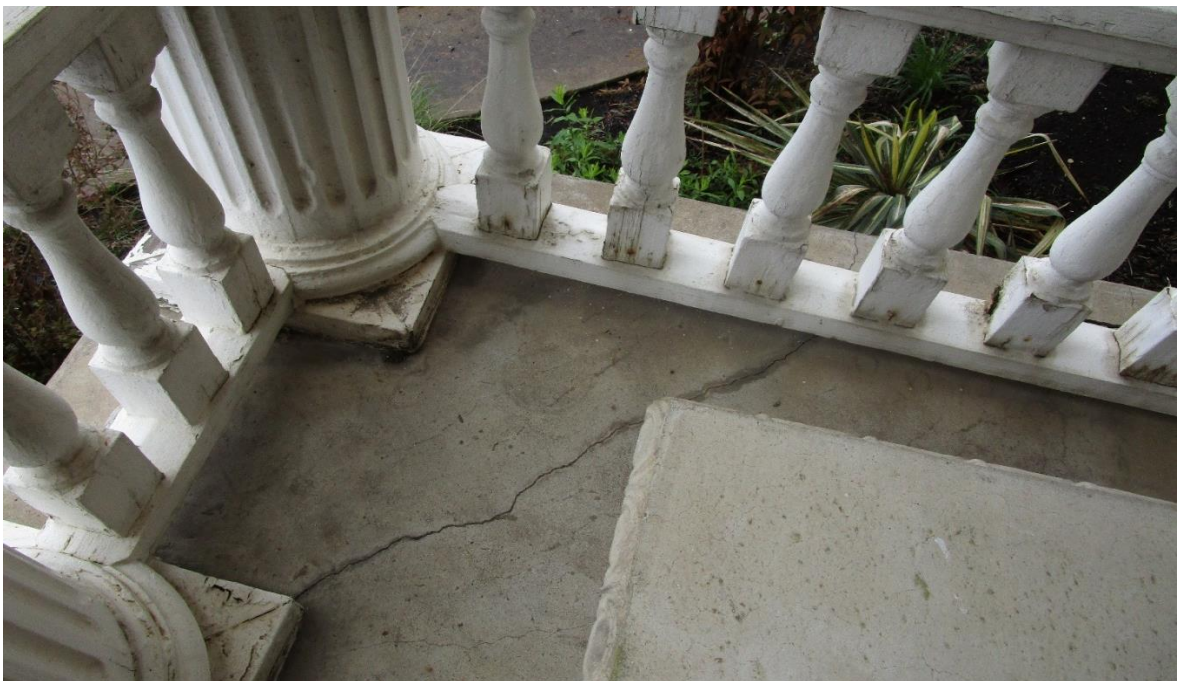
Photo #28 Damaged concrete slab at the south patio.

Photo #29 Damaged concrete slab at the south patio.

Photo #30 Damaged concrete slab at the south patio.

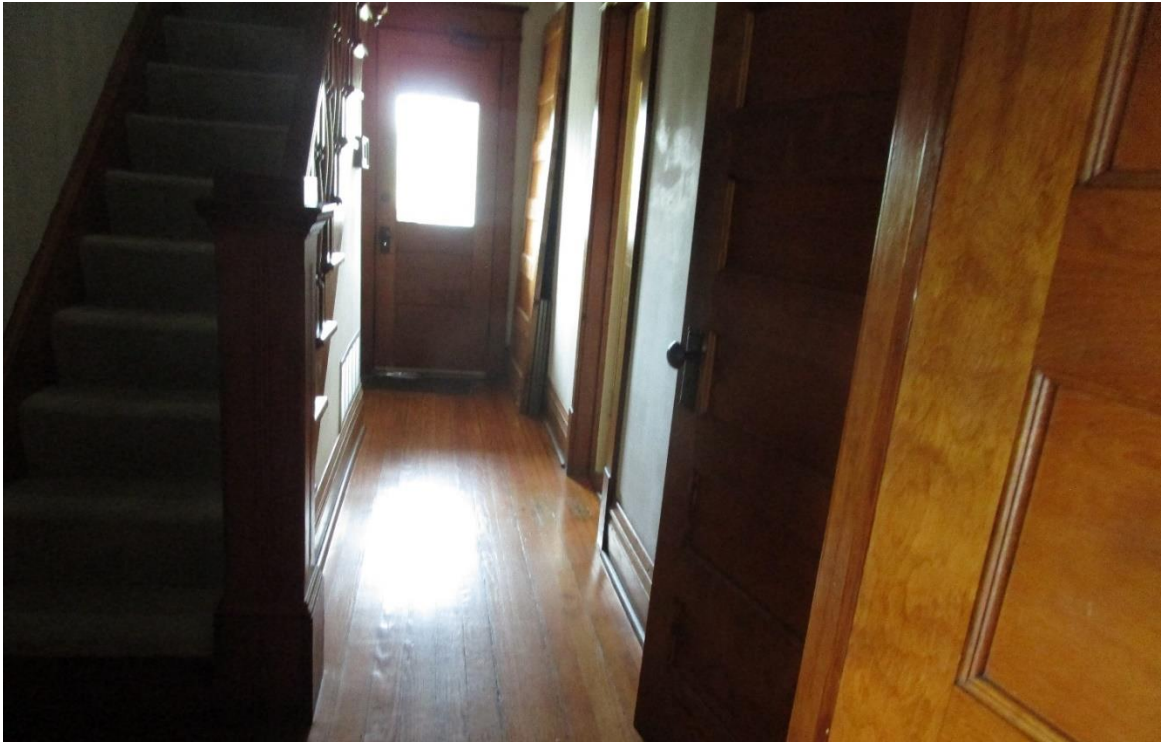
Photo #31 View of main hallway on first floor looking towards the west. Note some ripples in the hardwood floor.

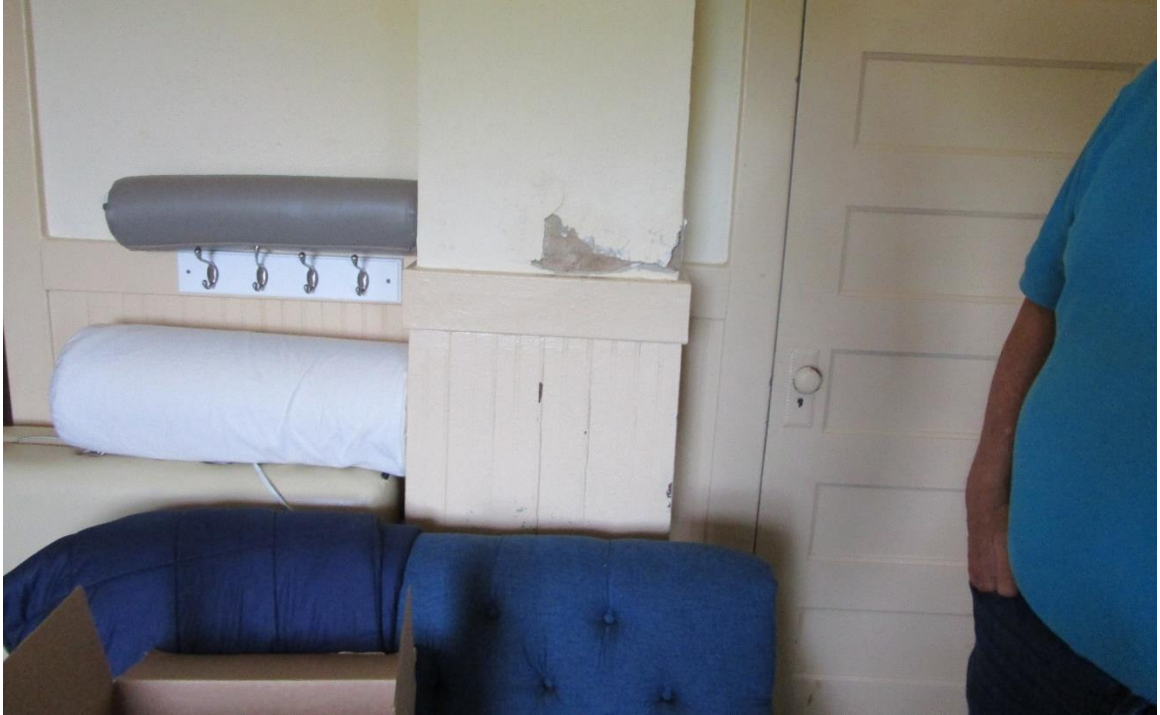
- The plaster around a “bump out” in the kitchen on the first floor has water damage. The “bump out” is likely due to water leaking in at the roof – chimney intersection. **Recommendation:** Repair roof to chimney connection. Paint the brick chimney above the roof line or wrap in sheet metal and inspect and repair/replace chimney caps. If the chimney is no longer functional, remove portion of chimney above the roof and roof over the opening. This is the best option.

Photo #33 Damaged plaster in the kitchen. This is likely a part of the brick chimney that has water coming around the roof penetration.

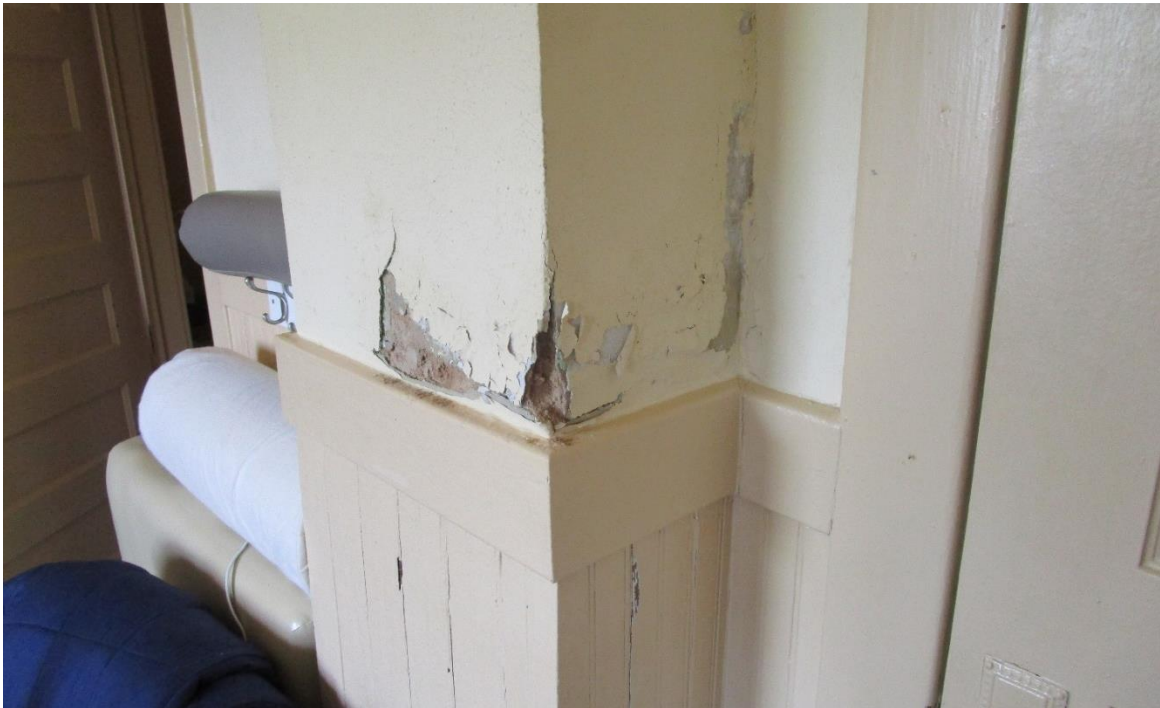
Photo #34 Another view of the damaged plaster in the kitchen.

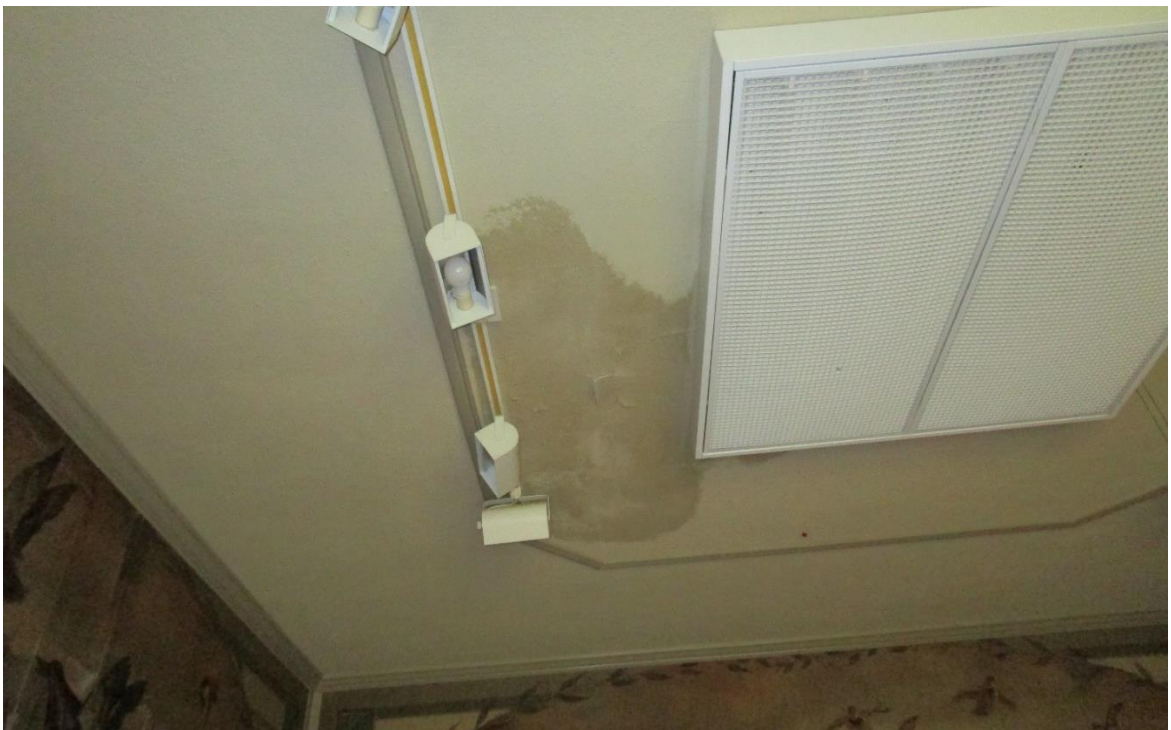
Photo #36 Water damage to a ceiling on the first floor.

- There are numerous areas on the first floor ceiling and wall murals with water damage. **Recommendation:** The roof likely needs replacing and any roof penetrations as previously described.

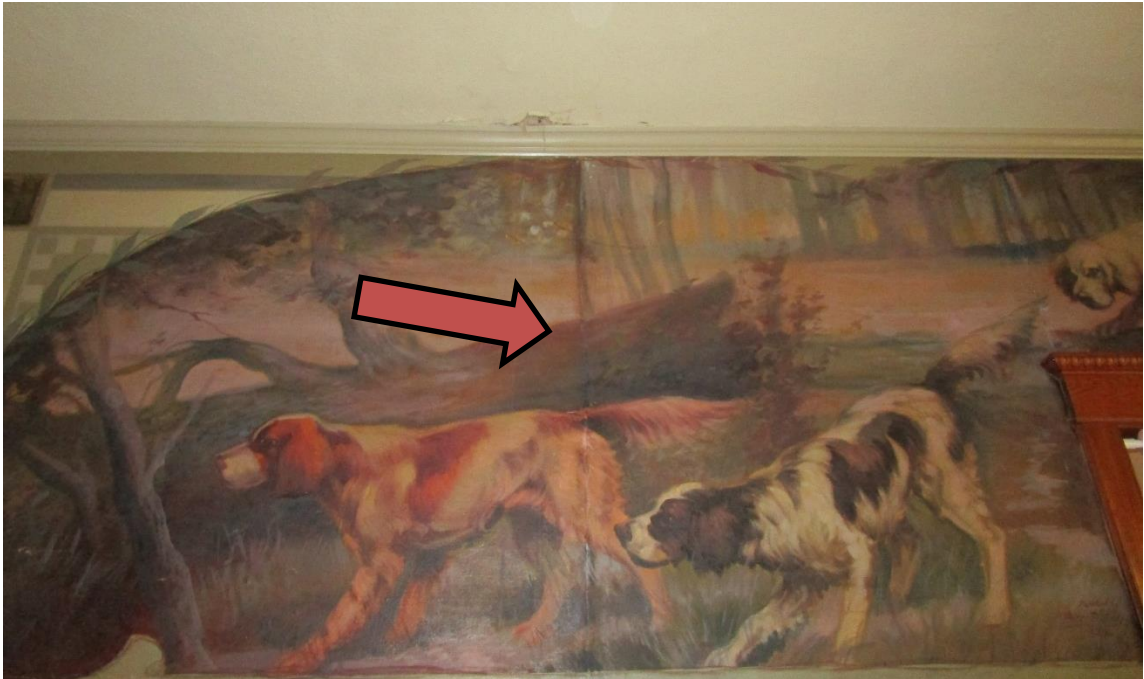
Photo #37 The arrow points to a crack in the wall mural. The crack is likely due to water from a roof leak.
