## Building Due Diligence

110 Davis Street

McKinney, TX

Prepared for:  
**Parks Church**

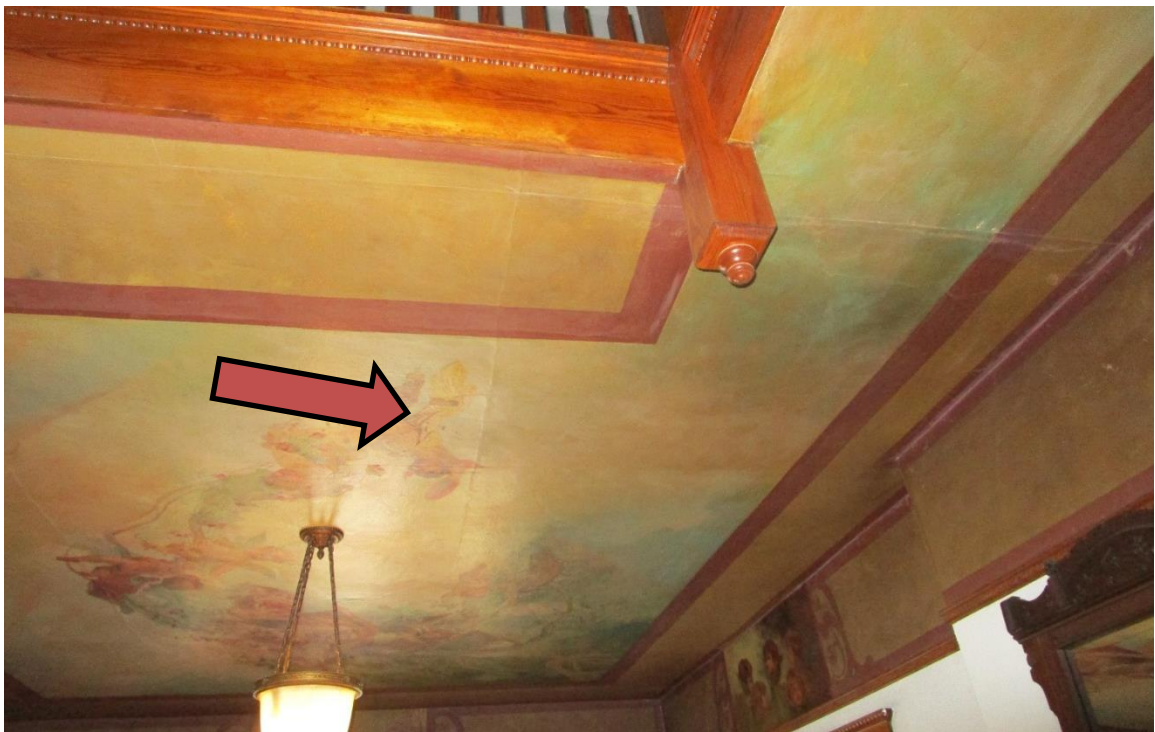
Photo #38 The arrow points to a crack in the ceiling mural. The crack is likely due to water from a roof leak.

- There are numerous areas on the first floor ceiling and wall murals with water damage. **Recommendation:** The roof likely needs replacing and any roof penetrations as previously described.

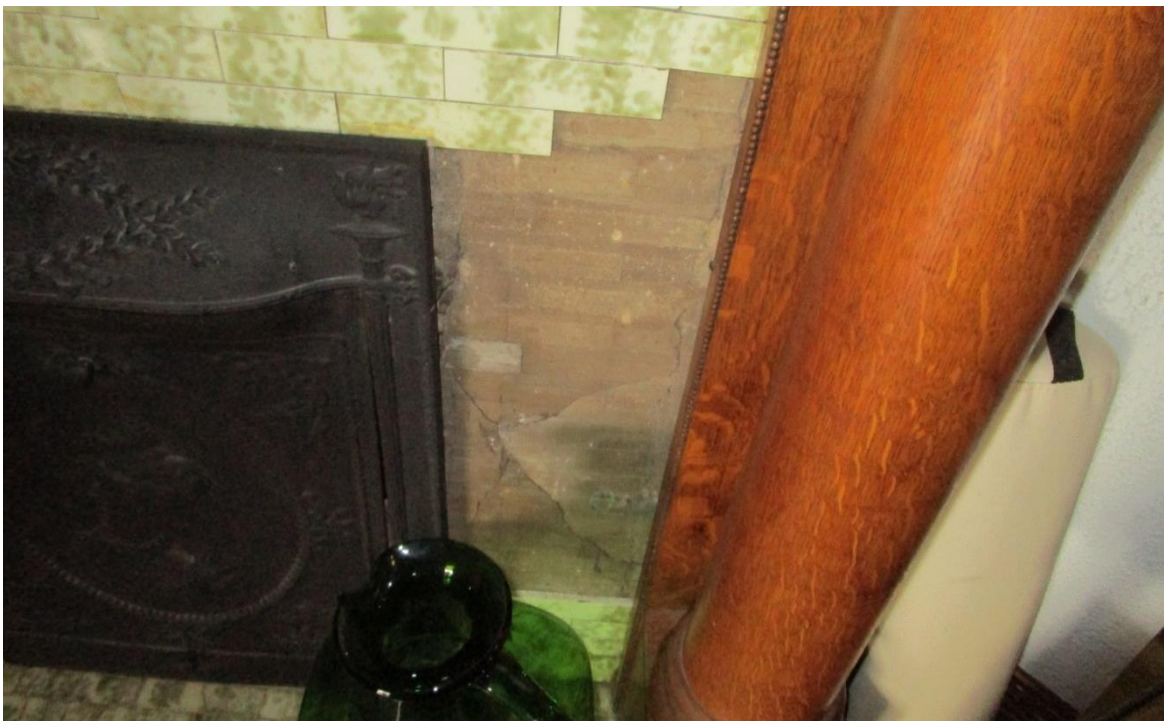
Photo #40 Tile missing from the right side of the fireplace surround. This may be due to a water leak or an overheating of the fire brick that is now exposed and cracked.

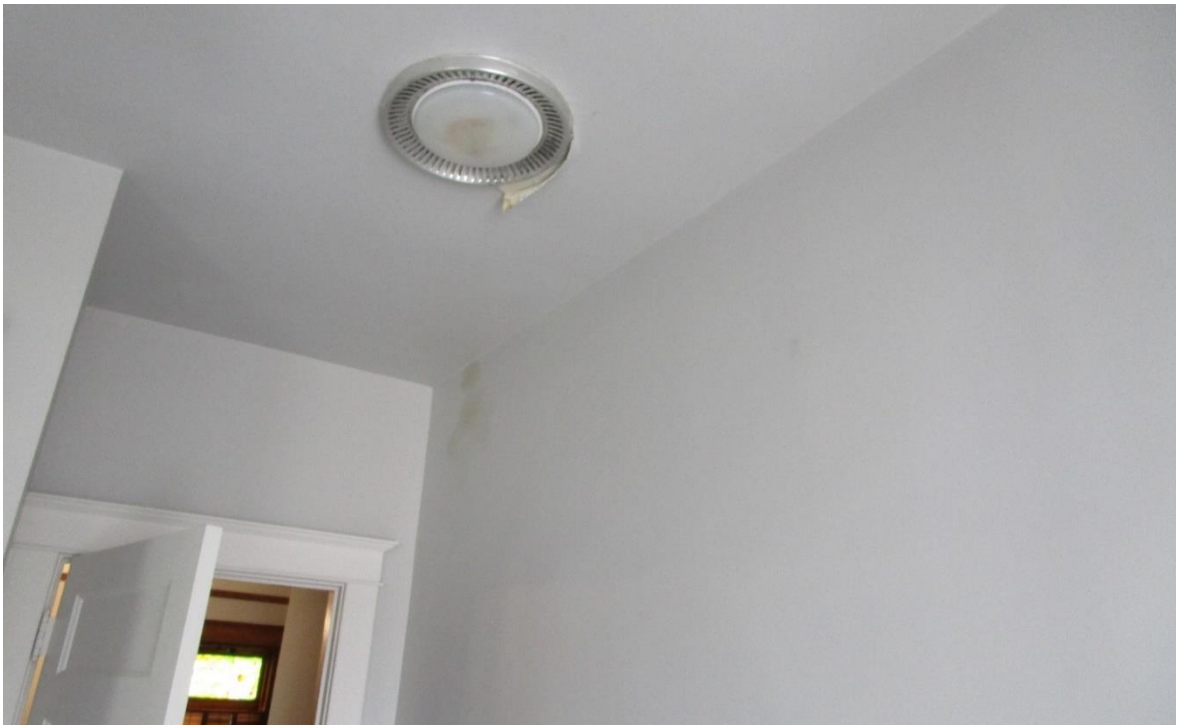
Photo #42 Some water damage to the wall near the ceiling and to the wall paper around the ceiling light.

- There is other interior damage to plaster ceilings and walls on the second floor. **Recommendation:** Once the roof leaks have been rectified, repair and paint damaged plaster.

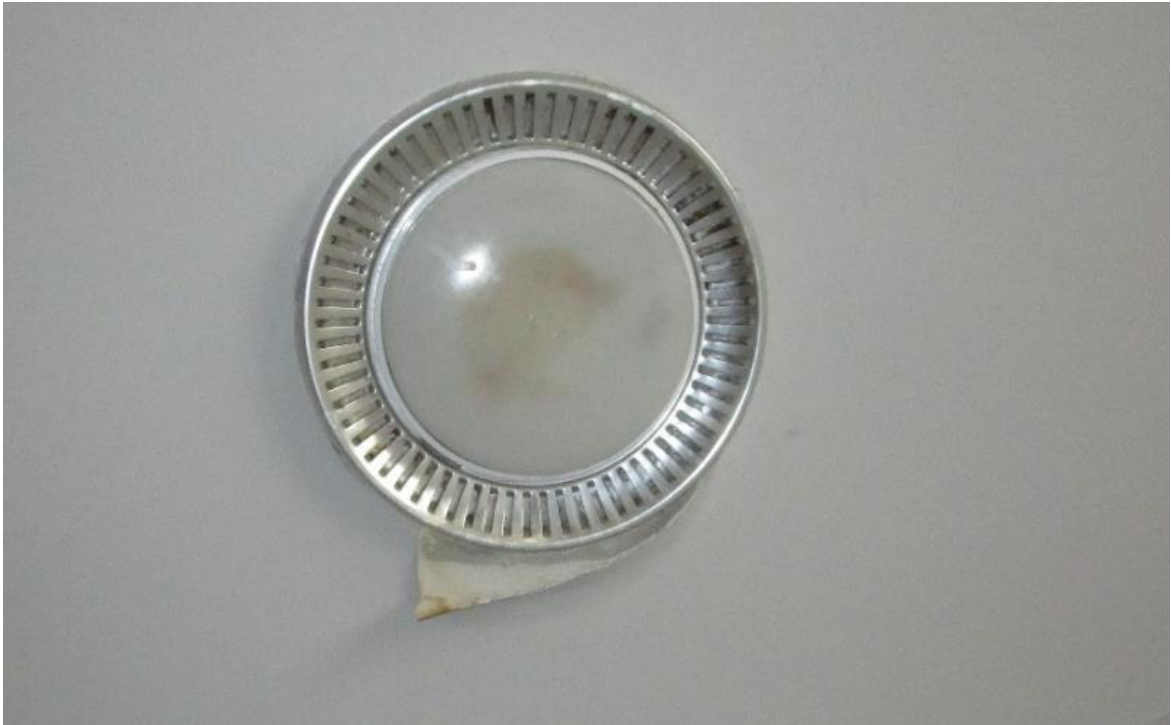
Photo #43 Close up of damaged wall paper around the ceiling light fixture. The fixture likely has water damage as well.

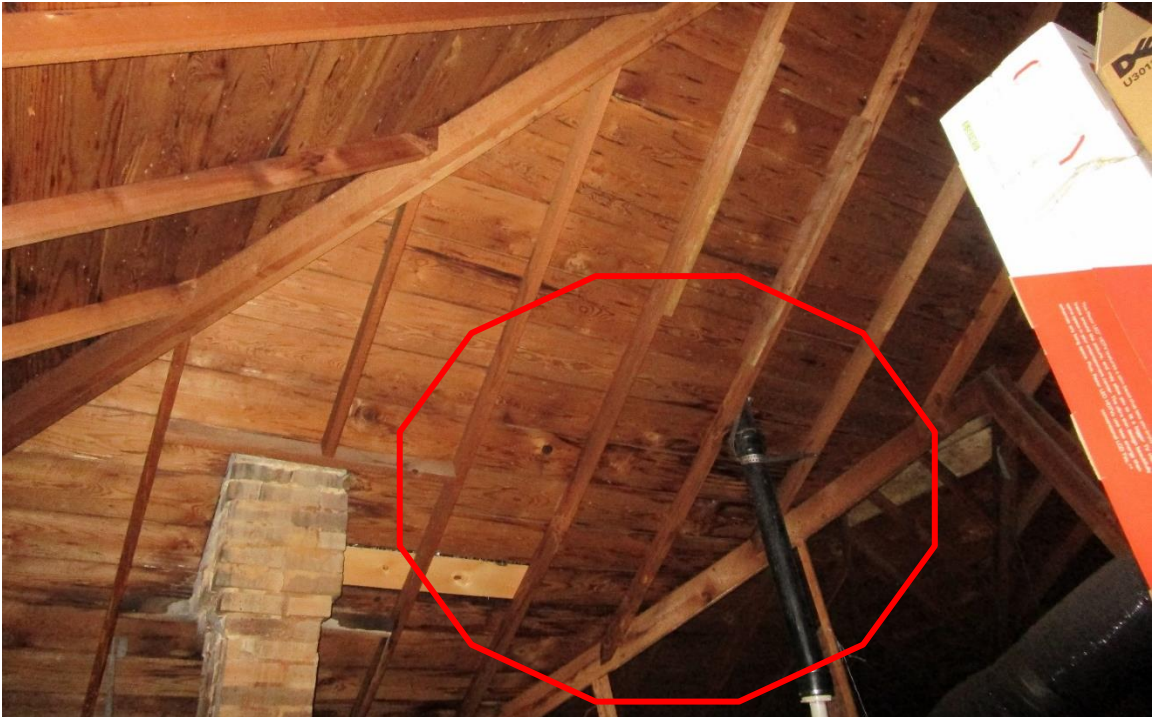
Photo #45w View of the underside of the north side of the roof. The circled area appears to have water damage. Two deck boards have been replaced. Some of the roof rafters have been repaired.

- The 1x6 wood roof decking has water staining on the underside in the attic in numerous locations throughout the attic. **Recommendation:** Install a new roof.

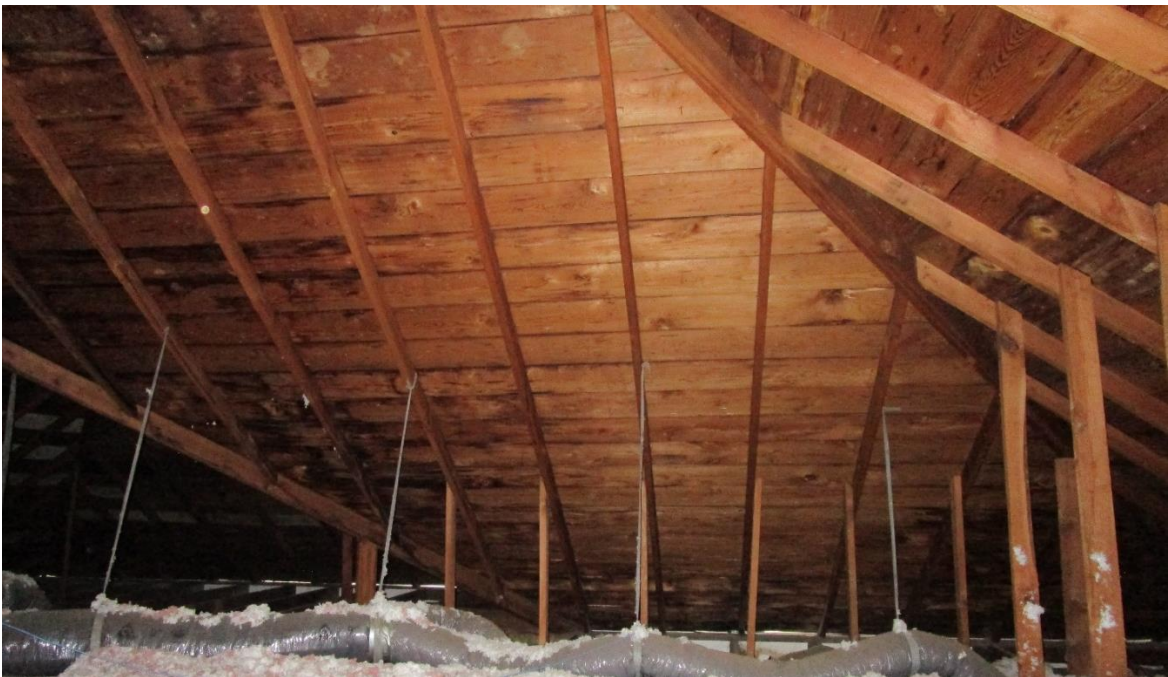
Photo #46 Underside of the west portion of the roof. The roof rafters are 2x4's at 24 inches on center and are spanning way beyond the code allowable spans. The decking on the left side of the photo has a lot of water staining.

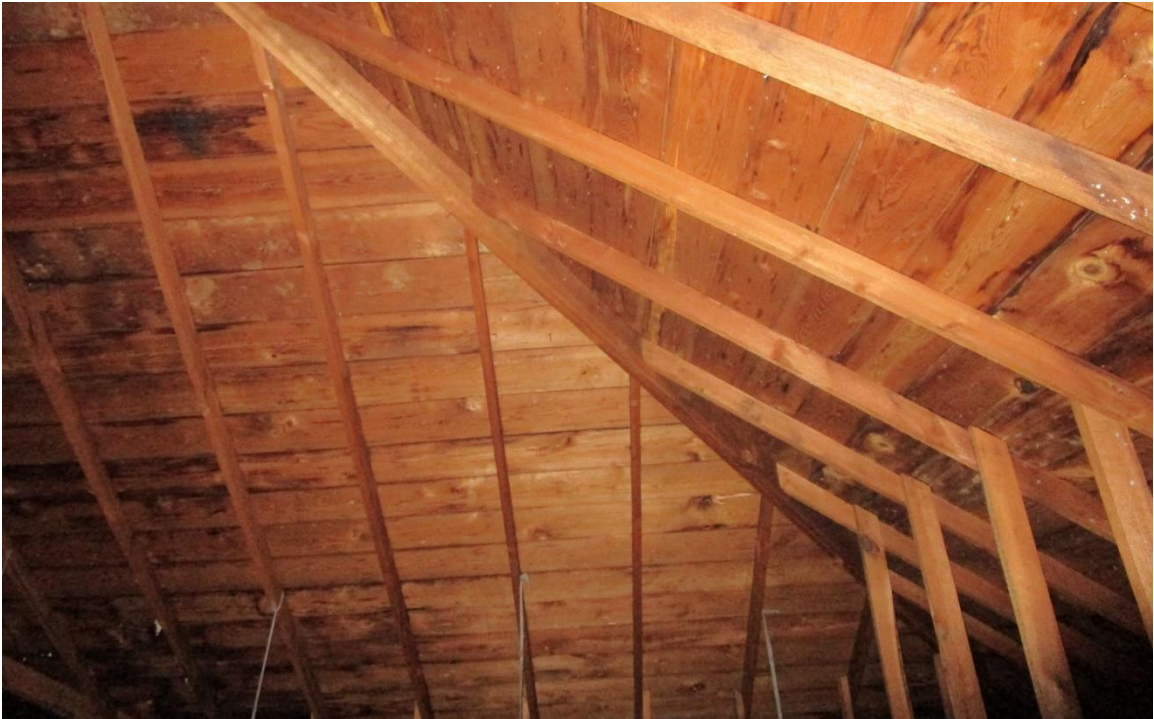
Photo #47 Southwest corner of the roof. Some water staining is visible on the roof deck on the left side of the photo.

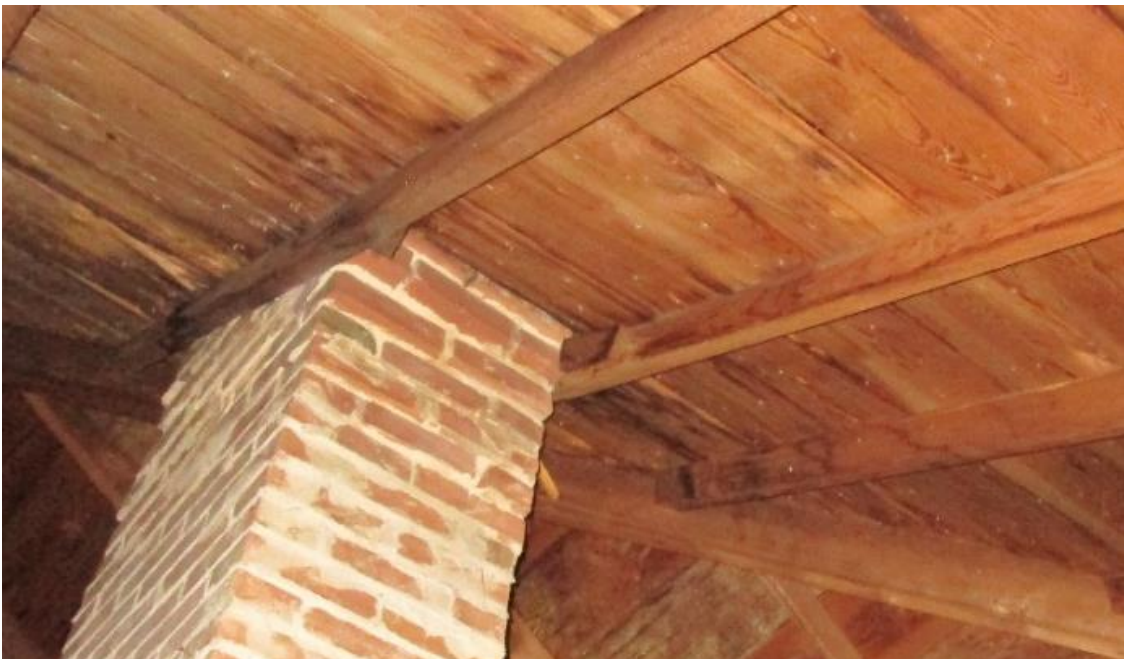
Photo #48 Close up view of the chimney – roof intersection. The decking has apparent water damage and some of it needs to be replaced.

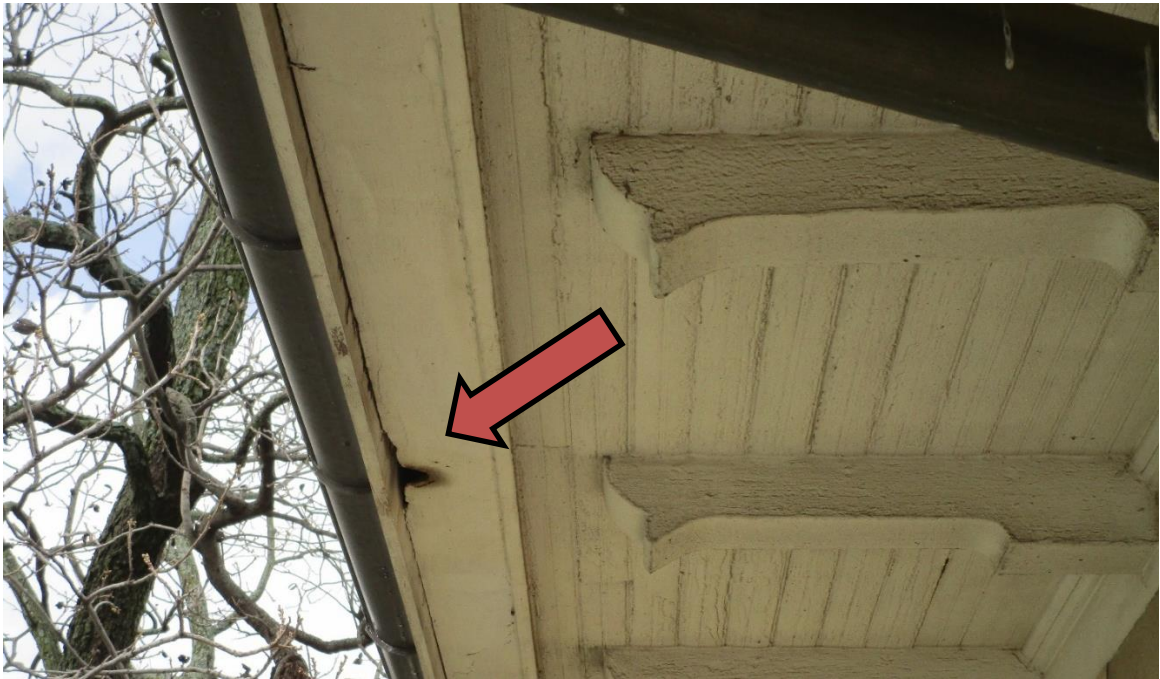
Photo #51 Arrow points to a hole in the roof soffit that is likely due to roof rats or squirrels. This hole should be filled. Note that rodents will chew thru wood to gain access to attics.

- A vermin hole is in the roof soffit on the south side of the building. **Recommendation:** Hire exterminator to rid building of pests. Fill hole with a metal plate and paint to match siding.

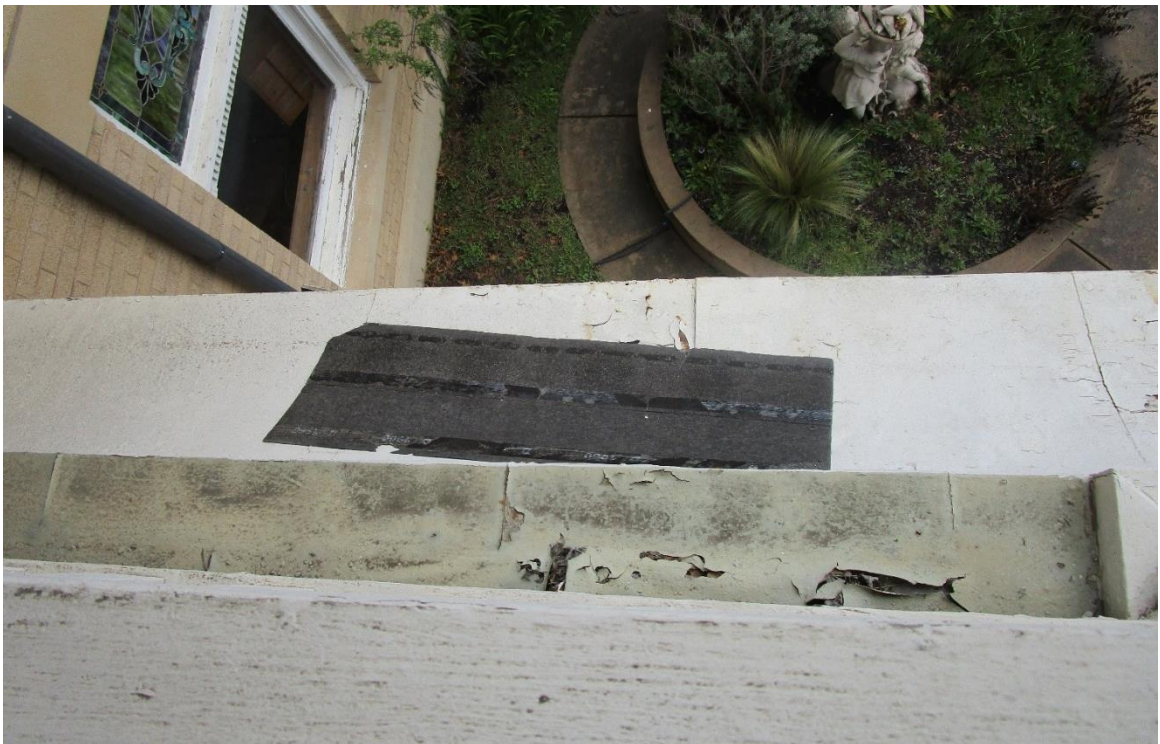
Photo #52 A roof shingle from upper roof that is laying on the east side of the lower roof for the south side entrance.

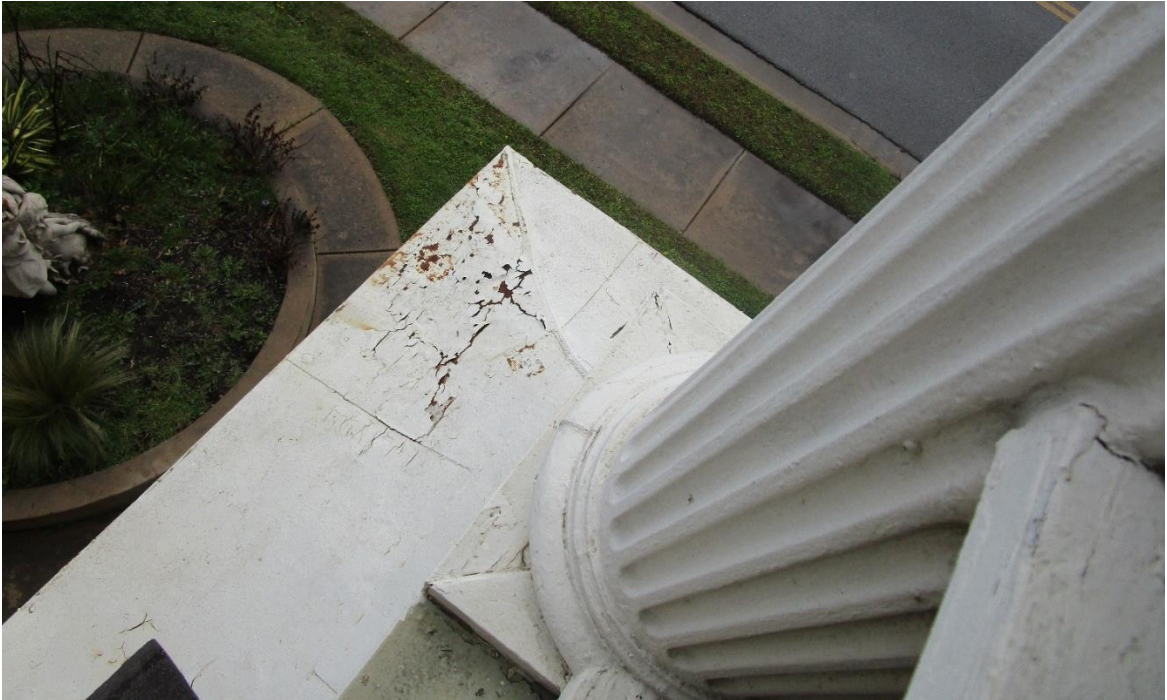
Photo #53 Crack paint on the lower roof southeast corner. It appears that the metal for the lower roof is rusting.

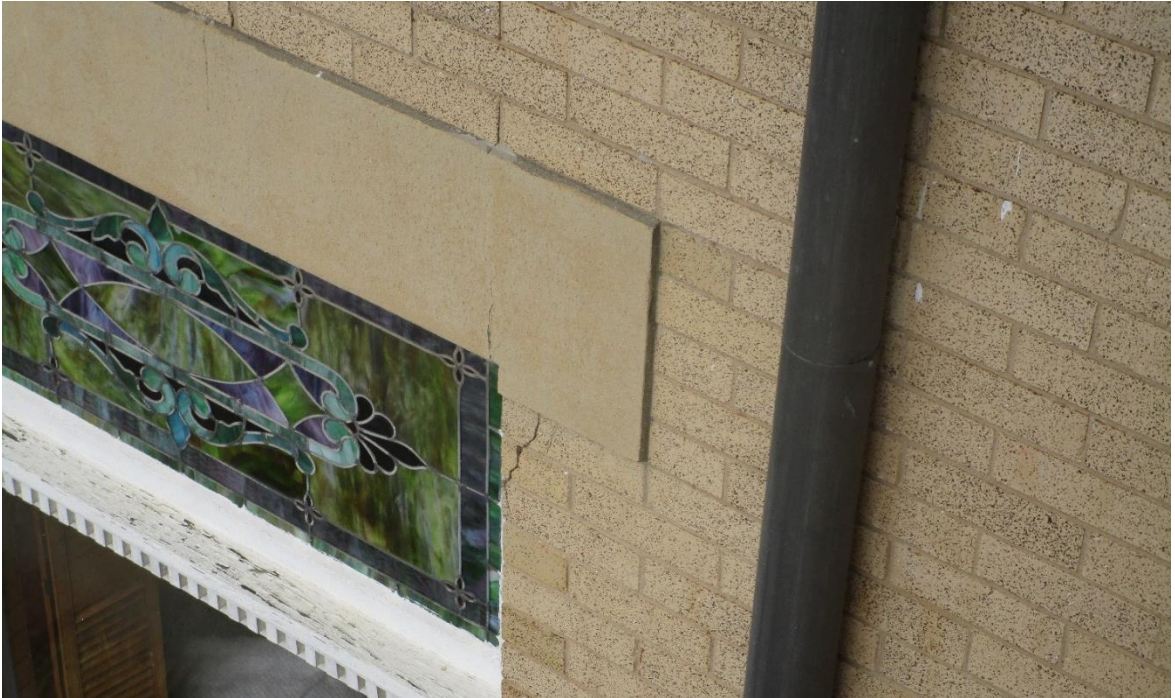
Photo #55 Crack in brick at the top of the window jamb for a first floor window on the south side of the building.

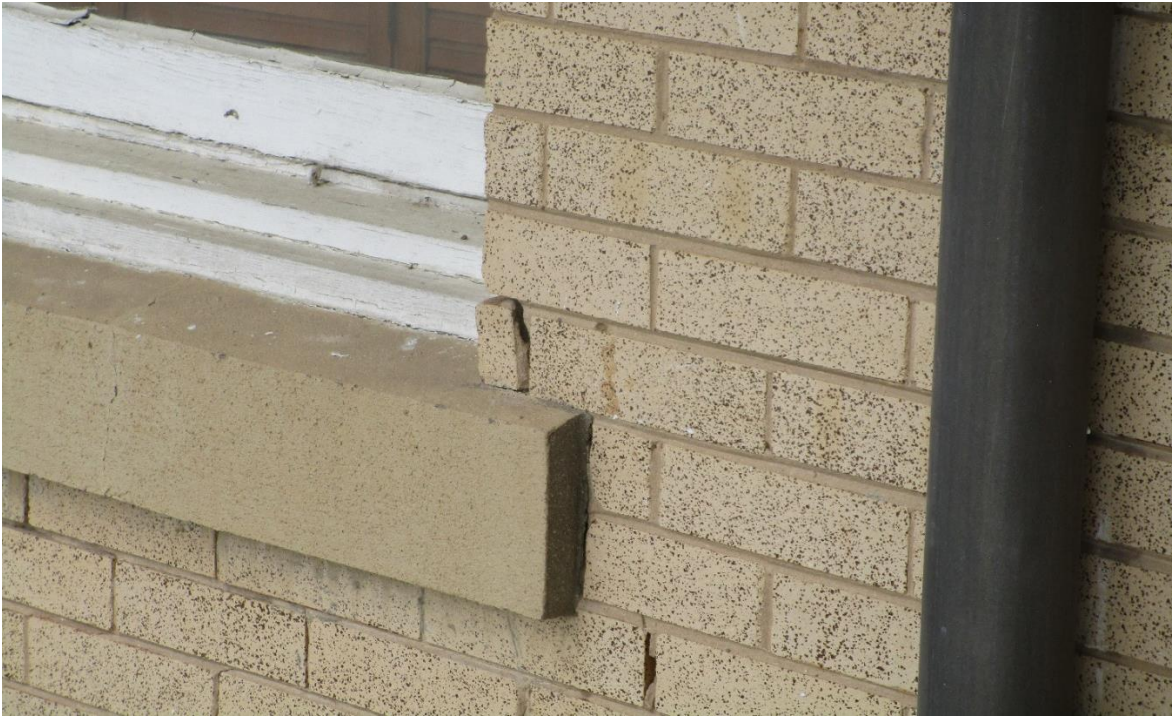
Photo #57 A small piece of brick has lost the mortar tying it to the remaining brick.

- There is a crack in the brick at the lower right corner and of a second-floor window on the south side of the building. **Recommendation:** Remove broken brick and install a new one or seal crack in brick with a sealant that matches color of the brick.

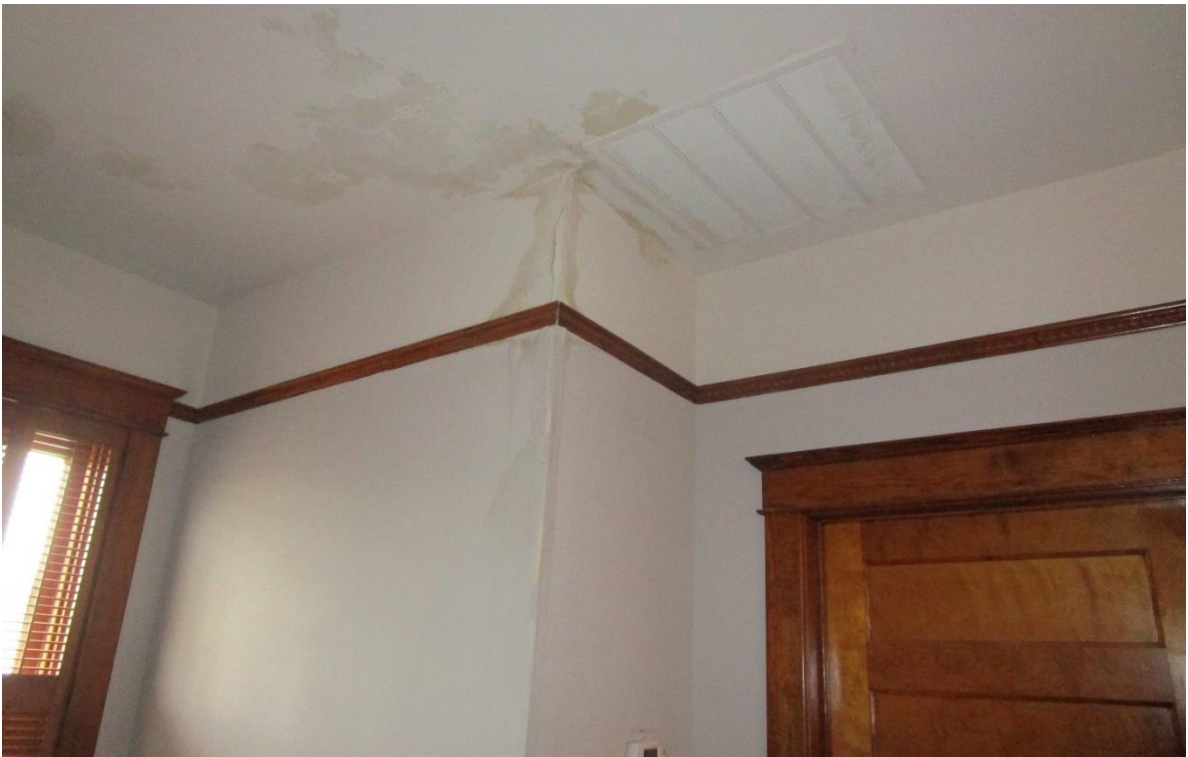
Photo #58 Water staining on the wall and ceiling in the second-floor hallway.

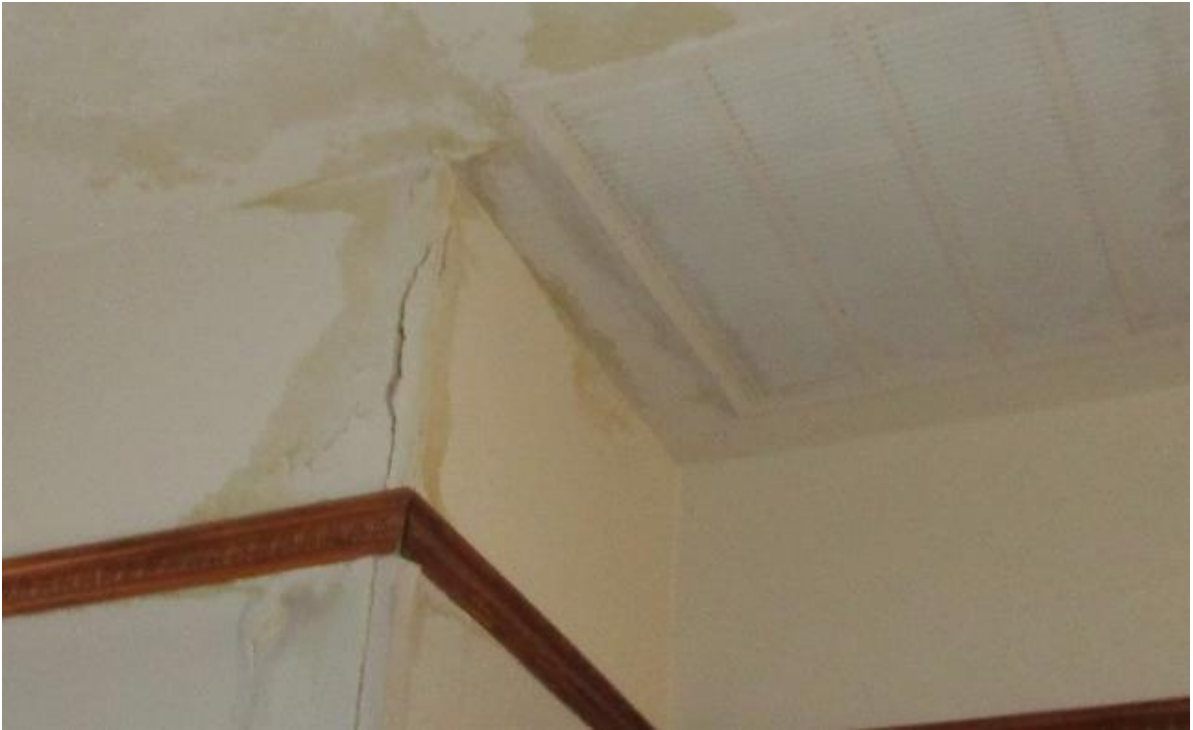
Photo #59 Close up of water damage at second floor ceiling. This is above the kitchen on the first floor where the plaster is damaged.

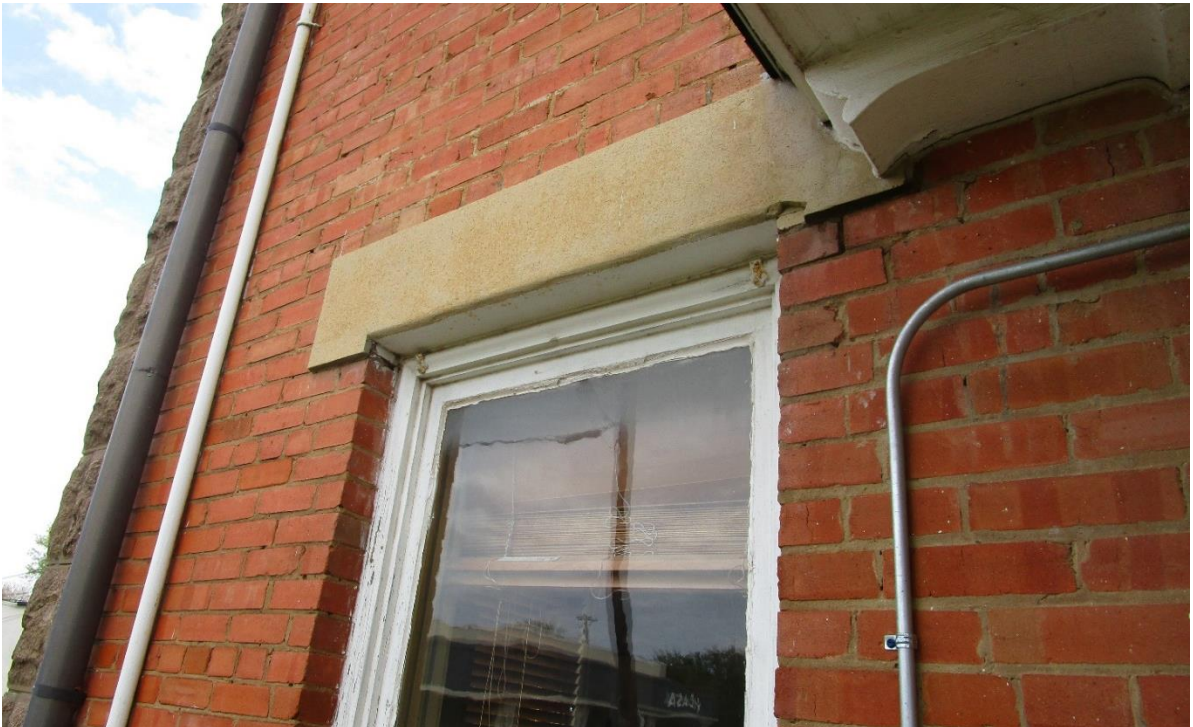
Photo #60 Window on the west side of the building has some water damage at the upper right-hand corner

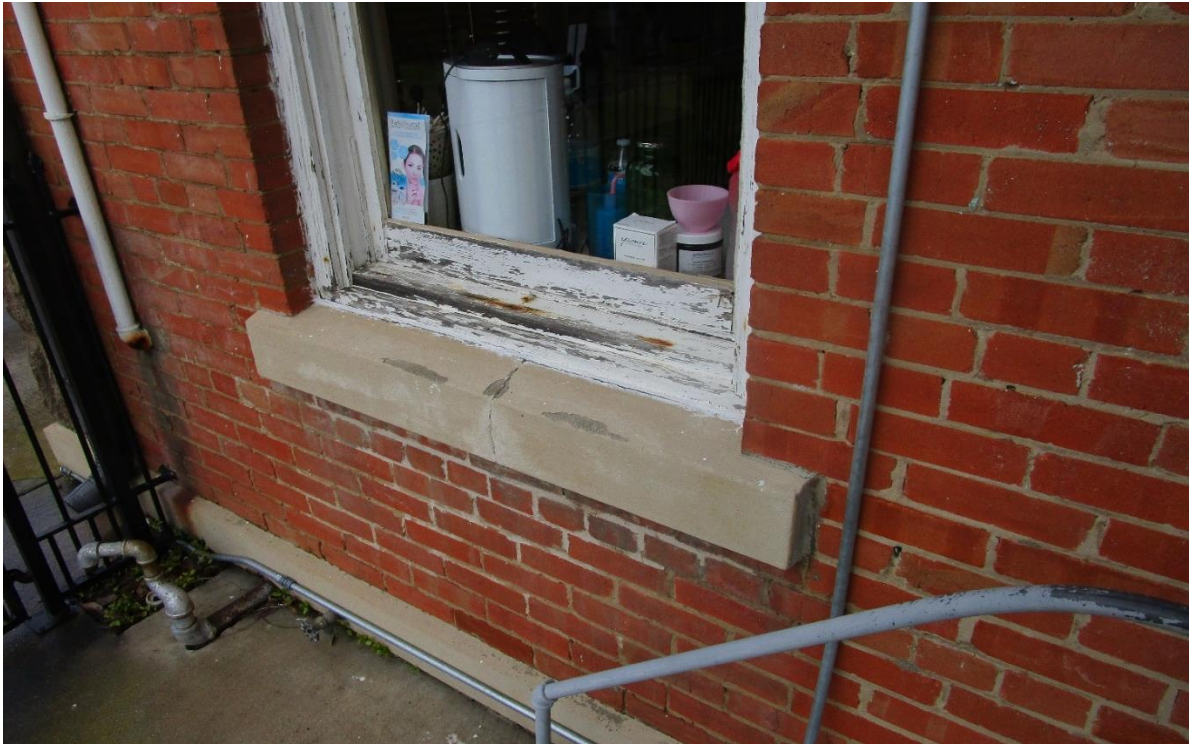
Photo #61 Windowsill on the west side of the building. The wood windowsill has severe water damage. The limestone sill has a crack in the middle.

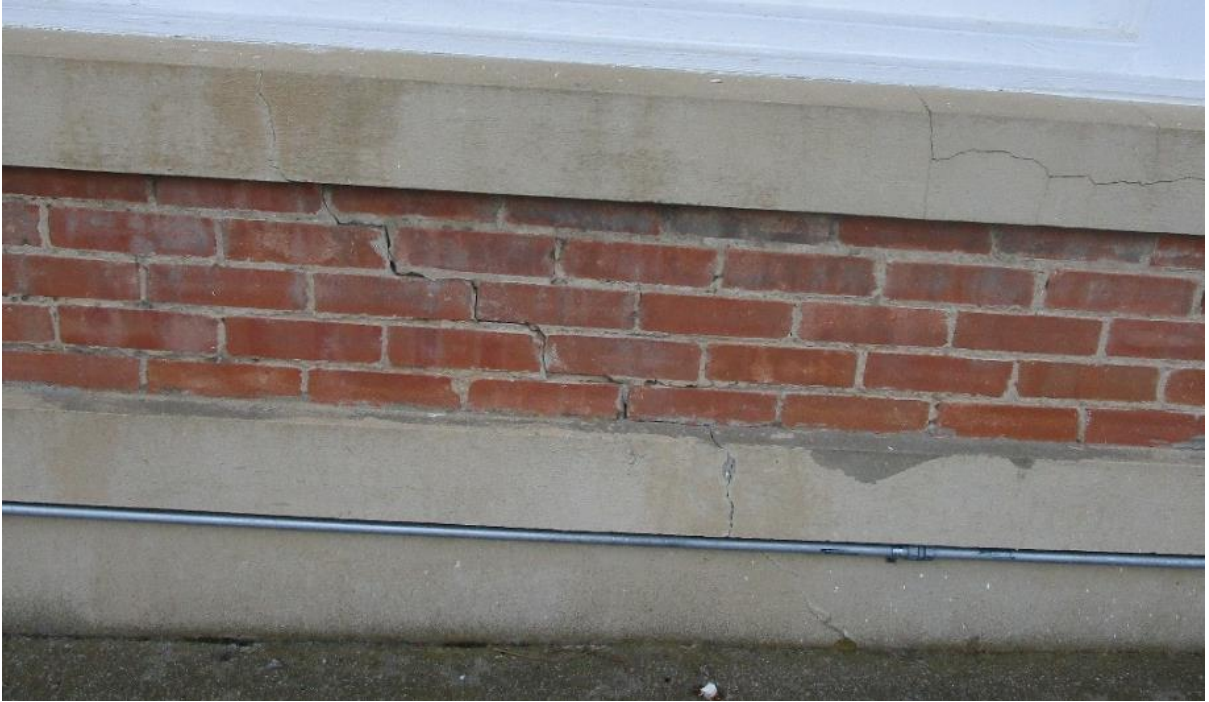
Photo #63 Crack in the brick and foundation under the window on the north side of the building.

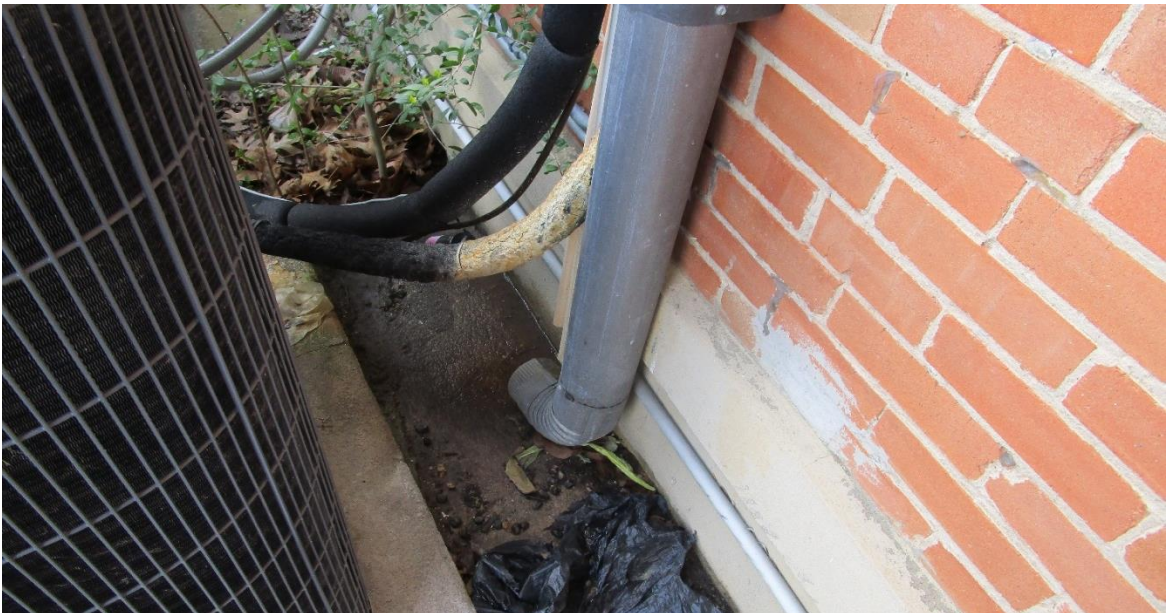
Photo #64 Downspout discharges water on the north side of the building behind the AC condensing unit. The AC condensate lines are discharging next the foundation as well. None of this water is directed away from the foundation.

- A downspout on the north side of the building discharges behind the AC units. There are AC condensate lines that discharge next to the downspout also. **Recommendation:** Downspout should be connected to an underground line and routed to discharge at the street or into the parking lot. AC condensates should be connected to a sewer line or discharged into the street or parking lot.
