Letter of Intent – 1505 Louisiana.

Re: Structural and Environmental Assessment – 1505 Louisiana Street, McKinney, Texas 75071

FINAL FOUNDATION INSPECTION (ZL2)

INITIAL FOUNDATION INSPECTION (ZL1)

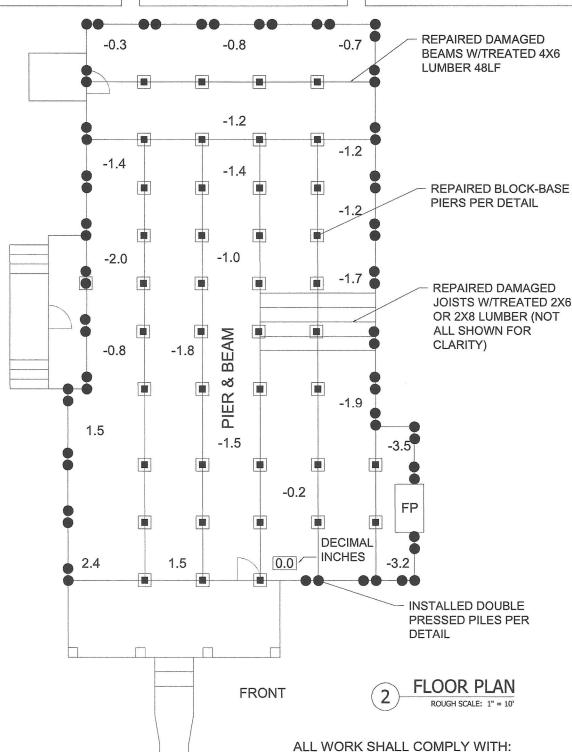
ALL ITEMS LISTED IN REDLINE'S INSPECTION REPORT DATED 03/09/2022 HAVE BEEN COMPLETED TO THE BEST OF OUR KNOWLEDGE AND THE ELEVATIONS POST-REPAIRS ARE DOCUMENTED ON SHEET Z2. THE CONTRACTOR IS RESPONSIBLE FOR THE PERFORMANCE OF THEIR WORK AND ANY FUTURE DEFLECTIONS IN THE FOUNDATION SHALL BE COMPARED TO THE PRESENT ELEVATIONS. THE CONTRACTOR IS ALSO RESPONSIBLE FOR COMMUNICATING ANY CHANGED LOCATIONS OF THE PILES/PIERS AS SHOWN IN PLAN.

- 1. INSTALLED BLOCK-BASE PIERS PER DETAIL
- 2. REPAIRED DOUBLE PRESSED-PILES PER DETAIL
- 3. LIFTED/STABILIZED FOUNDATION TO PERMISSIBLE ELEVATIONS
- 4. ELEVATION ADJUSTMENTS WERE MADE BY SHIMMING SUPPORTS WITH STEEL PLATES

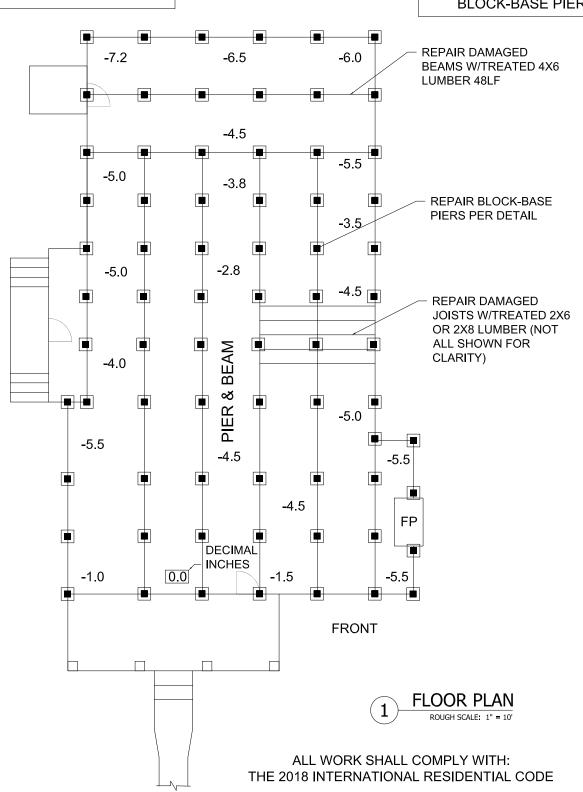
AN INTERIOR REFERENCE POINT OF 0.0 INCHES HAS BEEN USED TO RECORD THE ELEVATION VARIATIONS THROUGHOUT THE FLOOR PLAN. SHEET Z1 SHOWS THE PRESENT INDIVIDUAL ELEVATIONS OF FINISH FLOOR WHICH TAKE INTO ACCOUNT THE DIFFERENCES IN FLOOR COVERINGS.

- 1. REPAIR BLOCK-BASE PIERS PER PLAN AND DETAIL ON SHEET Z1.
- 2. BALANCE STRUCTURE TO WITHIN 0.7 INCH IN 10 FEET TOLERANCE BY JACKING AND USING SHIMS WHERE PERMISSIBLE (AVOID FURTHER DAMAGE TO WALLS, DOORS & WINDOWS).
- 3. A POST-BALANCING REPORT SHOWING NEW ELEVATIONS SHALL BE TAKEN BY REDLINE ENGINEERING USING THE SAME REFERENCE POINT.

- 1. REPAIR BLOCK-BASE PIERS PER DETAIL
- 2. LIFT/STABILIZE FOUNDATION TO PERMISSIBLE ELEVATIONS
- 3. REPORT WATER LEAKS AND VISIBLE ROOTS UNDER/NEAR FOUNDATION
- 4. ELEVATION ADJUSTMENTS SHALL BE MADE BY SHIMMING SUPPORTS WITH STEEL PLATES

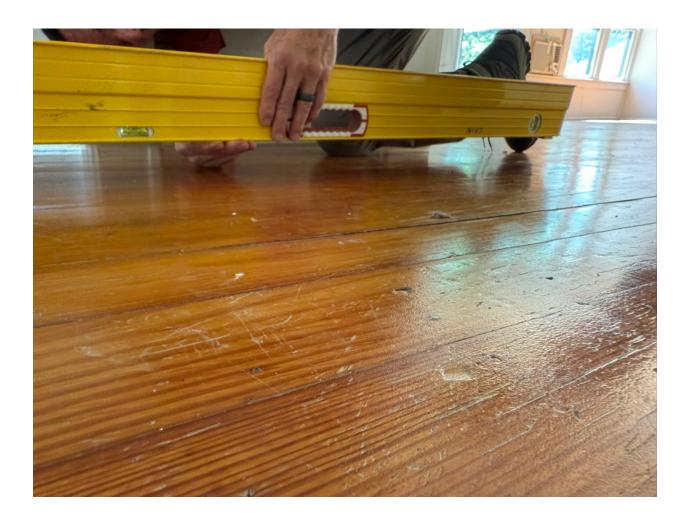
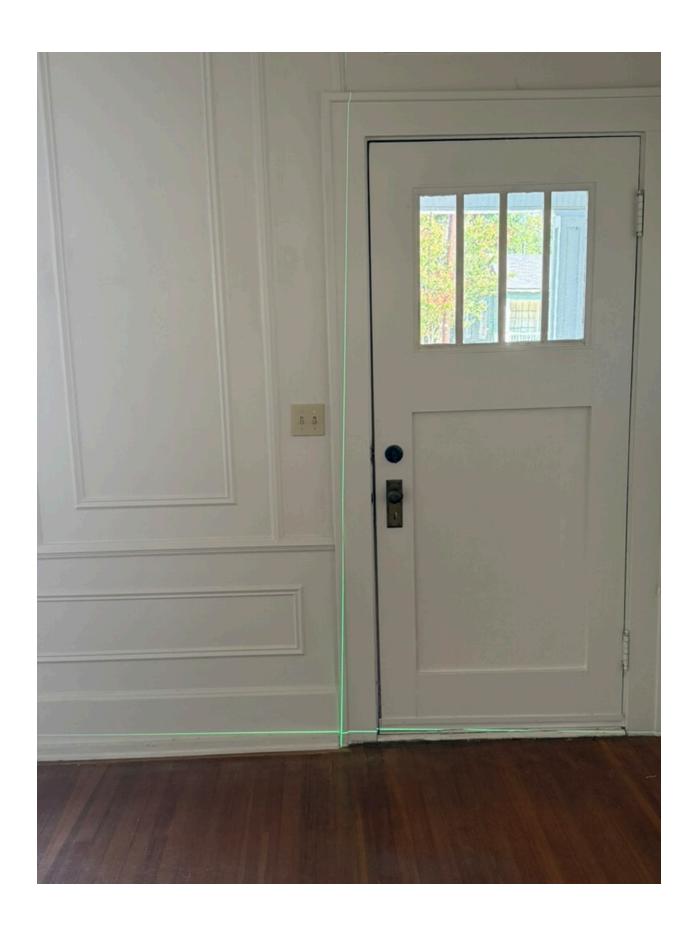
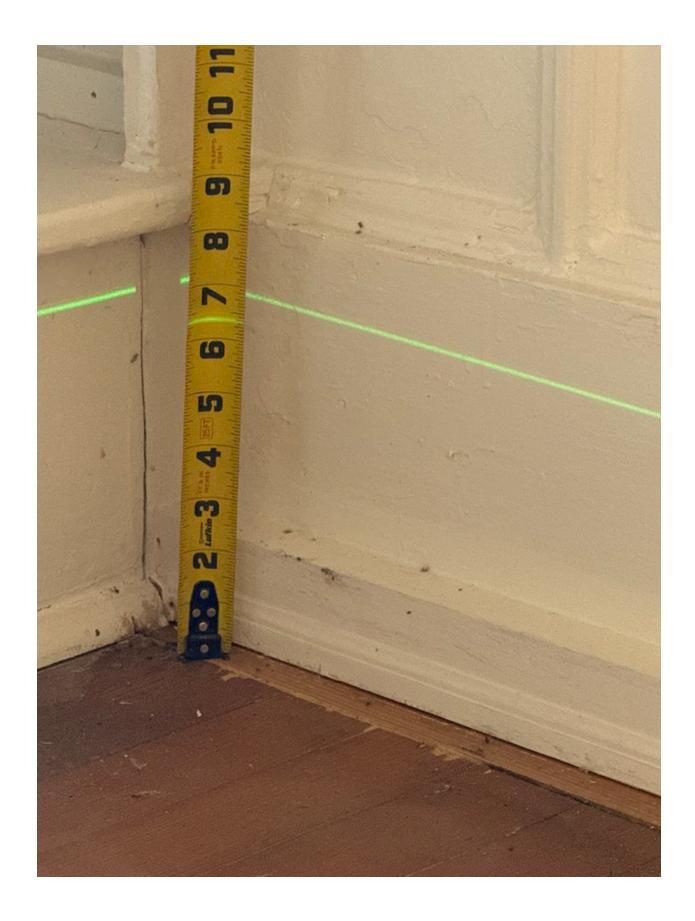
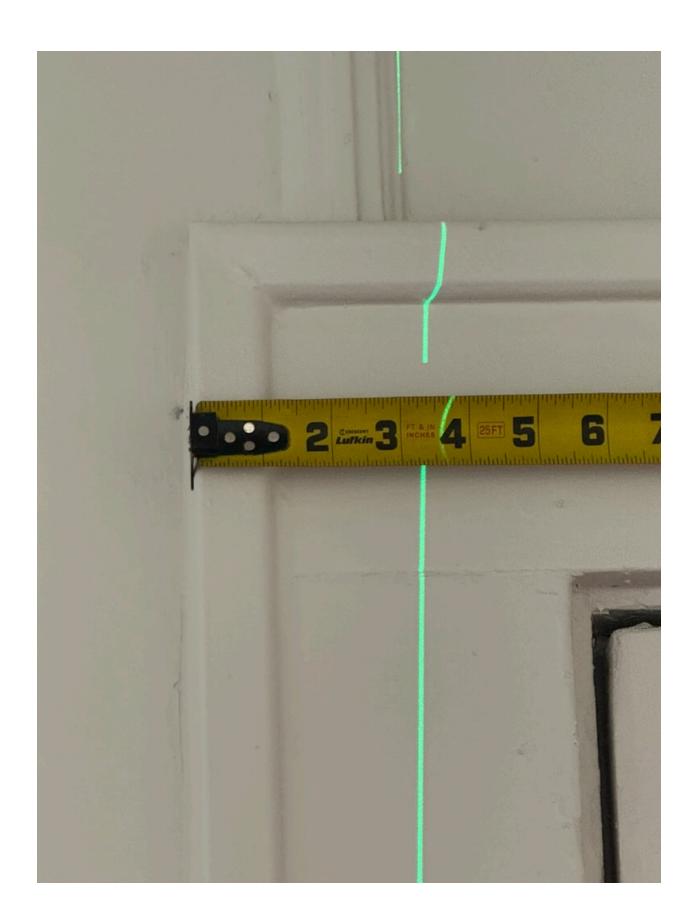
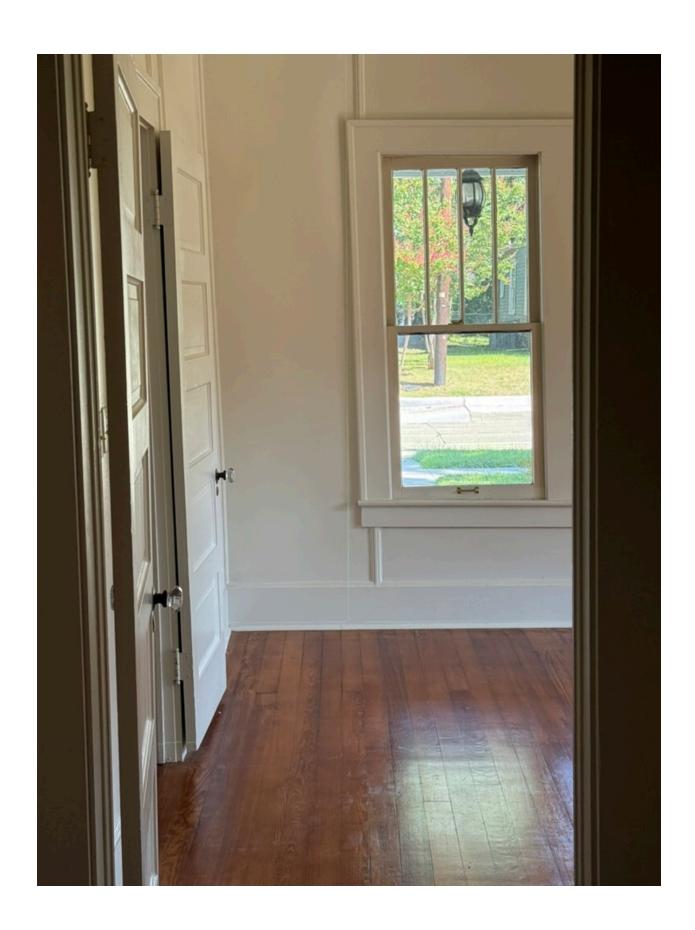
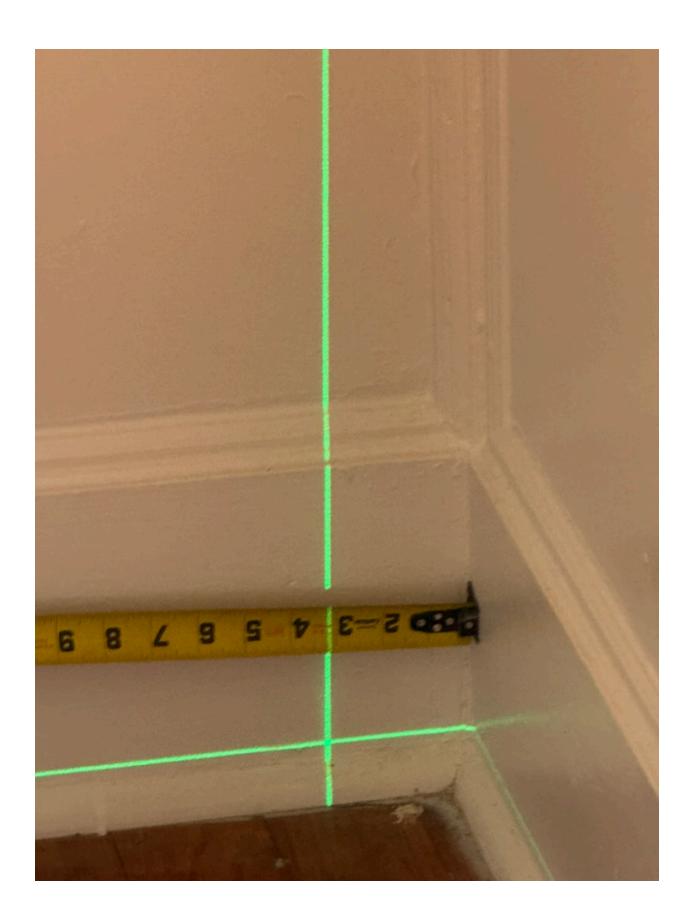
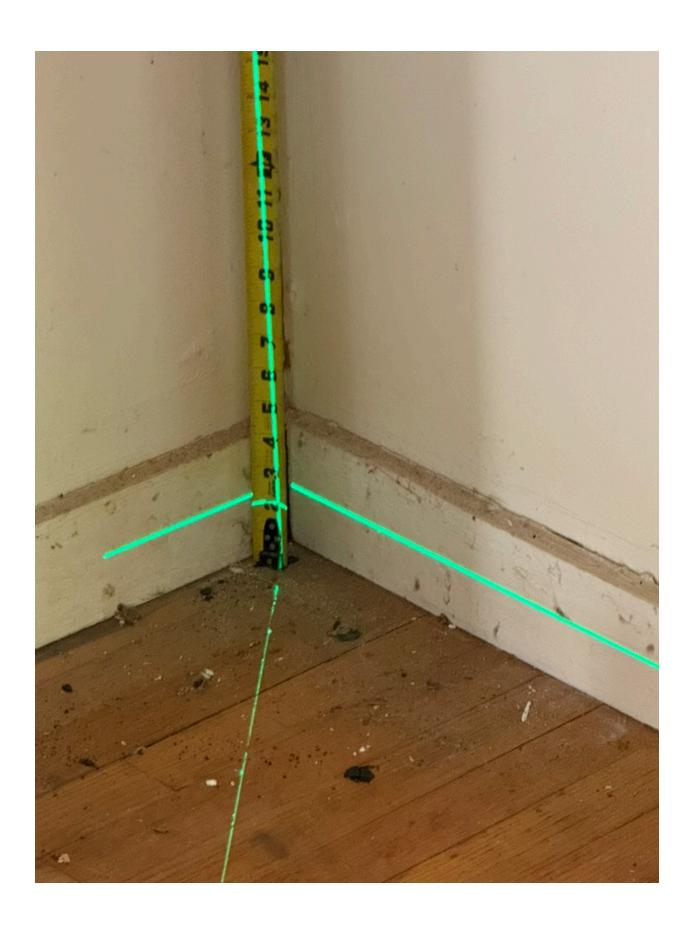
The photos below all show images throughout the entire house, the failing foundation structure. It's worth noting that the prior owners had a prominent McKinney contractor, who performs work is the historic district regularly, level the house as much as possible within the last year.
