Date:	November 12, 2024
Attention:	Kelly Sheriff (
Subject:	Pre-Repair Foundation Repair Evaluation Block and Base Foundation 612 West Virginia Street, McKinney, TX

Date:	February 26, 2025
Attention:	Structured Foundation Repairs, Inc. (SFR) (via e-mail)
Subject:	Final Report & Inspection 612 West Virginia St., McKinney, TX. 75069

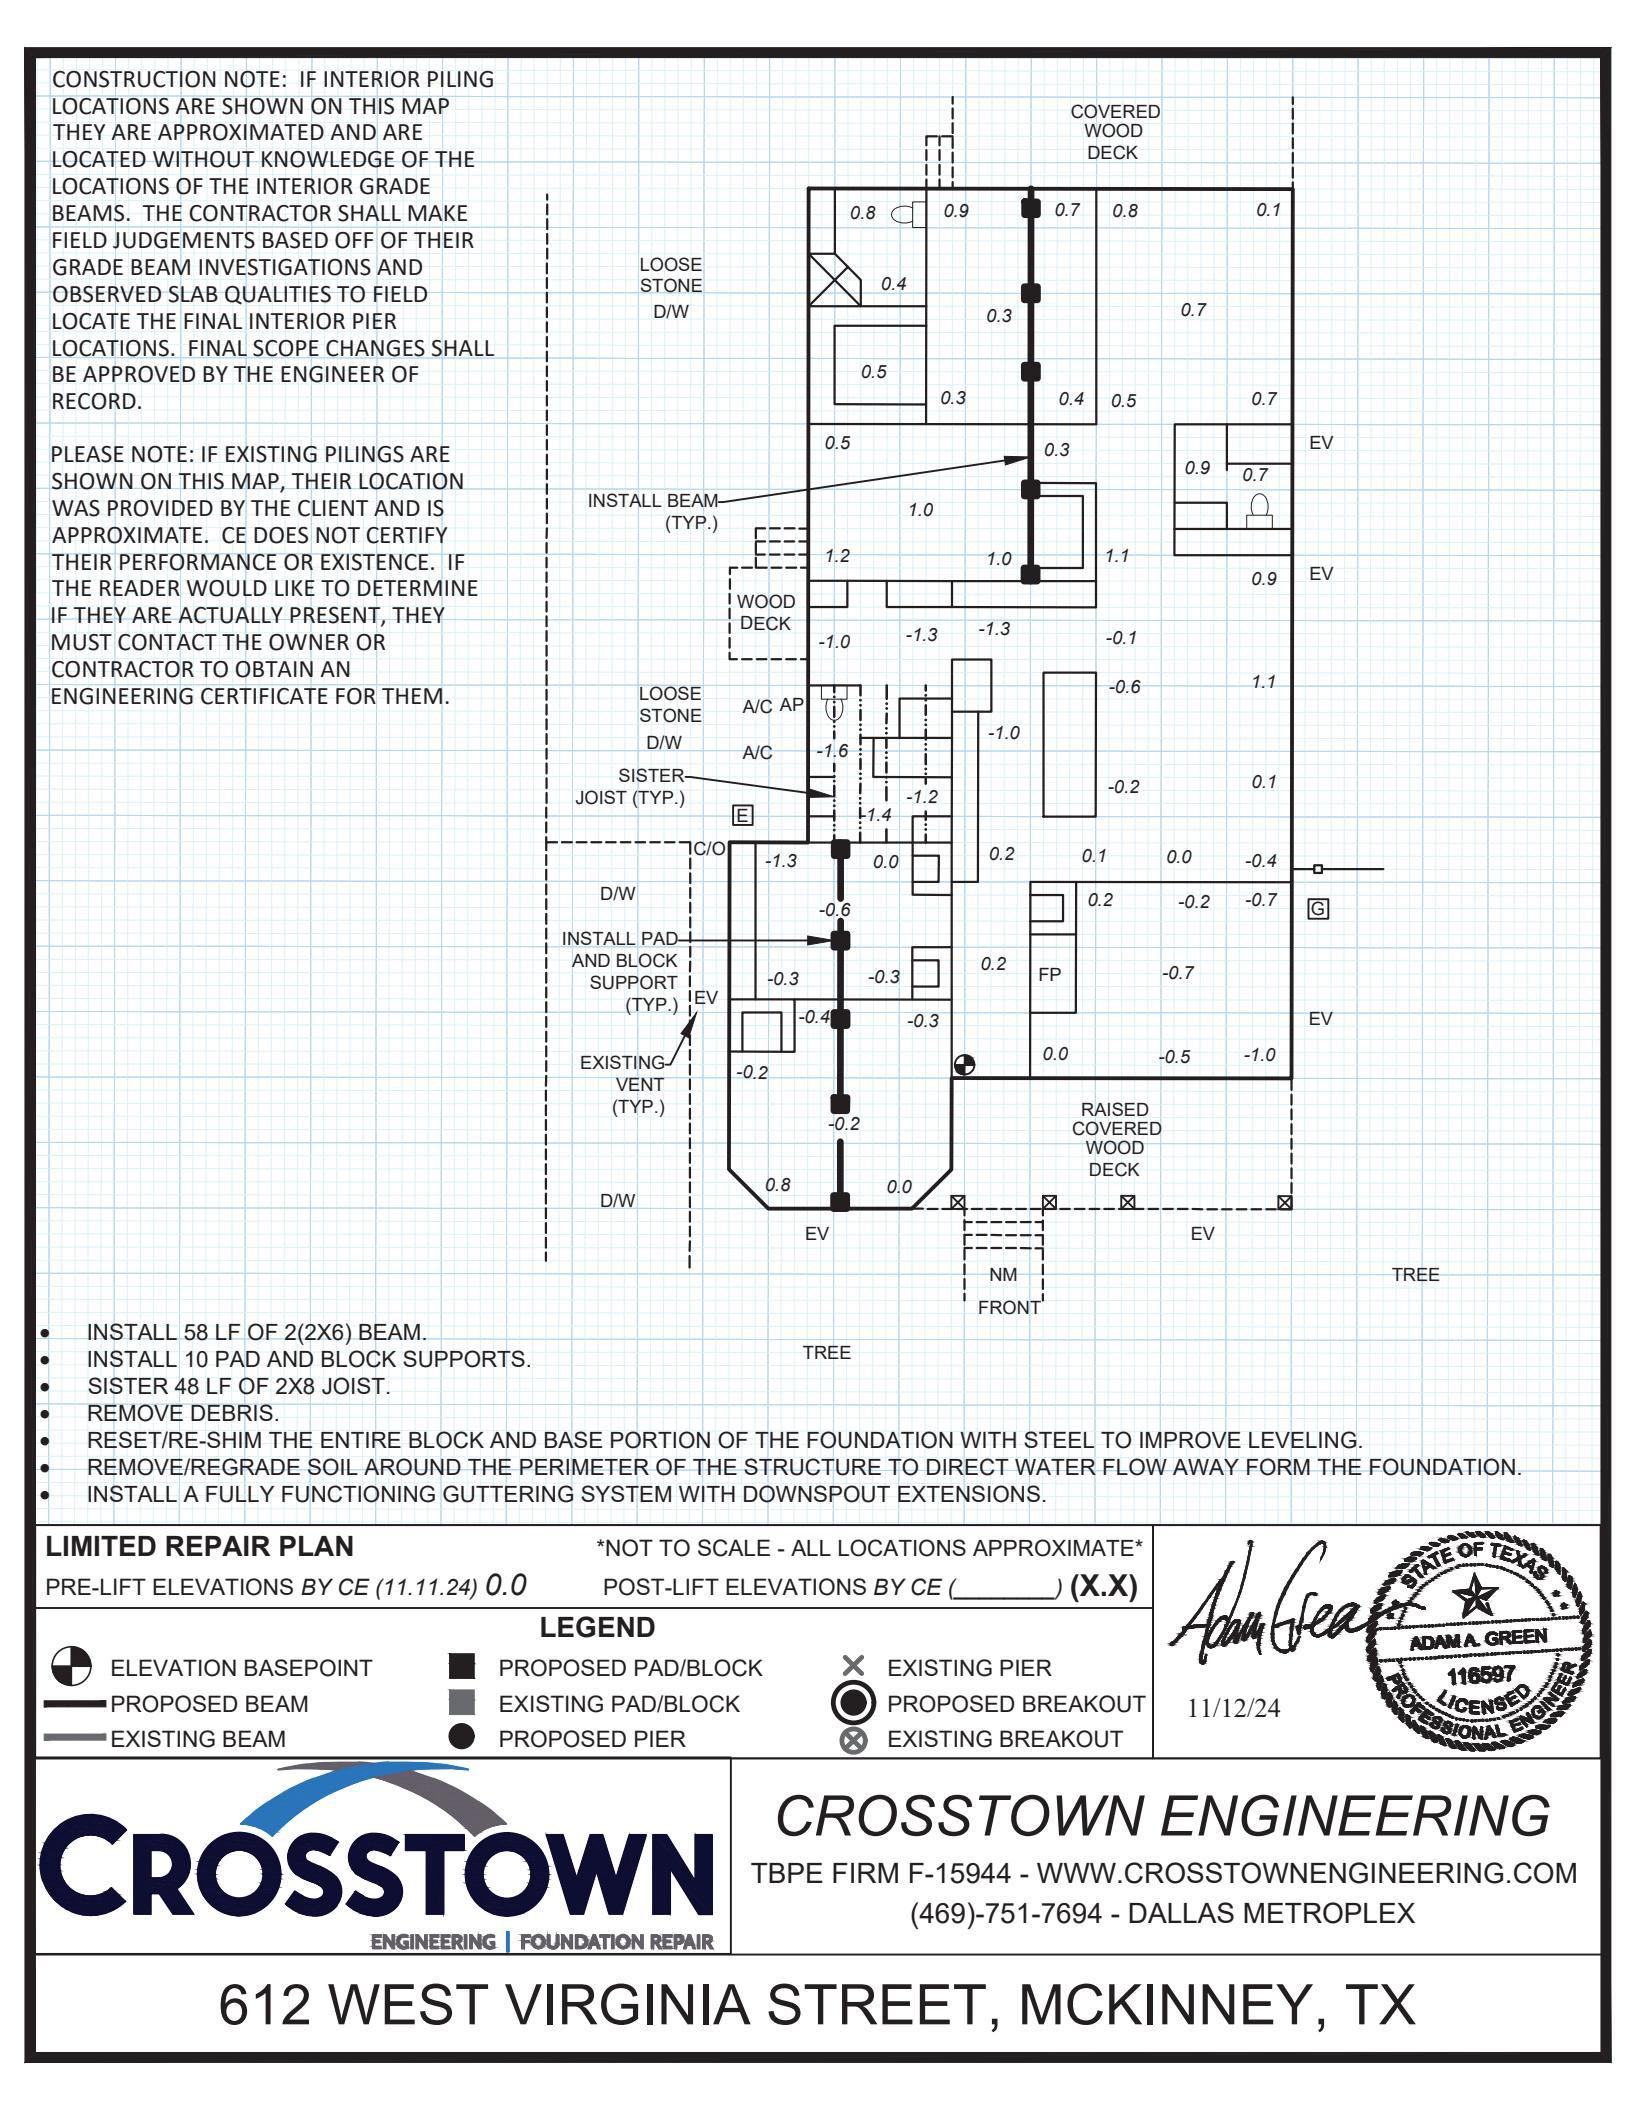
A relative elevation floor survey was performed using a Ziplevel Pro-2000B to map the surface topography of the floor of the living area and garage (if present). The floor plans and the elevations are illustrated on the limited repair plan. The elevations were adjusted based on the flooring type encountered to be on the same plane as the base point floor type. If a garage was present, the garage ceiling was measured and adjusted to be on the same plane as the foundation. Garage floors are designed to slope and are not as effective in measuring foundation movement.

This residence has had previous foundation repairs completed multiple times with the last foundation repair completed in 2021. Visual inspection of the crawlspace shows existing bark stump supports as well as pad and block supports, poured concrete sonotube supports and previous repairs to beams, joists, sub-flooring and plumbing. Drywall cracks, floor cracks, sticking doors, debris, damaged joist, damaged beams and damaged supports were observed. Based on our observations of the structure, the structure's physical damage and review of the elevation map, we believe the structure has experienced seasonal foundation movement over the life of the structure, resulting in differential movement of the block and base foundation.

Damage observations were notable on the interior of the structure and are correlated with floor elevation data.

We recommend performing the following in the approximate locations of the structure as indicated on the limited repair plan:

- Install 58 LF of 2(2x6) beam.
- Install 10 pad and block supports.
- Sister 48 LF of 2x8 joist.
- Remove debris.
- Reset/re-shim the entire block and base portion of the foundation with steel to improve leveling.
- Remove/regrade soil around the perimeter of the structure to direct water flow away form the foundation.
- Install a fully functioning guttering system with downspout extensions.

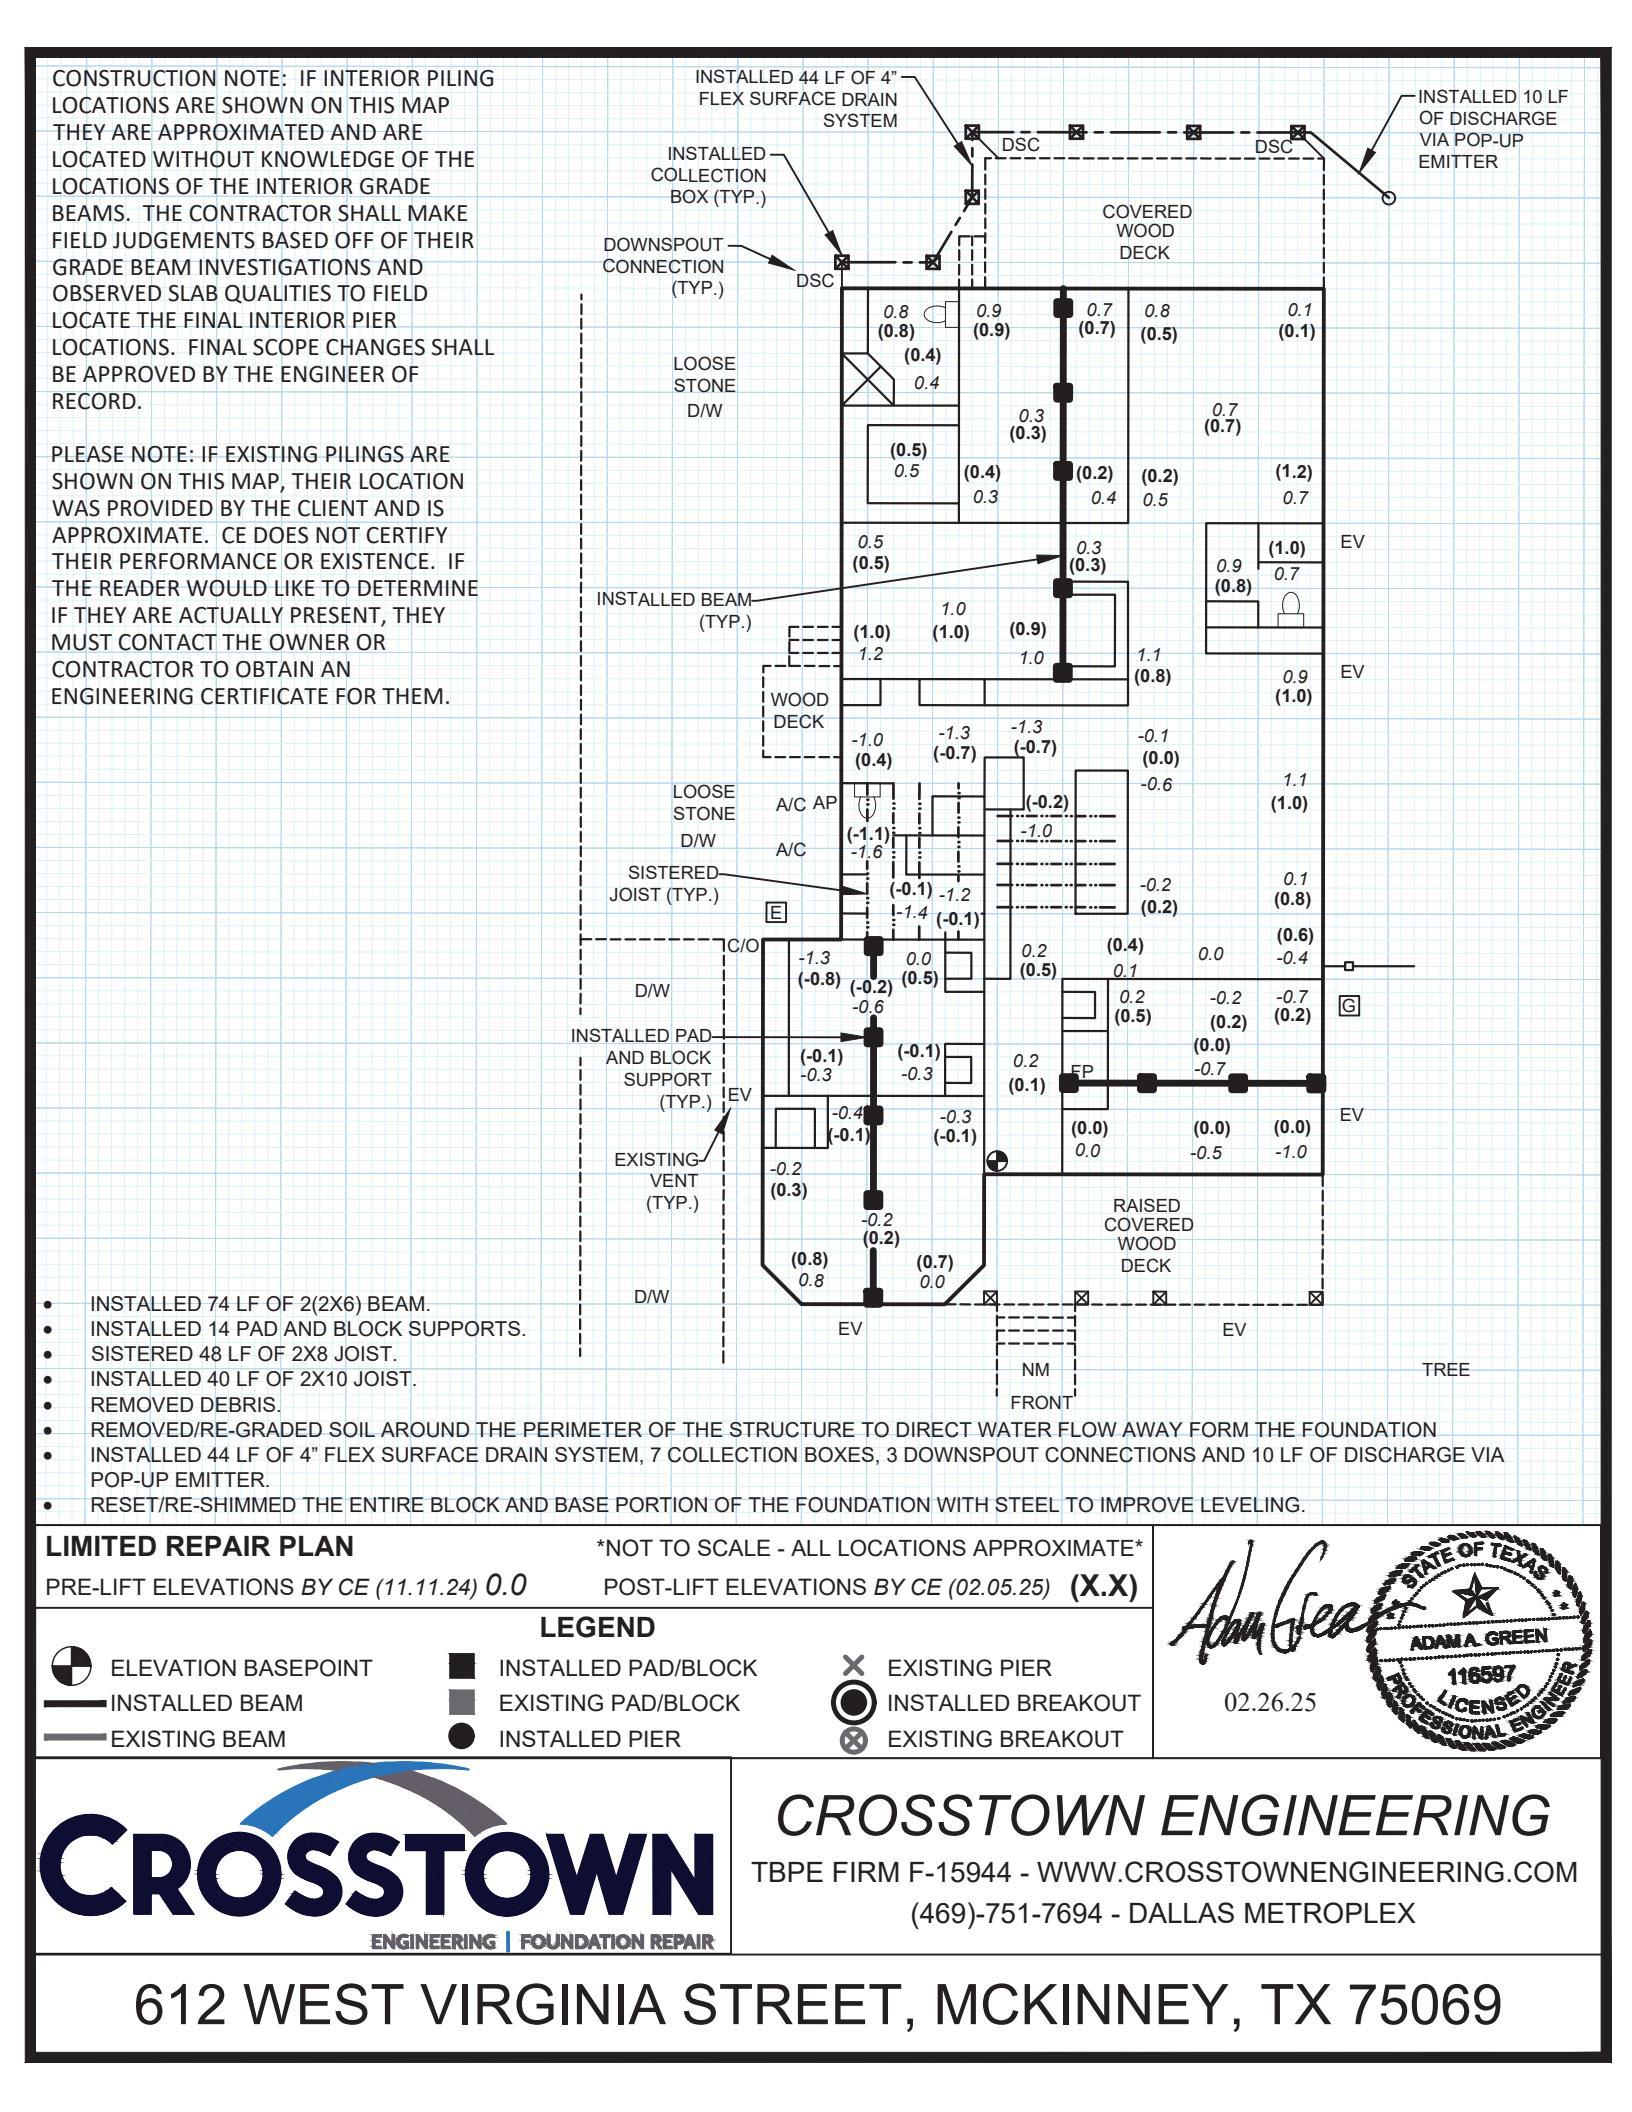
- Installed 74 LF of 2(2x6) beam.
- Installed 14 pad and block supports.
- Sistered 48 LF of 2x8 joist.
- Installed 40 LF of 2x10 joist.
- Removed debris.
- Removed/regraded soil around the perimeter of the structure to direct water flow away form the foundation.
- Installed 44 LF of 4" flex surface drain system, 7 collection boxes, 3 downspout connections and 10 LF of discharge via pop-up emitter.
- Reset/re-shimmed the entire block and base portion of the foundation with steel to improve leveling.

The following changes were made to the original repair plan: 16 LF of beam, 40 LF of joist, 4 pad and block supports and 44 LF of 4" flex surface drain system, 7 collection boxes, 3 downspout connections and 10 LF of discharge via pop-up emitter were added to the installation. The elevation data obtained during the inspection indicates the foundation is supported by beam and joists to prevent further downward movement and may have been lifted. In some cases, the beam and joists are meant to support the foundation and minimal to zero lift was intentional. The foundation repairs meet or exceed the 2021 IRC.
