McKinney Community Development Corporation
Project Grant #16-07
The Heritage Guild of Collin County
Owner of Chestnut Square Historic Village

1875 Dulaney Cottage
307 S. Chestnut St.

Final Report

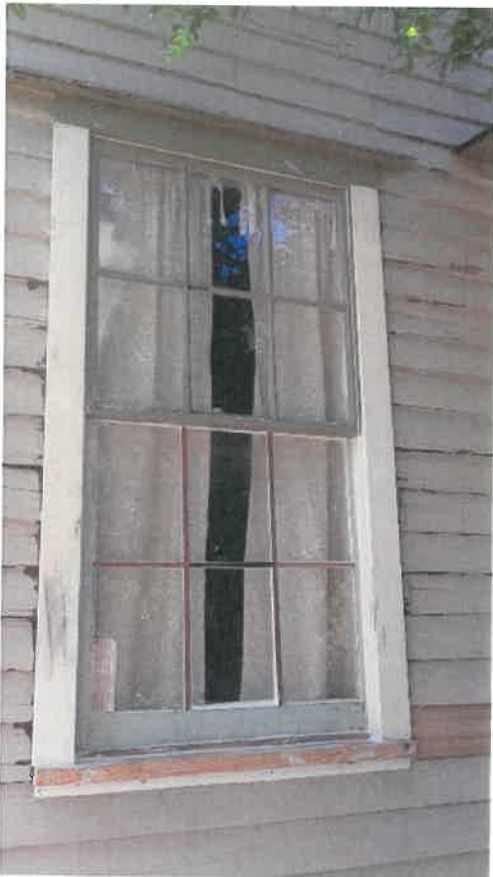
Exterior Window during work

From then, work continued on the exterior. Window frames were repaired or rebuilt, gutters were installed, significant amounts of rotted siding and fascia trim was replaced, and in November, a fresh paint was applied to the outside. At this point, we had achieved all of the exterior items on the list from the request – one bid for that work alone was \$65,0000 – and had spent only \$24,751.

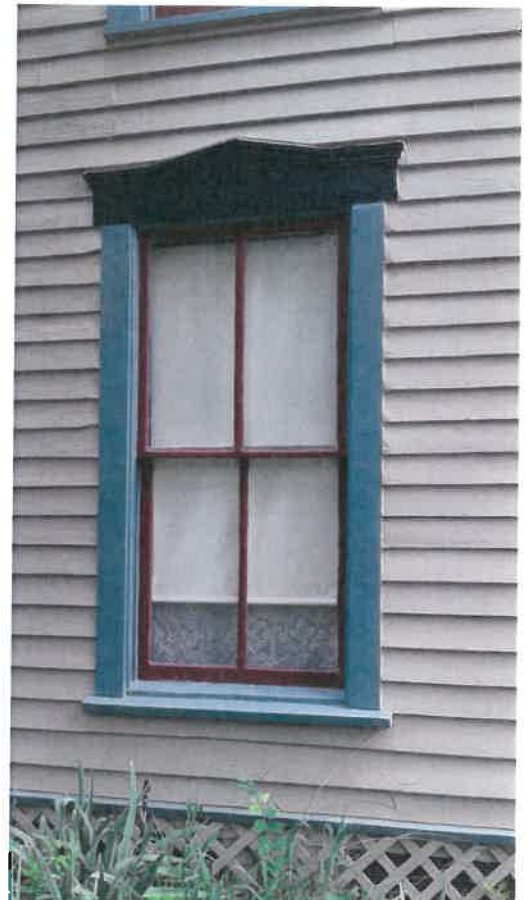
Repaired and repainted window

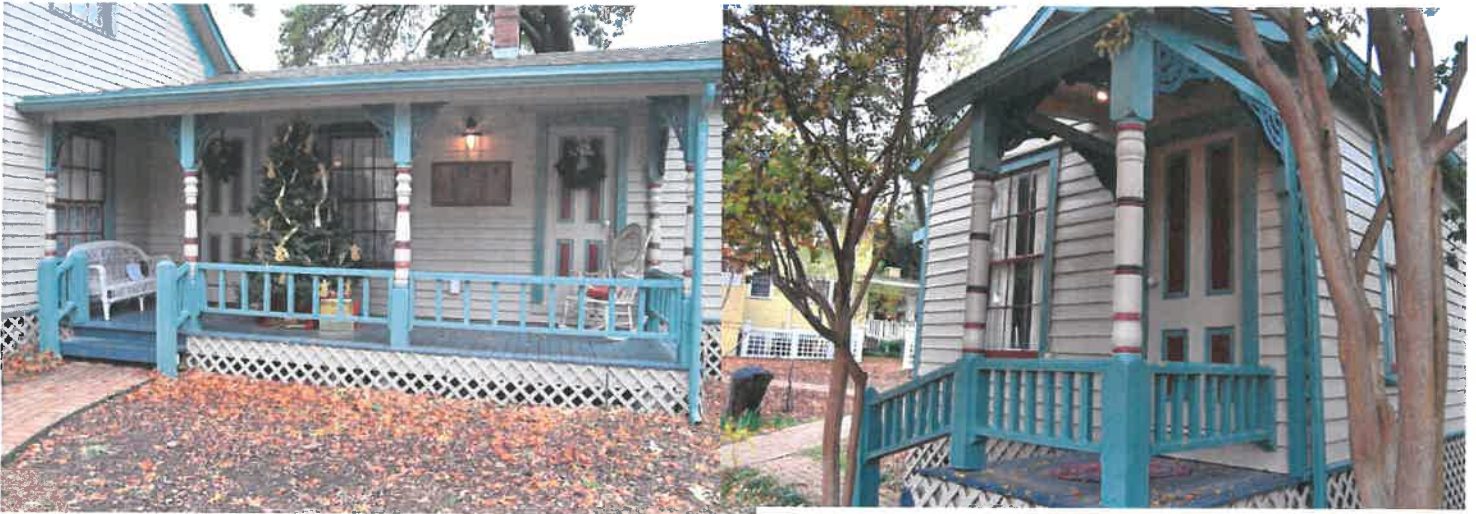
New Exterior period appropriate Tri-Tonal paint, fitting for a Victorian style home

We used several sources to research wallpaper patterns and paint colors. Curator Leisha Phipps worked with Guy, local historian Deborah Kilgore, and the Sherwin Williams historic collection to choose the four exterior colors – which are much more vibrant and highlight the Victorian workmanship far better than the former bi-tonal color scheme. The wallpapers were chosen in the same color scheme as what was removed, however they are lighter and brighter, enhancing the tall ceilings and dramatic entry hall.

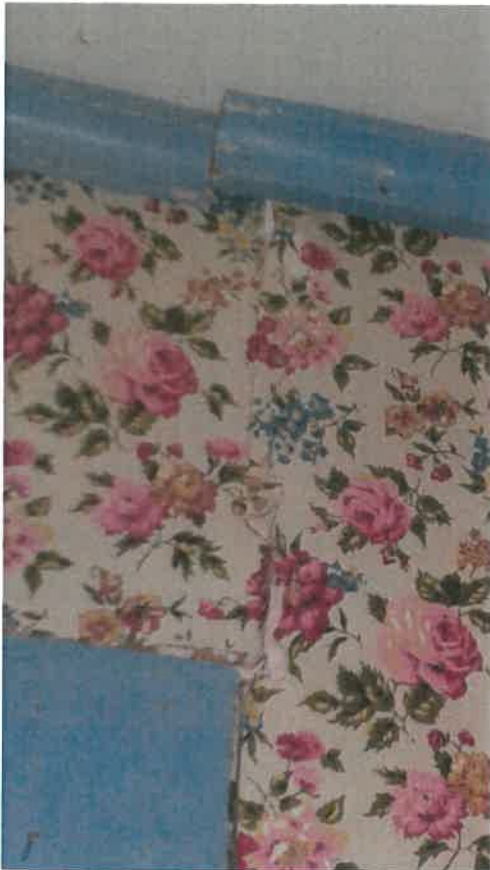
Old Entry paper and trim

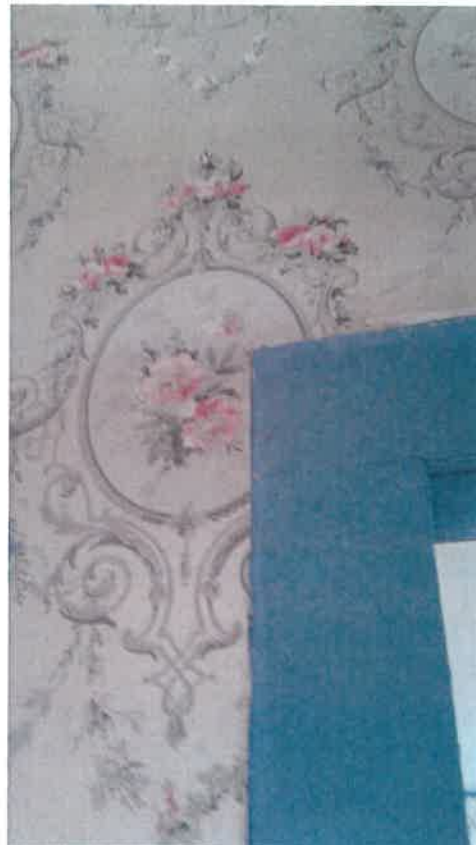
New Entry paper and Trim paint

All of the baseboard and wall board repair/replacement has been completed, and the 2 rooms in most need of new wallpaper have it – the entry hall and the Dr.’s office. In the first floor bedroom, the wallpaper, fireplace and floor boards have been repaired.

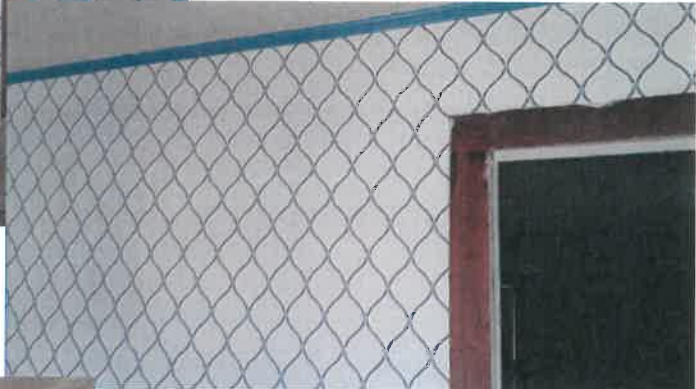
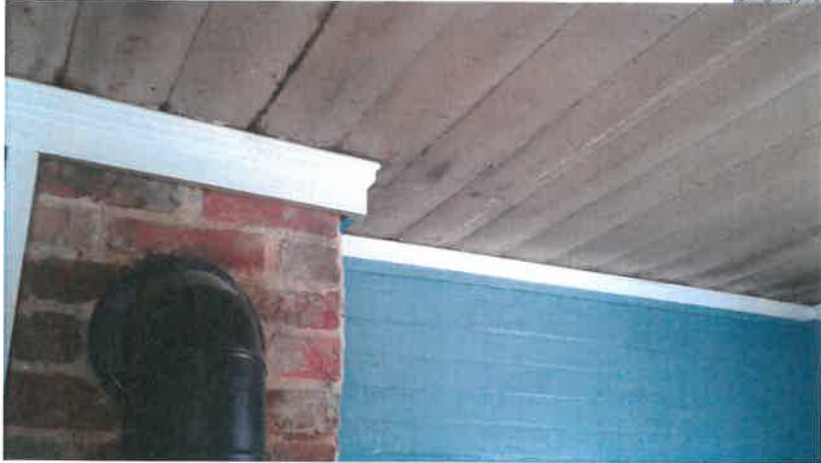
New exposed shiplap ceiling in kitchen

Along with the “OOPS” surprise of the foundation shift, there was a nice surprise. Once the damage was assessed in the dining room and kitchen, and the damaged ceiling was removed for repair – under the plasterboard we uncovered the original shiplap ceiling, in pristine condition. We suspect that it was covered for insulation purposes, however we left it exposed for exhibition. Climate control is not a huge factor in this building.

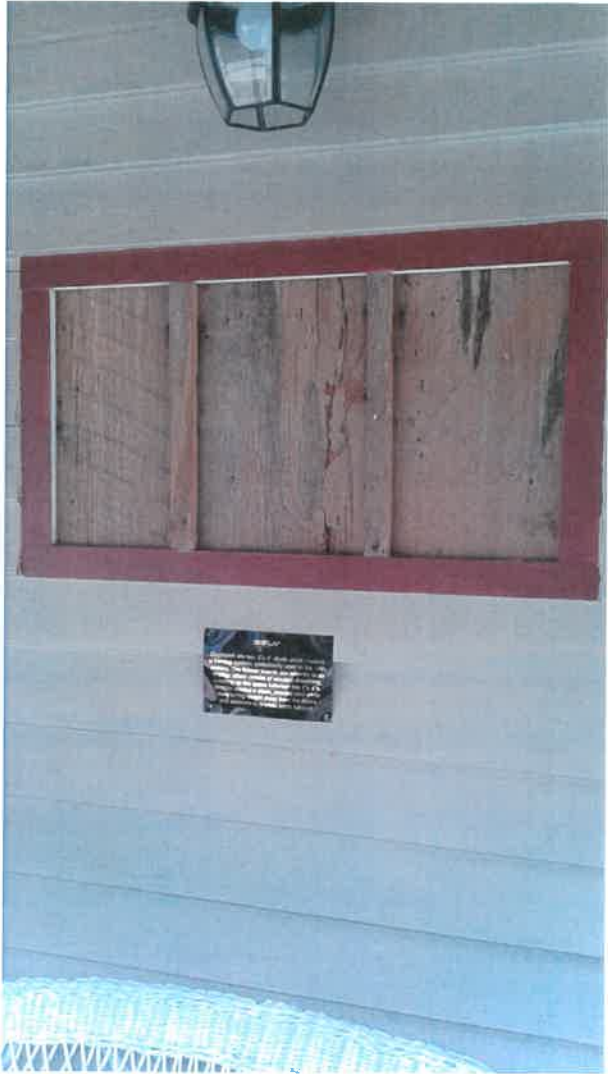
Exposed shiplap with explanation of structural use
