RE: Letter of Intent for Certificate of Appropriateness Application – 311 S Kentucky St,  
McKinney, Texas 75069

Reference: Field Observation Report

Address: 311 S. Kentucky St.  
McKinney, Texas 75069

311 S Kentucky St, Mckinney, TX 75069

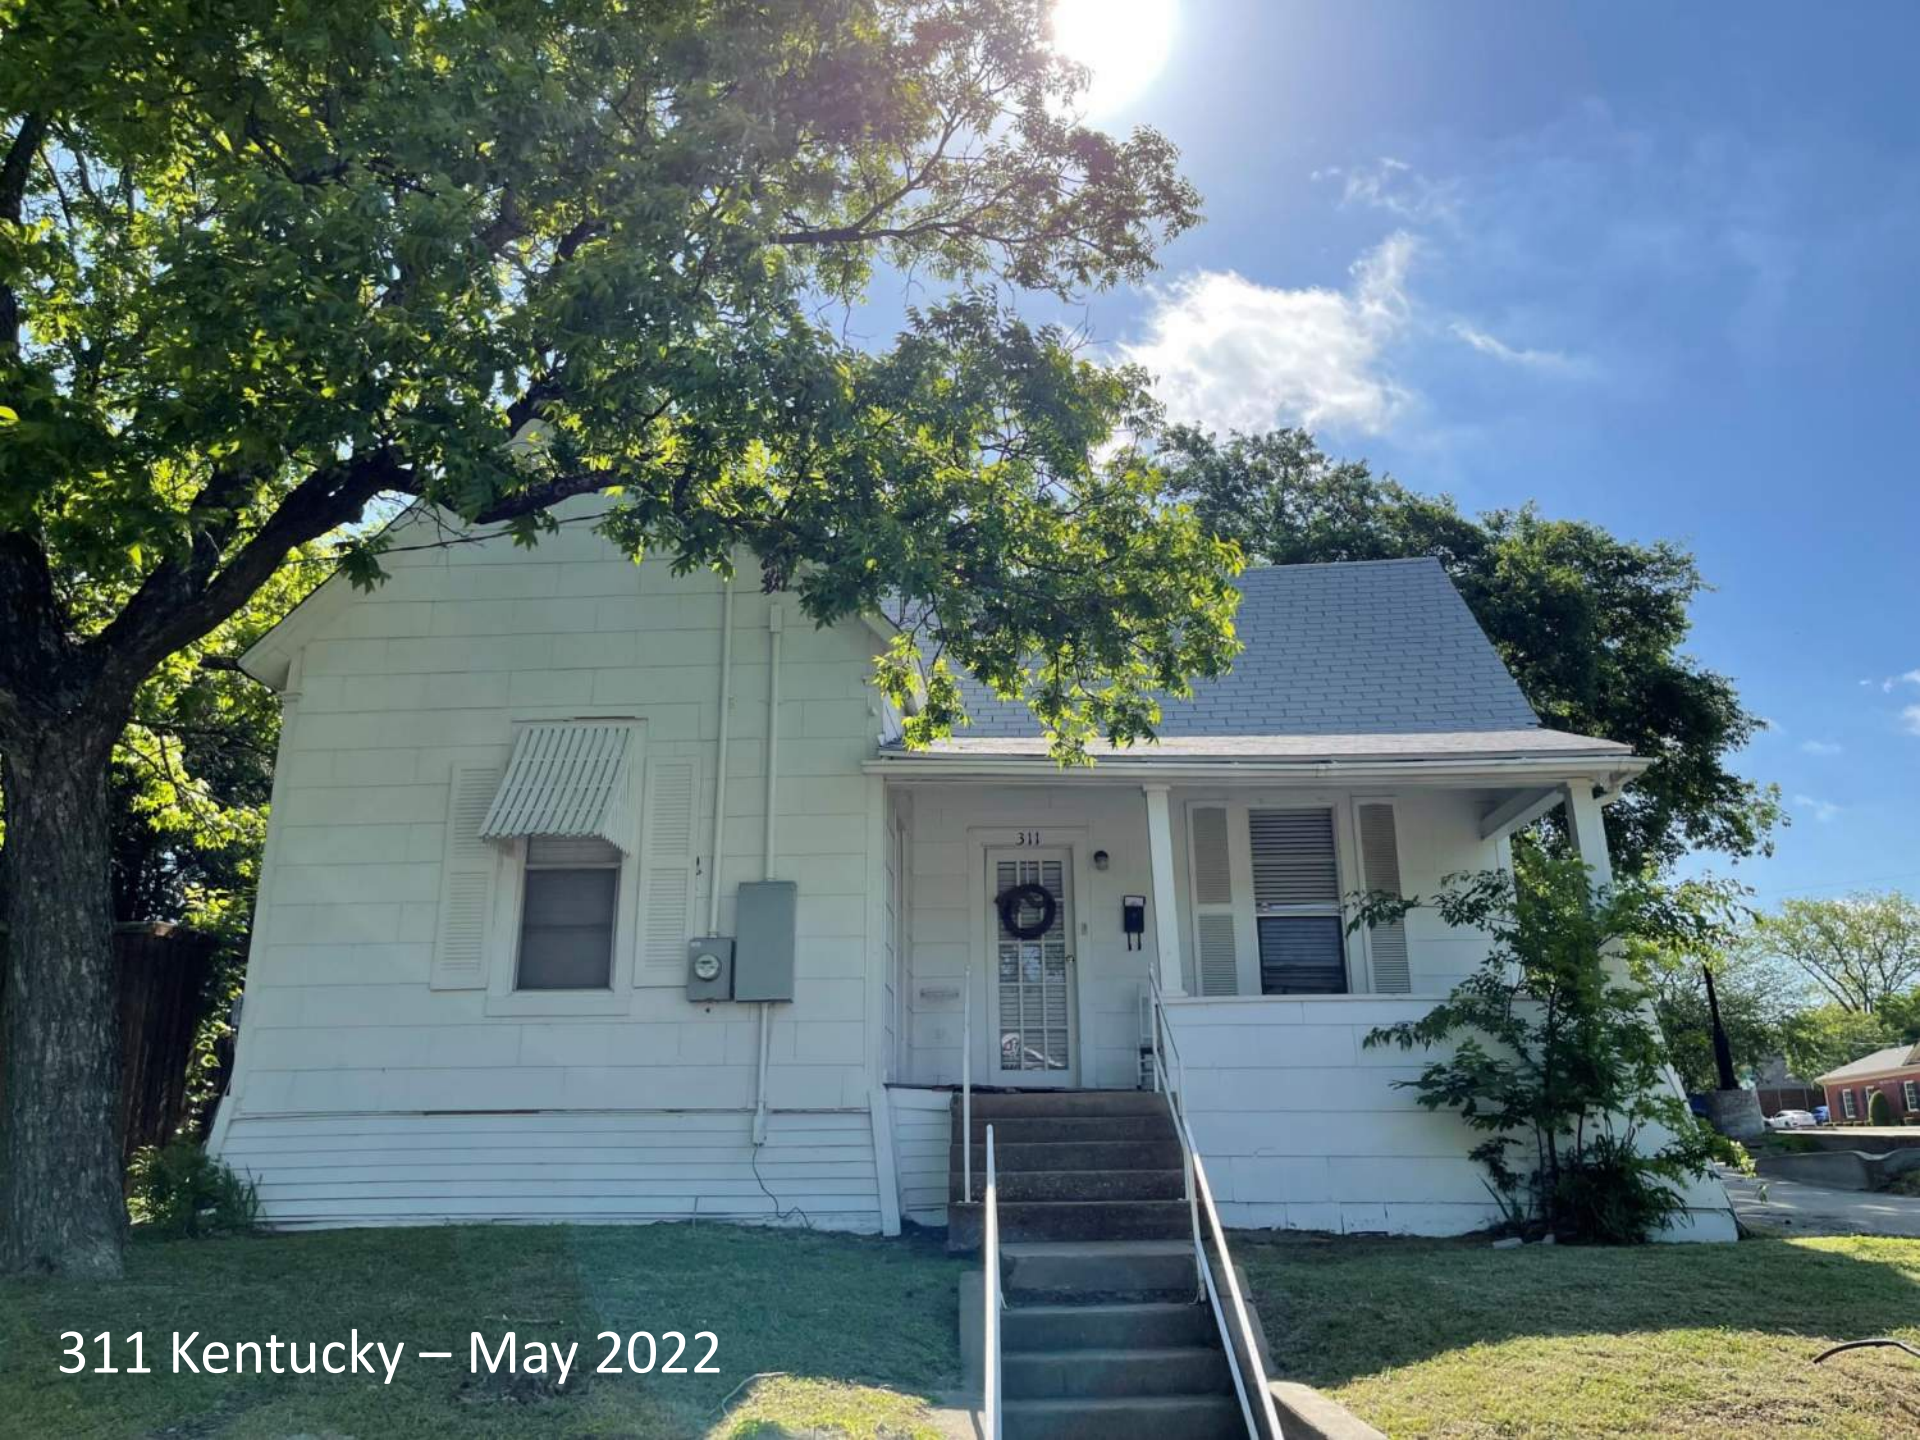
311 Kentucky – May 2022

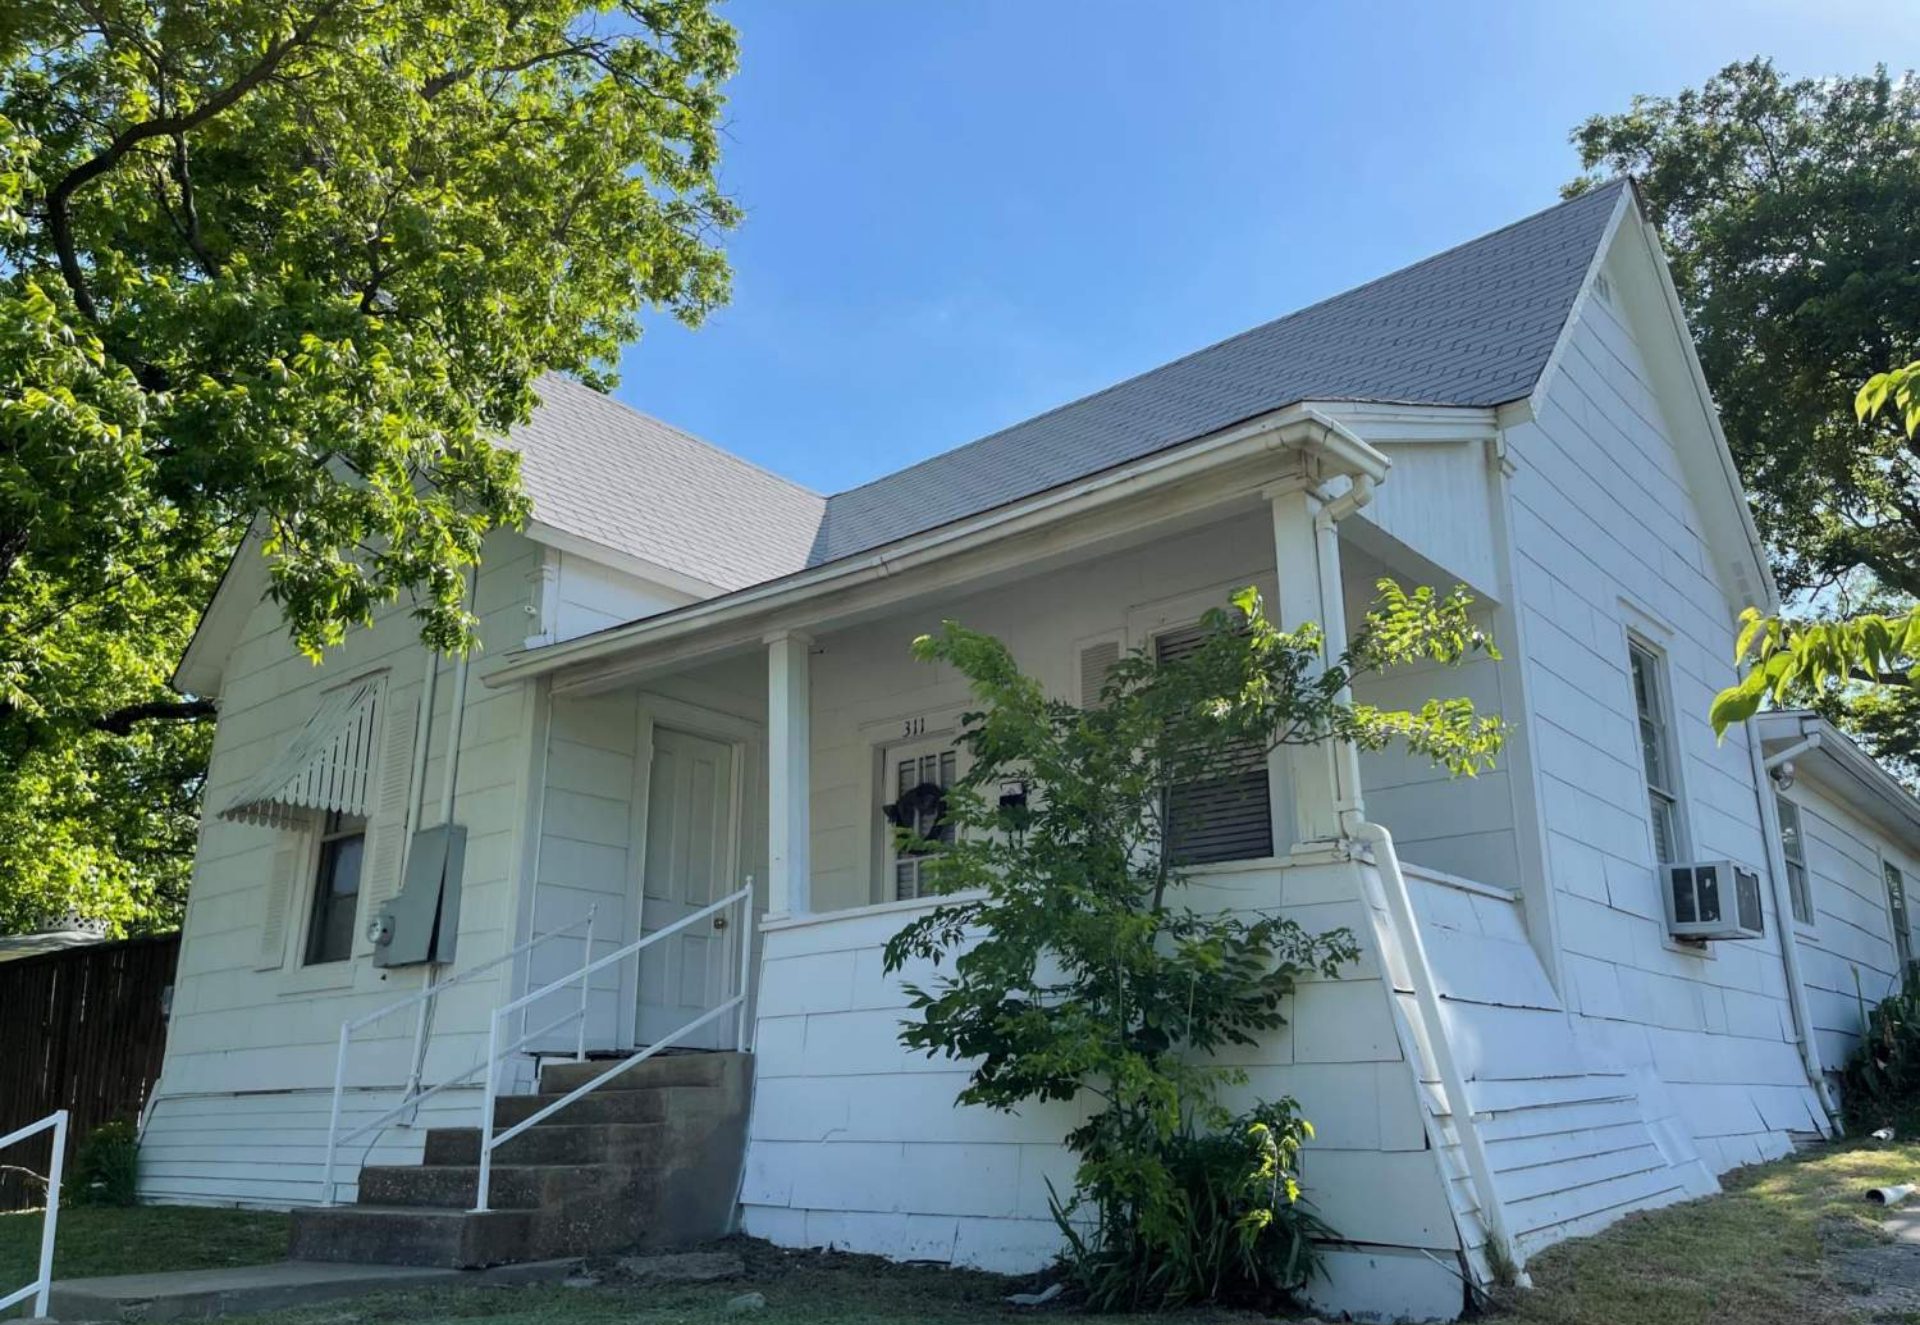
311 Kentucky – May 2022

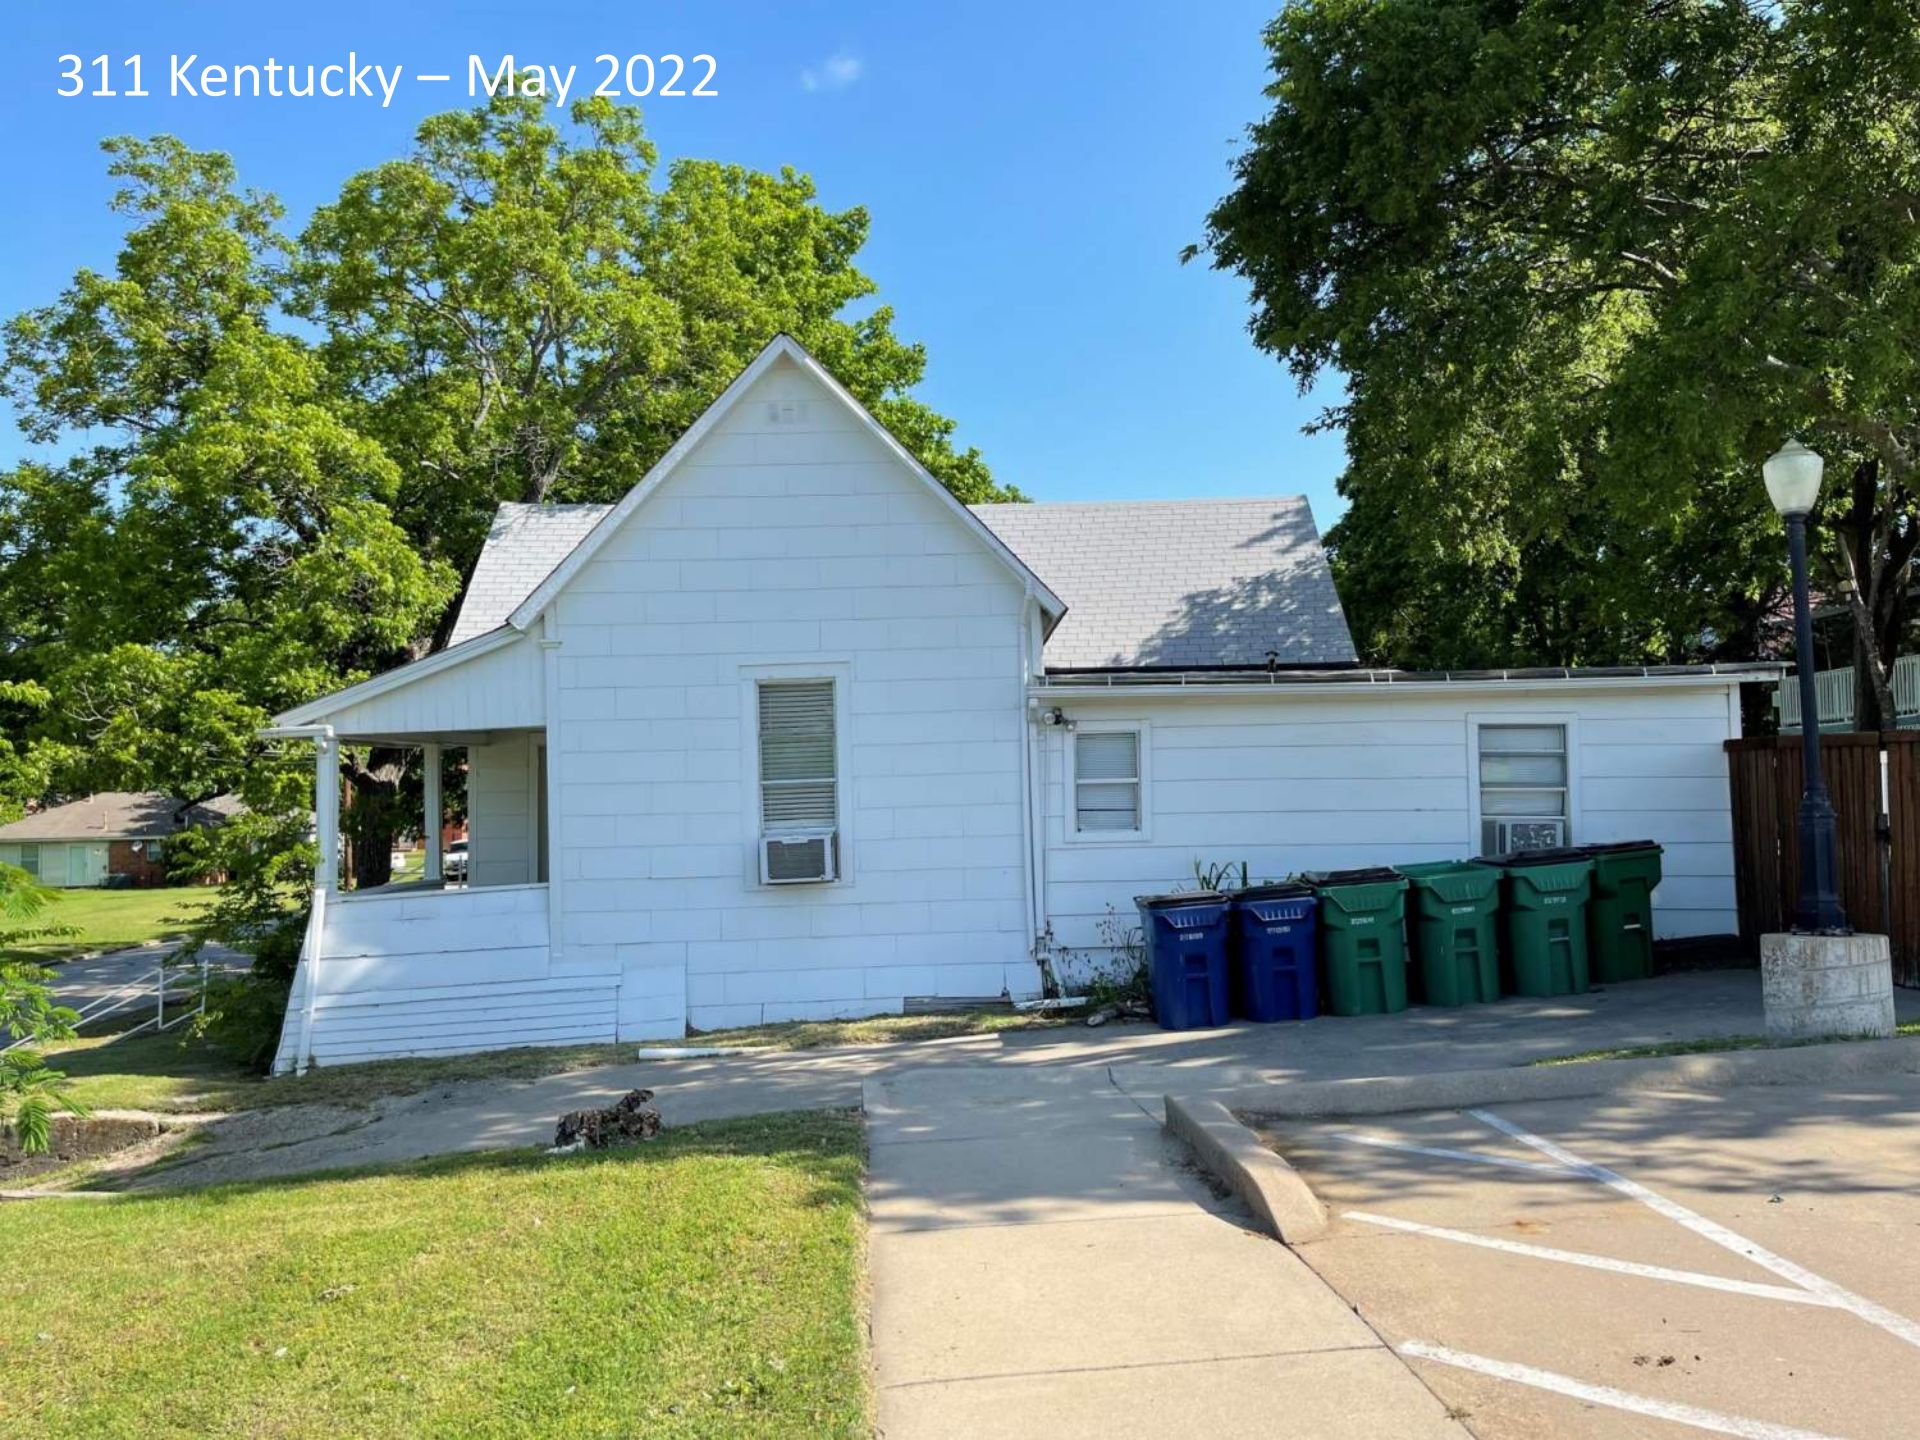
311 Kentucky – May 2022

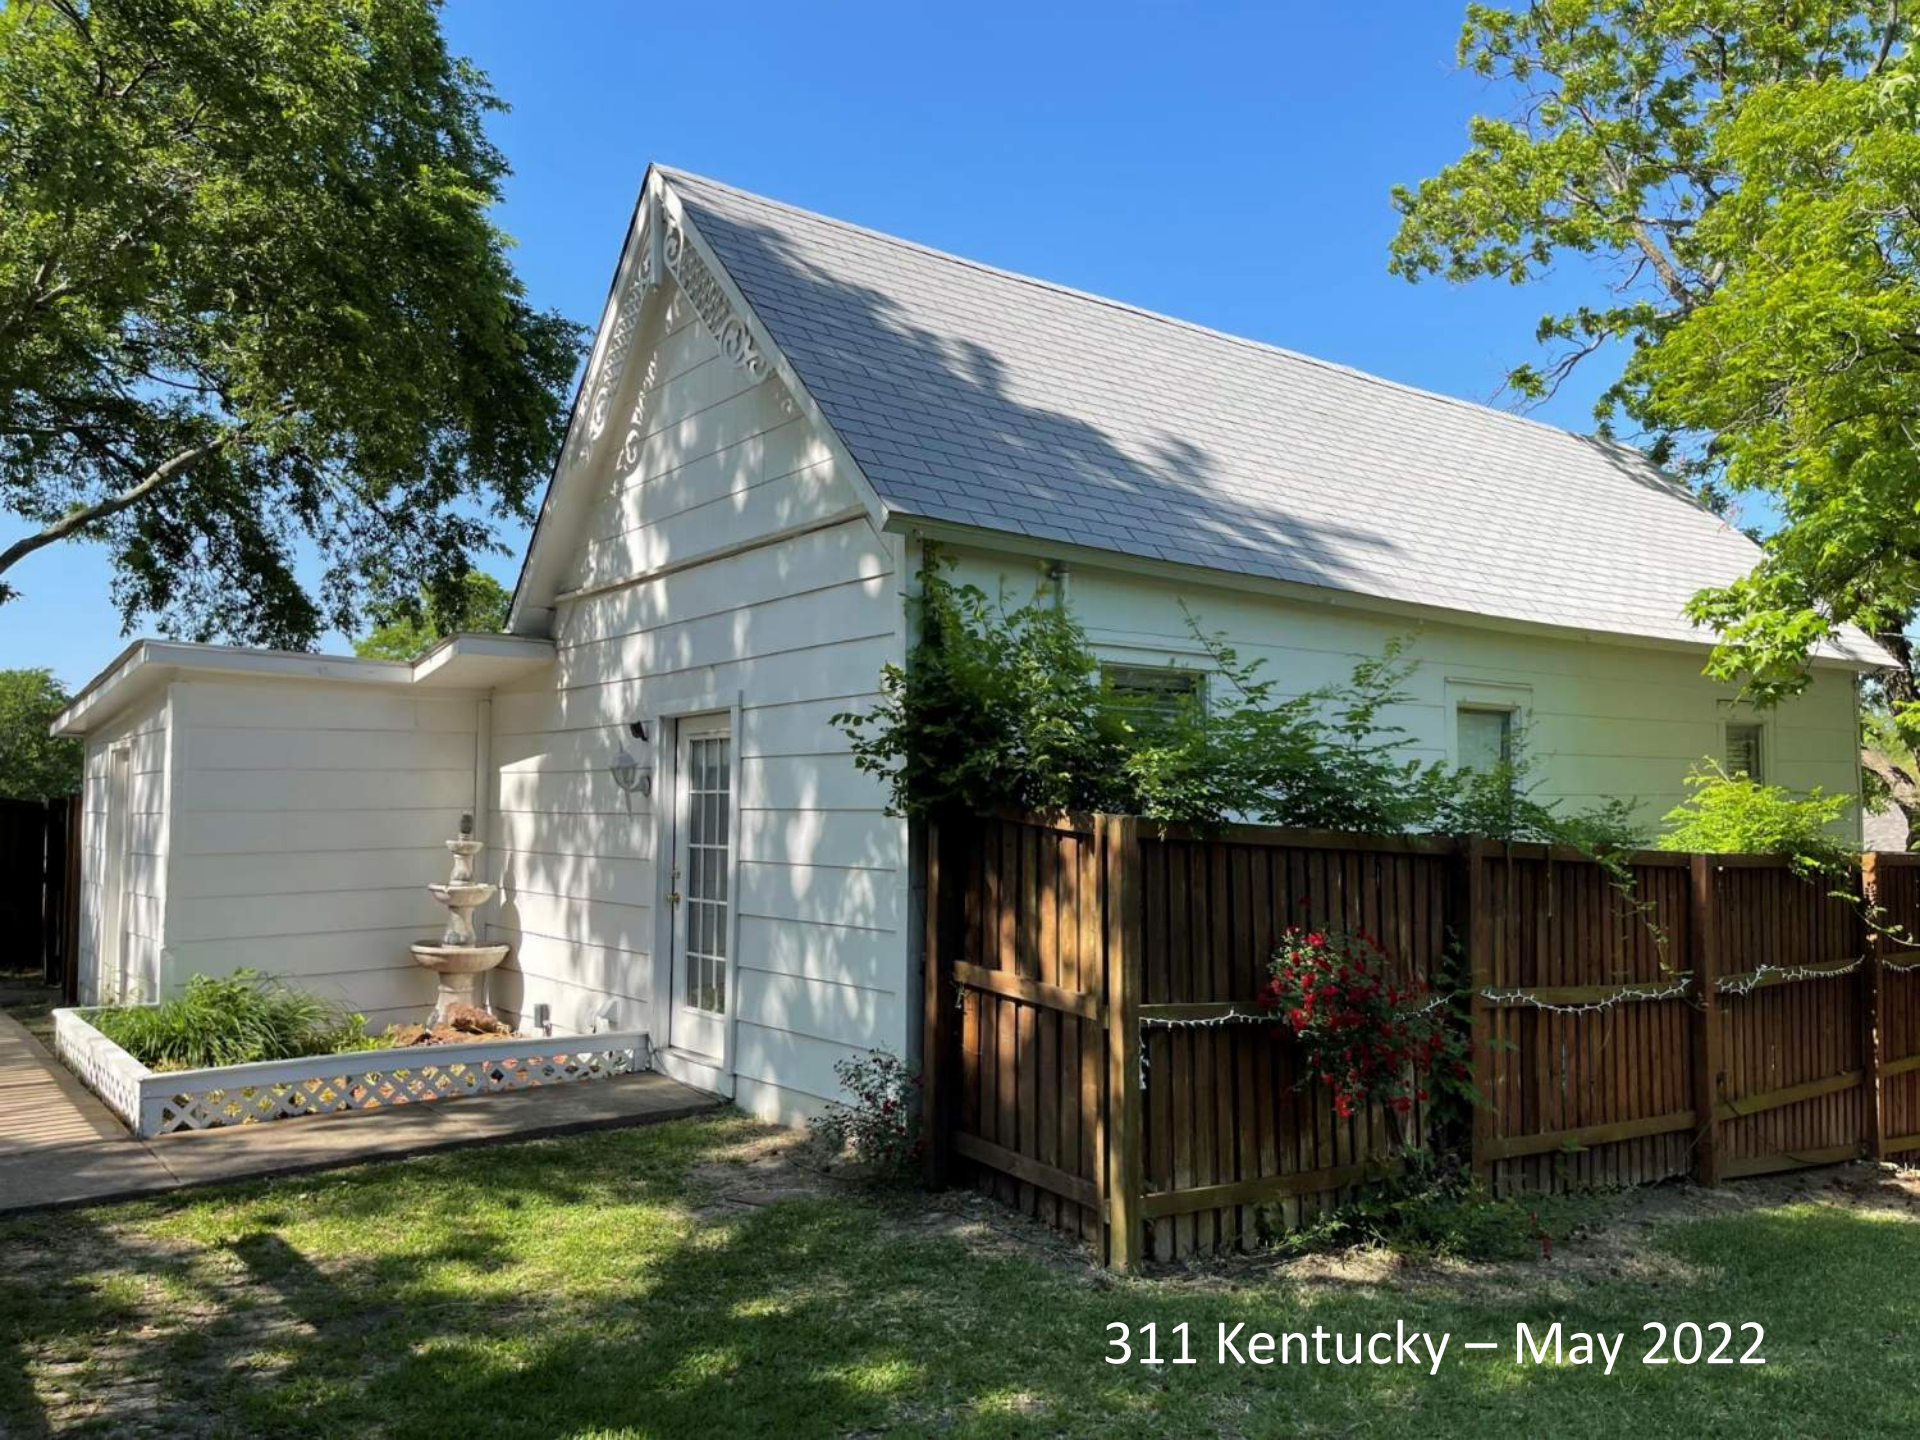
311 Kentucky – May 2022

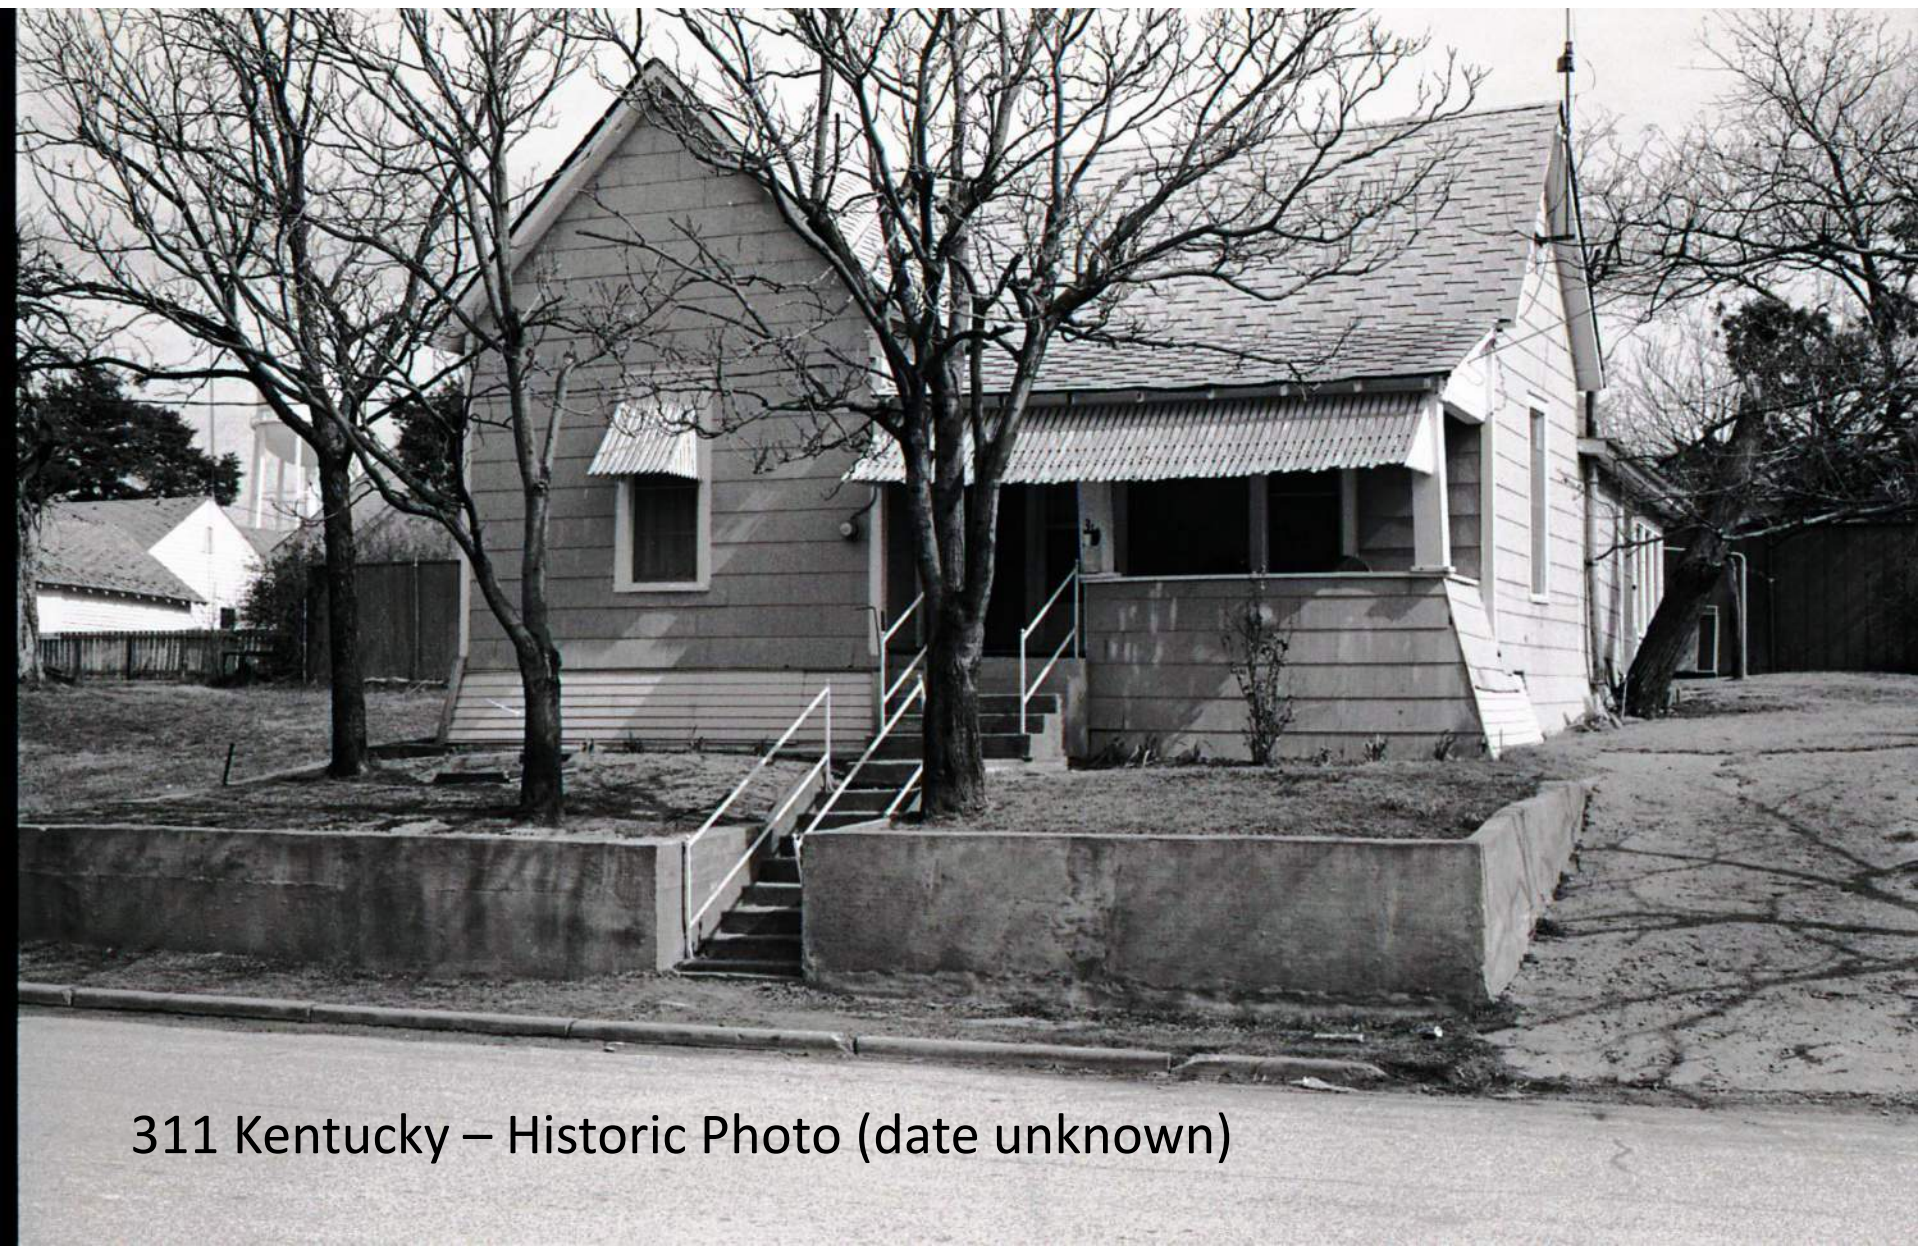
311 Kentucky – Historic Photo (date unknown)
