Roof Inspection Report

HCI Number 201505203

Meals On Wheel—McKinney
600 North Tennessee Street
McKinney, TX 75069

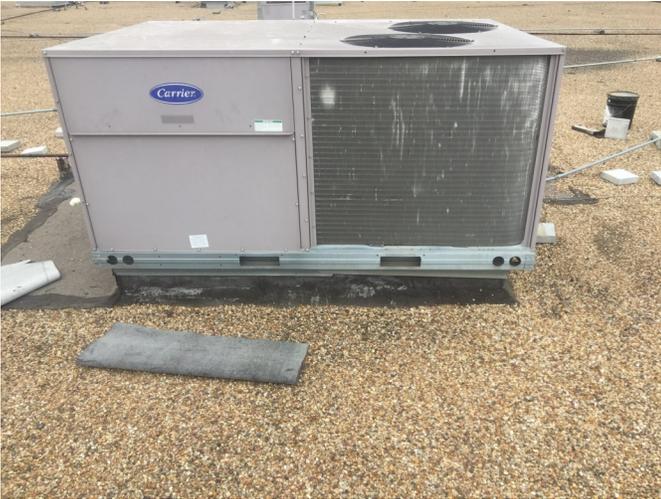
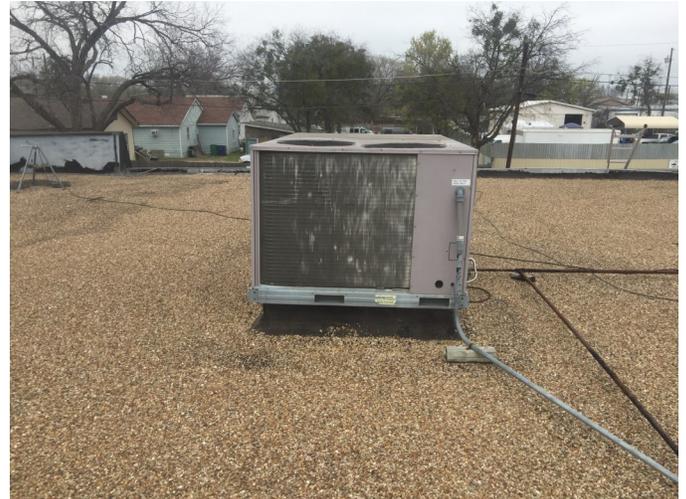
The package units on curbs have flex lines. The top row of pictures.

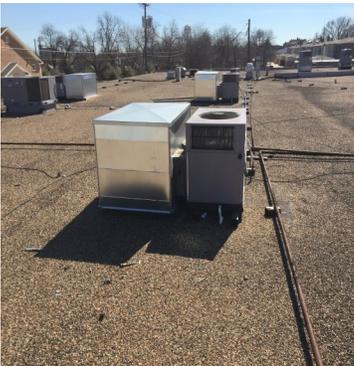
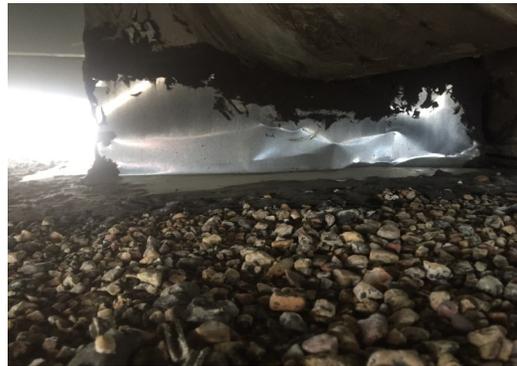
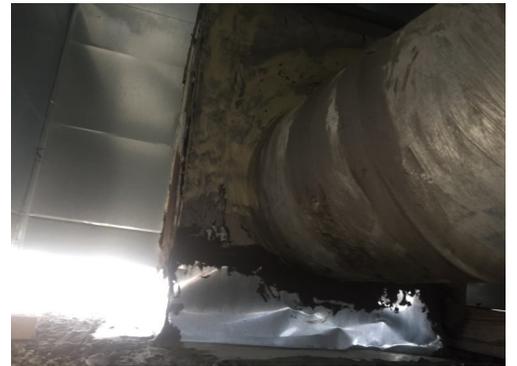
The package units with external duct work will need to be lifted. It will require disconnecting the duct work. The duct work is in poor shape and has had a hood built to cover the duct work. Second row of pictures.

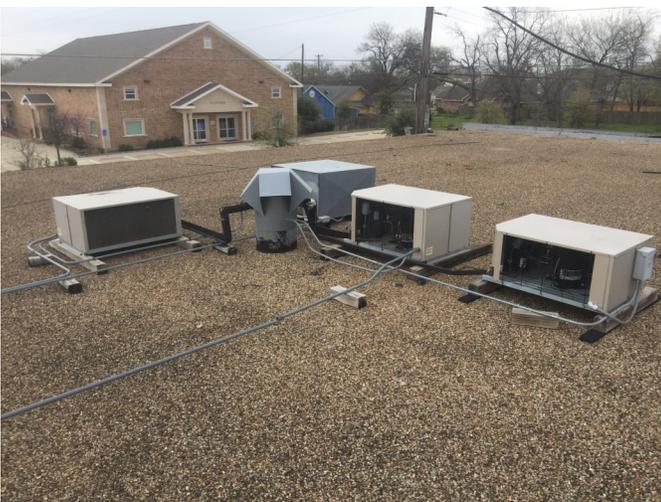
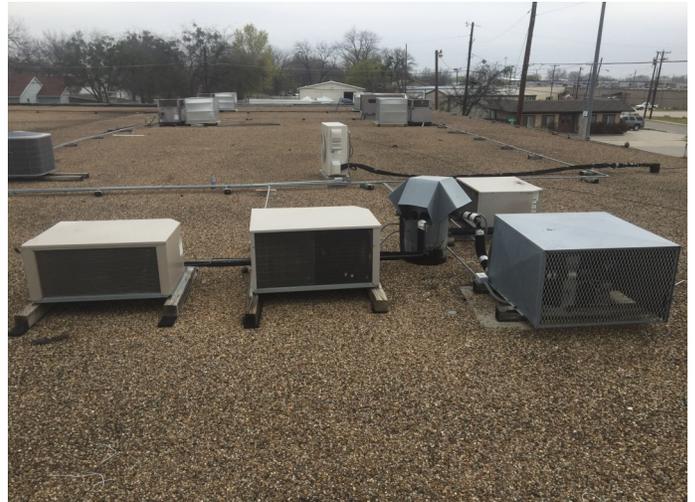
There are four units that will also need to be lifted. These have flex lines and will require disconnection. Both the gas and electrical. Third row of pictures.
