# PROPERTY INSPECTION REPORT

**110 E Davis St**  
**Inspection Prepared For: The Parks Church**  
**Agent:**

**Date of Inspection: 3/11/2024**  
**Age of House: 110 Years, Size: 4,400 SF**  
**Weather: Cloudy/Rain, 50-60 Degrees**

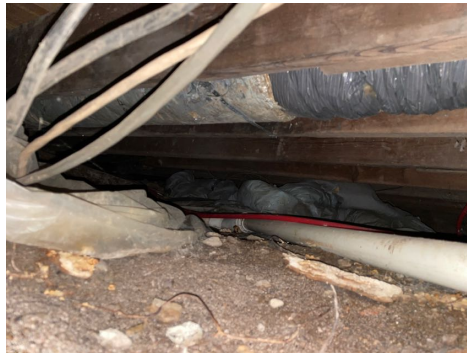
General Crawlspace picture

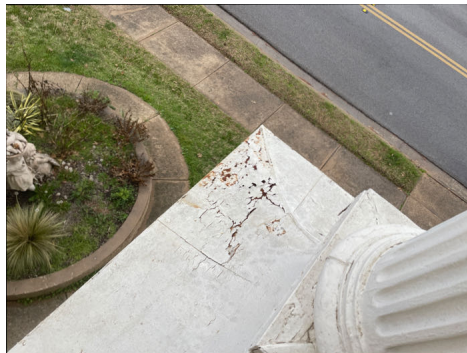
Front porch peeling paint

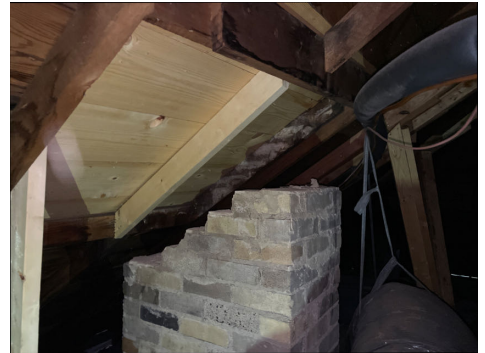
Attic: Chimney terminated

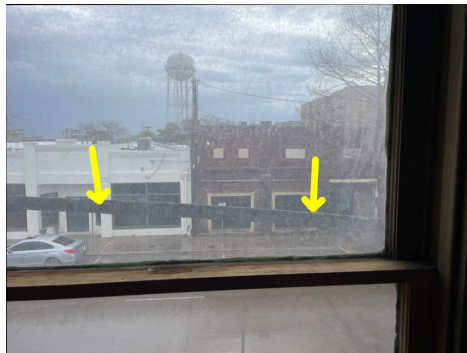
East exterior: Service wires are too close to window openings

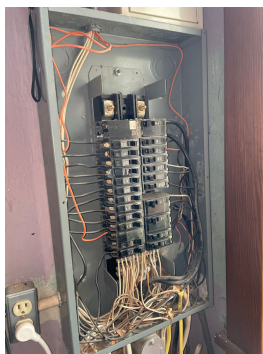
Sub Panel with front removed

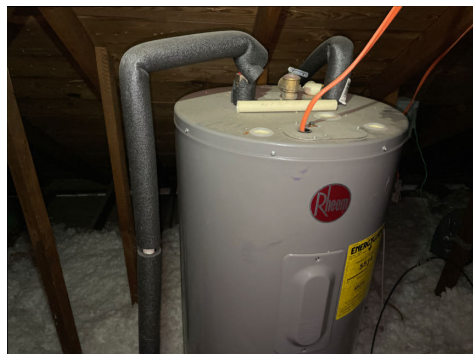
Attic: Water Heater

**Attic: Discharge piping for the Temperature and Pressure Relief (TPR) Valve on the water heater was not present. Installation needed.**
