9 Preservation Briefs

National Park Service
U.S. Department of the Interior

The Repair of Historic Wooden Windows

John H. Myers

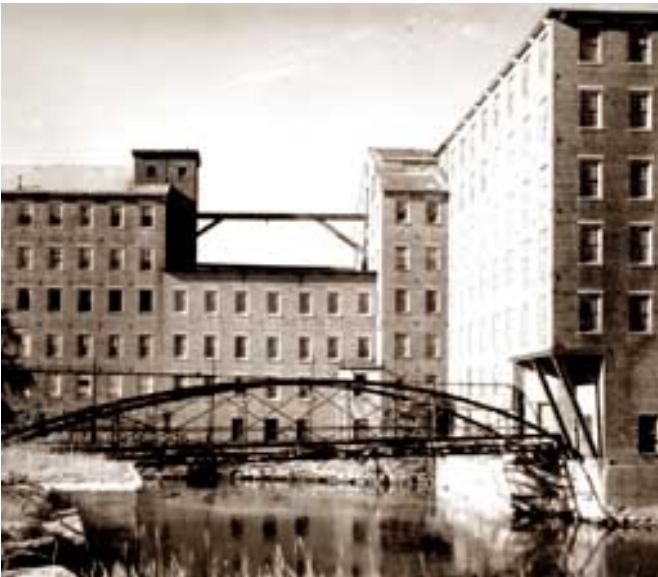
Windows are frequently important visual focal points, especially on simple facades such as this mill building. Replacement of the multi-pane windows with larger panes could dramatically alter the appearance of the building. Photo: NPS files.

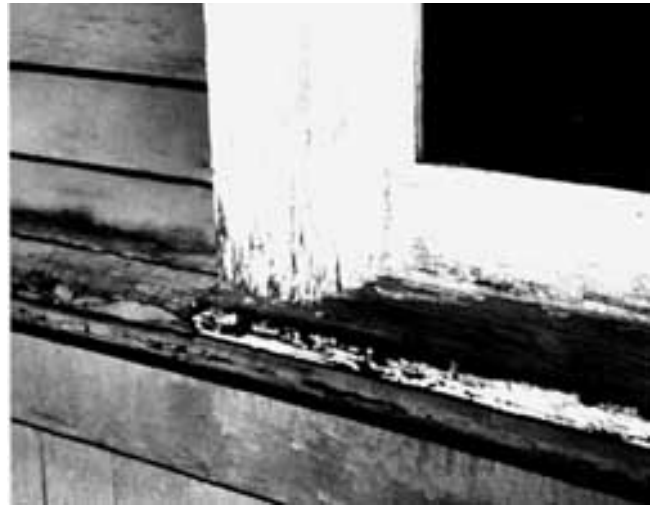
Deterioration of poorly maintained windows usually begins on horizontal surfaces and at joints, where water can collect and saturate the wood. Photo: NPS files.

Each window should be examined for operational soundness beginning with the lower portions of the frame and sash. Exterior rainwater and interior condensation can flow downward along the window, entering and collecting at points where the flow is blocked. The sill, joints between the sill and jamb, corners of the bottom rails and muntin joints are typical points where water collects and deterioration begins. The operation of the window (continuous opening and closing over the years and seasonal temperature changes) weakens the joints, causing movement and slight separation. This process makes the joints more vulnerable to water which is readily absorbed into the endgrain of the wood. If severe deterioration exists in these areas, it will usually be apparent on visual inspection, but other less severely deteriorated areas of the wood may be tested by two traditional methods using a small ice pick.

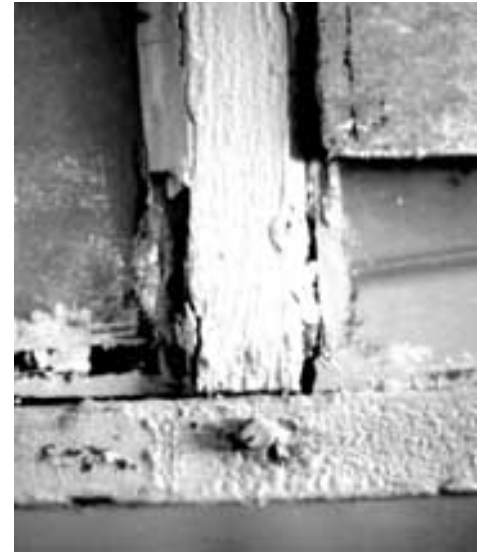
This historic double-hung window has many layers of paint, some cracked and missing putty, slight separation at the joints, broken sash cords, and one cracked pane. Photo: NPS files.

The operations just discussed summarize the efforts necessary to restore a window with minor deterioration to "like new" condition. The techniques can be applied by an unskilled person with minimal training and experience. To demonstrate the practicality of this approach, and photograph it, a Technical Preservation Services staff member repaired a wooden double-hung, two over two window which had been in service over ninety years. The wood was structurally sound but the window had one broken pane, many layers of paint, broken sash cords and inadequate, worn-out weatherstripping. The staff member found that the frame could be stripped of paint and the sash removed quite easily. Paint, putty

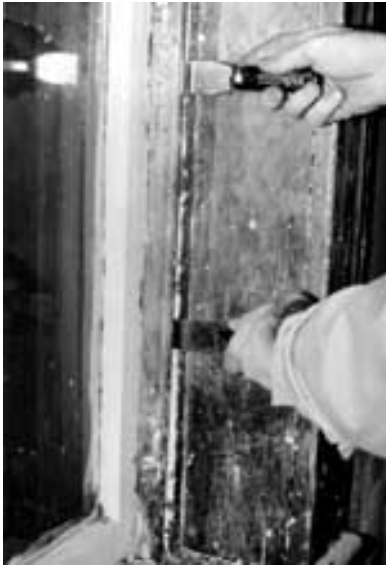
After removing paint from the seam between the interior stop and the jamb, the stop can be pried out and gradually worked loose using a pair of putty knives as shown. Photo: NPS files.

to remove the paint from the interior stop and the parting bead, particularly along the seam where these stops meet the jamb. This can be accomplished by running a utility knife along the length of the seam, breaking the paint bond. It will then be much easier to remove the stop, the parting bead and the sash. The interior stop may be initially loosened from the sash side to avoid visible scarring of the wood and then gradually pried loose using a pair of putty knives, working up and down the stop in small increments. With the stop removed, the lower or interior sash may be withdrawn. The sash cords should be detached from the sides of the sash and their ends may be pinned with a nail or tied in a knot to prevent them from falling into the weight pocket.

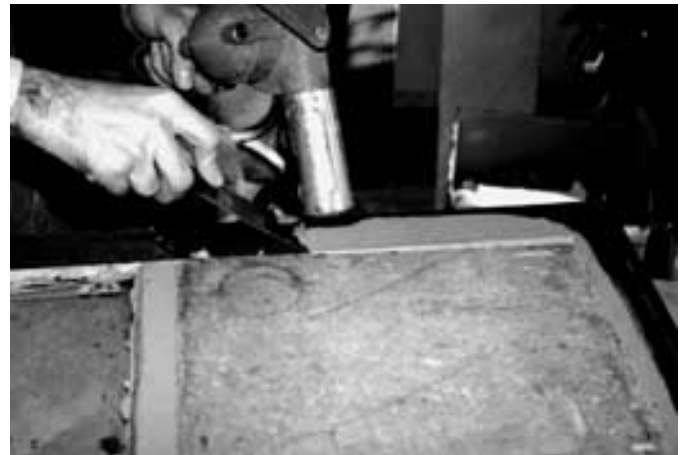
Sash can be removed and repaired in a convenient work area. Paint is being removed from this sash with a hot air gun. Photo: NPS files.

The sash can be stripped of paint using appropriate techniques, but if any heat treatment is used, the glass should be removed or protected from the sudden temperature change which can cause breakage. An overlay of aluminum foil on gypsum board or asbestos can protect the glass from such rapid temperature change. It is important to protect the glass because it may be historic and often adds character to the window. Deteriorated putty should be removed manually, taking care not to damage the wood along the rabbet. If the glass is to be removed, the glazing points which hold the glass in place can be extracted and the panes numbered and removed for cleaning and reuse in the same openings. With the glass panes out, the remaining putty can be removed and the sash can be sanded, patched, and primed with a preservative primer. Hardened putty in the rabbets may be softened by heating with a soldering iron at the point of removal. Putty remaining on the glass may be softened by soaking the panes in linseed oil, and then removed with less risk of breaking the glass. Before reinstalling the glass, a bead of glazing compound or linseed oil putty should be laid around the rabbet to cushion and seal the glass. Glazing compound should only be used on wood which has been brushed with linseed oil and primed with an oil based primer or paint. The pane is then pressed into place and the glazing points are pushed into the wood around the perimeter of the pane.

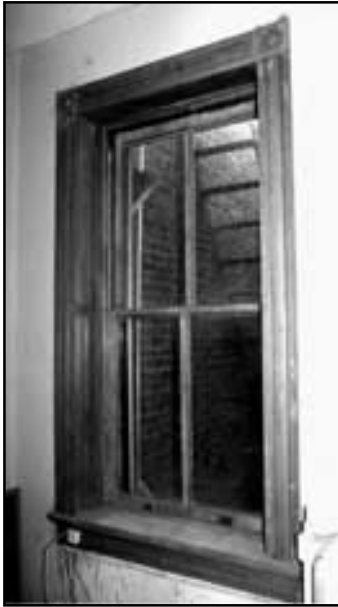
Following the relatively simple repairs, the window is weathertight, like new in appearance, and serviceable for many years to come. Photo: NPS files.

and glass removal required about one hour for each sash, and the reglazing of both sash was accomplished in about one hour. Weatherstripping of the sash and frame, replacement of the sash cords and reinstallation of the sash, parting bead, and stop required an hour and a half. These times refer only to individual operations; the entire process took several days due to the drying and curing times for putty, primer, and paint, however, work on other window units could have been in progress during these lag times.

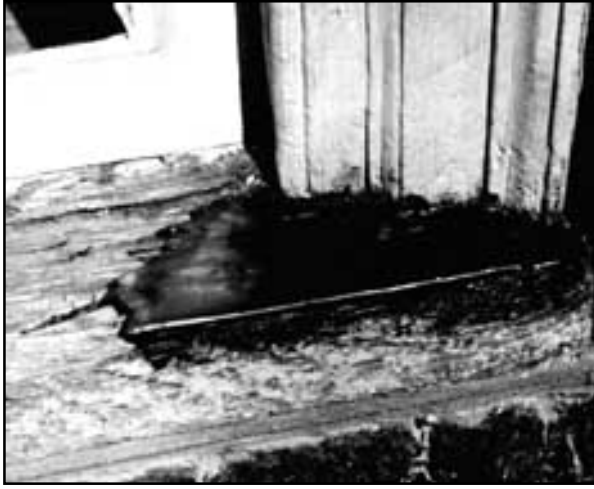
This illustrates a two-part epoxy patching compound used to fill the surface of a weathered sill and rebuild the missing edge. When the epoxy cures, it can be sanded smooth and painted to achieve a durable and waterproof repair. Photo: NPS files.

The surface of the consolidated wood can then be filled with a semirigid epoxy patching compound, sanded and painted. Epoxy patching compounds can be used to build up missing sections or decayed ends of members. Profiles can be duplicated using hand molds, which are created by pressing a ball of patching compound over a sound section of the profile which has been rubbed with butcher's wax. This can be a very efficient technique where there are many typical repairs to be done. The process has been widely used and proven in marine applications; and proprietary products are available at hardware and marine supply stores. Although epoxy materials may be comparatively expensive, they hold the promise of being among the most durable and long lasting materials available for wood repair. More information on epoxies can be found in the publication "Epoxies for Wood Repairs in Historic Buildings," cited in the bibliography.
