9 Preservation Briefs

National Park Service

The Repair of Historic Wooden Windows

John H. Myers

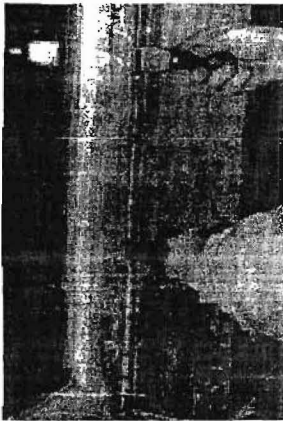
After removing paint from the seam between the interior stop and the jamb, the stop can be pried out and gradually worked loose using a pair of putty knives as shown. Photo: NPS files.

Paint removal should begin on the interior frames, being careful to remove the paint from the interior stop and the parting bead, particularly along the

seam where these stops meet the jamb. This can be accomplished by running a utility knife along the length of the seam, breaking the paint bond. It will then be much easier to remove the stop, the parting bead and the sash. The interior stop may be initially loosened from the sash side to avoid visible scarring of the wood and then gradually pried loose using a pair of putty knives, working up and down the stop in small increments. With the stop removed, the lower or interior sash may be withdrawn. The sash cords should be detached from the sides of the sash and their ends may be pinned with a nail or tied in a knot to prevent them from falling into the weight pocket.

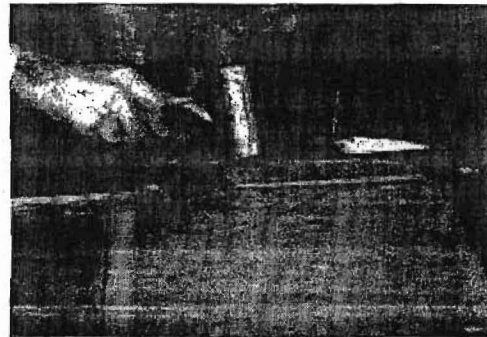
Sash can be removed and repaired in a convenient work area. Paint is being removed from this sash with a hot air gun. Photo: NPS files.

The sash can be stripped of paint using appropriate techniques, but if any heat treatment is used, the glass should be removed or protected from the sudden temperature change which can cause breakage. An overlay of aluminum foil on gypsum board or asbestos can protect the glass from such rapid temperature change. It is important to protect the glass because it may be historic and often adds character to the window. Deteriorated putty should be removed manually, taking care not to damage the wood along the rabbet. If the glass is to be removed, the glazing points which hold the glass in place can be extracted and the panes numbered and removed for cleaning and reuse in the same openings. With the glass panes out, the remaining putty can be removed and the sash can be sanded, patched, and primed with a preservative primer. Hardened putty in the rabbets may be softened by heating with a soldering iron at the
