CHESTNUT SQUARE

PROJECT GOALS

PROJECT OVERVIEW

Reference: **Chestnut Square Drainage**
315 S. Chestnut St.
McKinney, Texas 75069

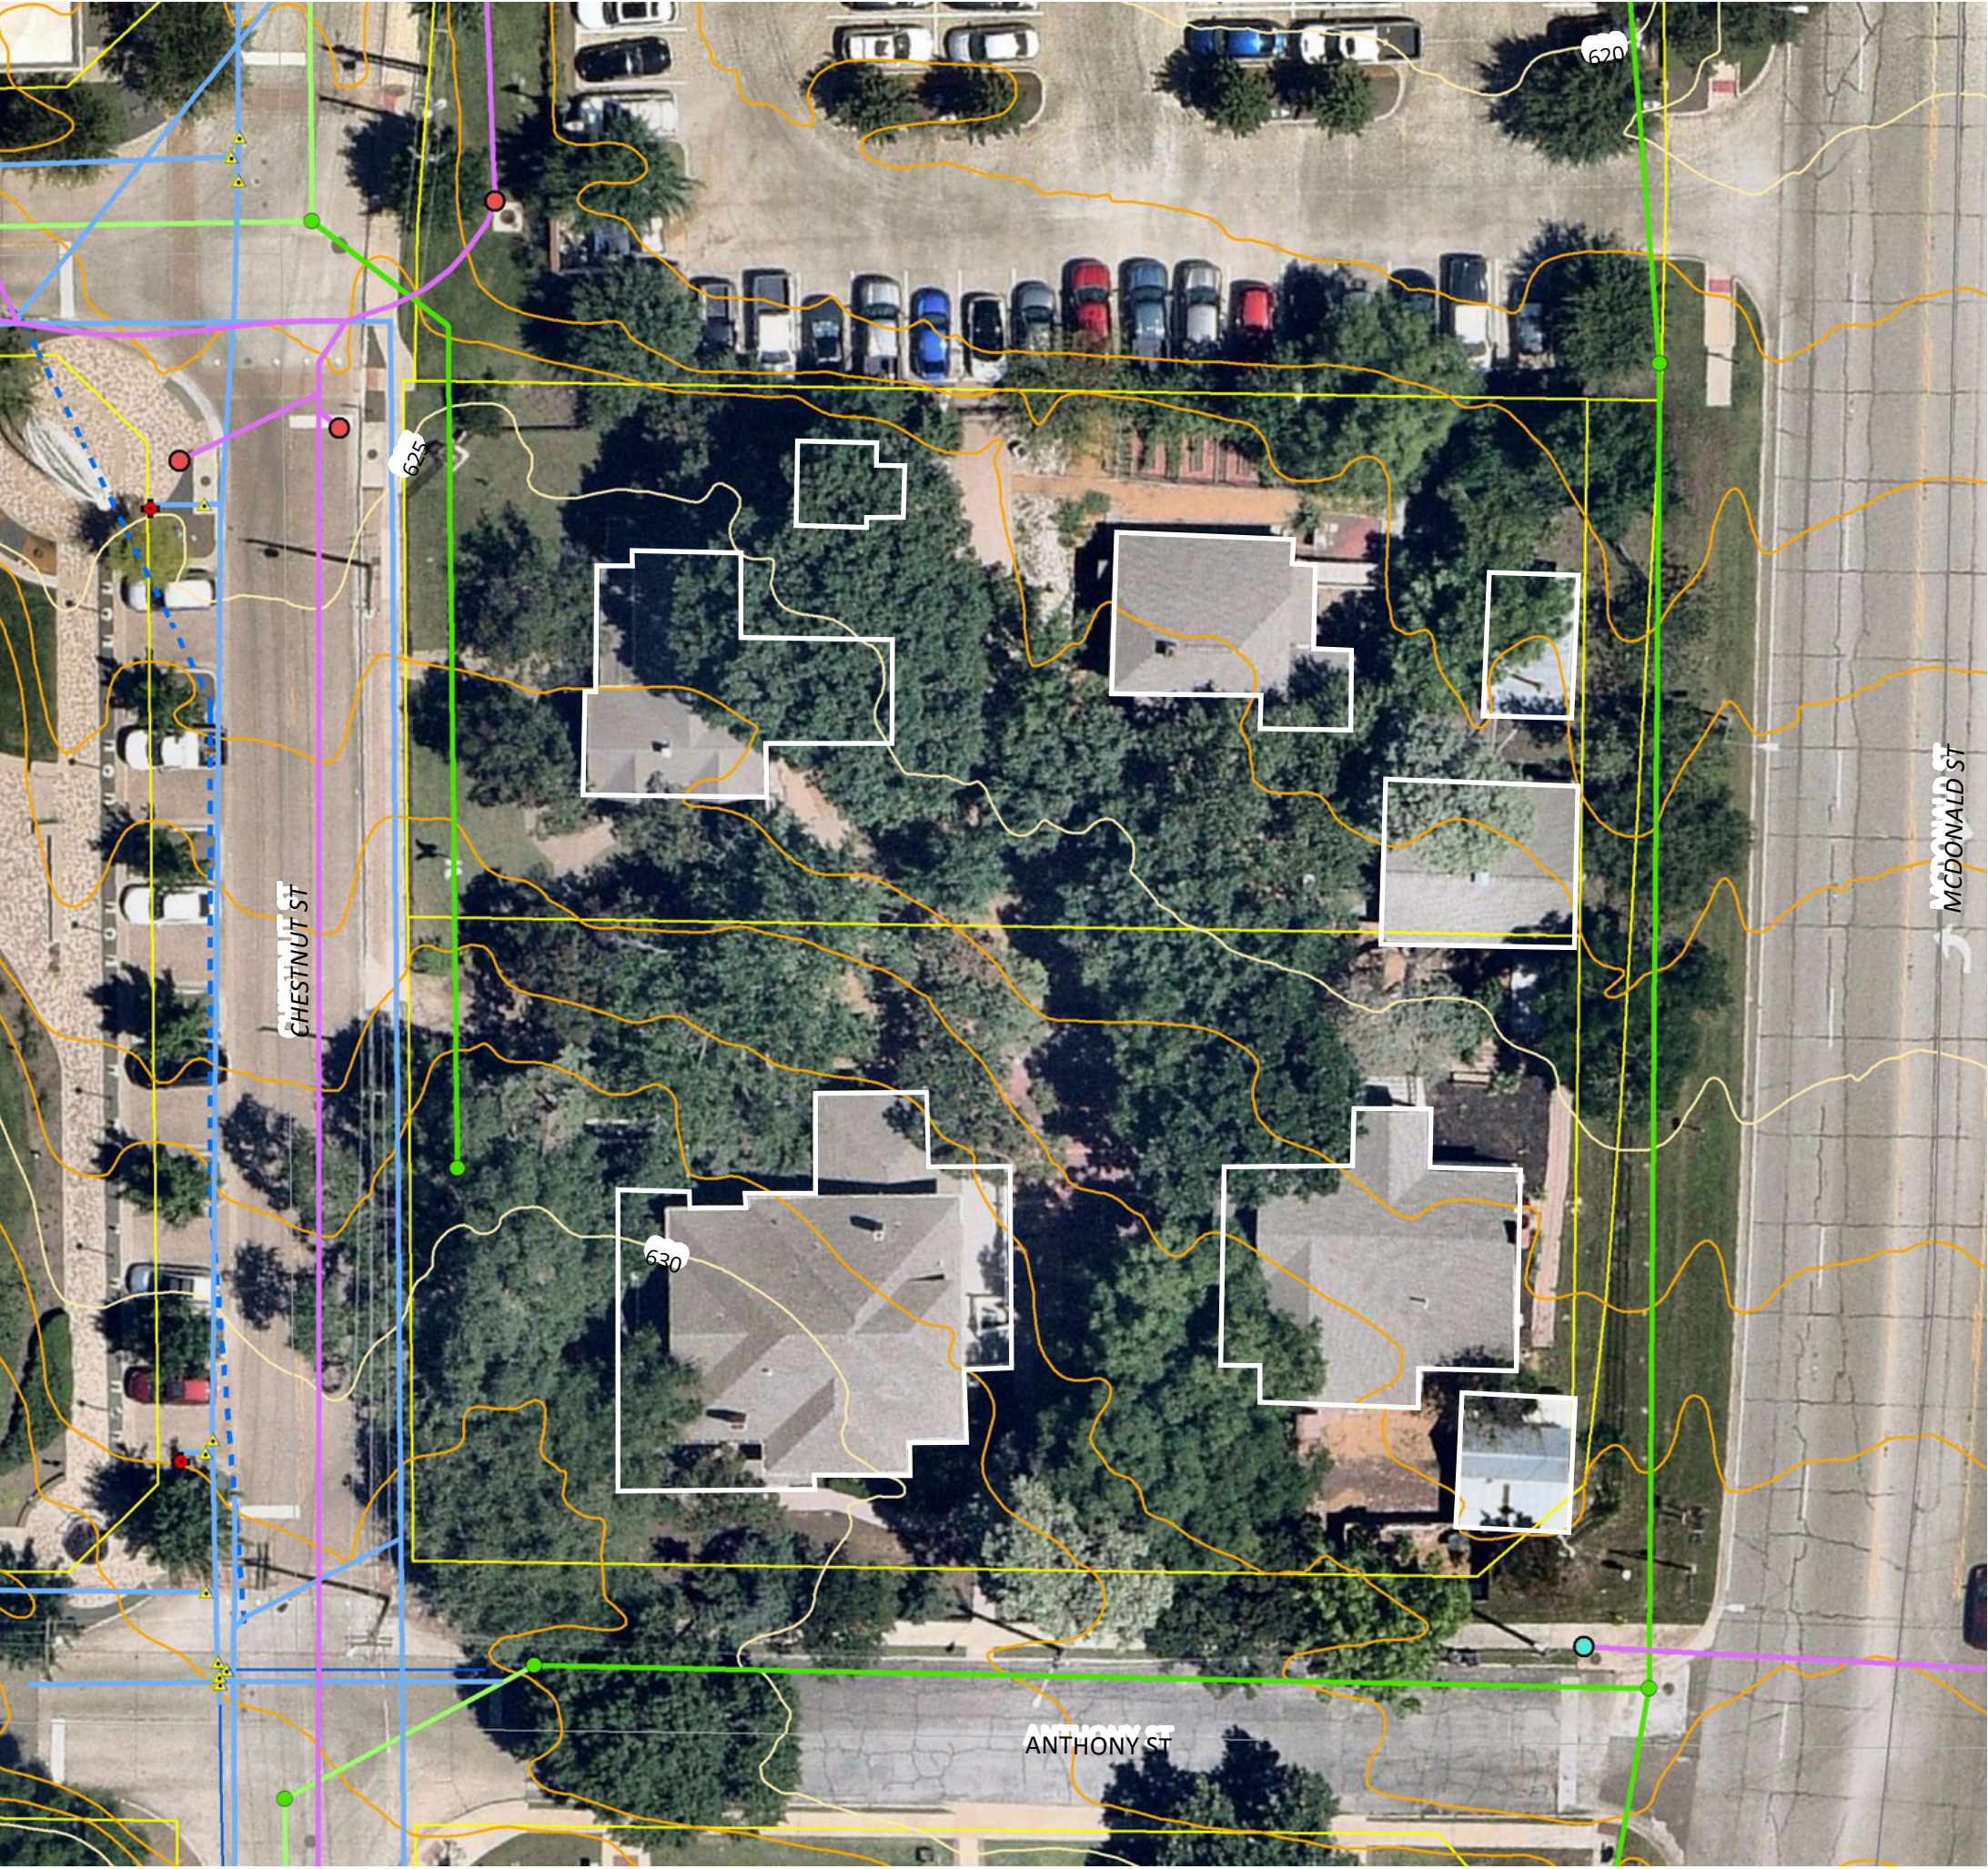
Chestnut Square
McKinney, Texas

The existing grading plan is attached, and it represents a natural sheet flow runoff pattern from
the southwest to the northeast. We understand there have been some slight adjustments made
to respective grading within the courtyard on the property to divert water around Taylor Inn
located on the northeast side (noted on the attachment). These adjustments include berms
and a river rock collection area which would result in a slight concentration of outfall to the north
in the approximate center of the Square.

The plan to divert runoff around Dulaney Cottage (noted on the attachment) would also result in
slight concentrations of outfall on the east and west sides of the Cottage but would not increase
the total outfall to the north. The parking lot developed to the north side of the Square was
apparently designed to accept the Square outfall and, along with its own surface area collection,
transport it to State Highway 5 and stormwater drains at the intersection of the Highway and
Davis Street.

1"= 30'

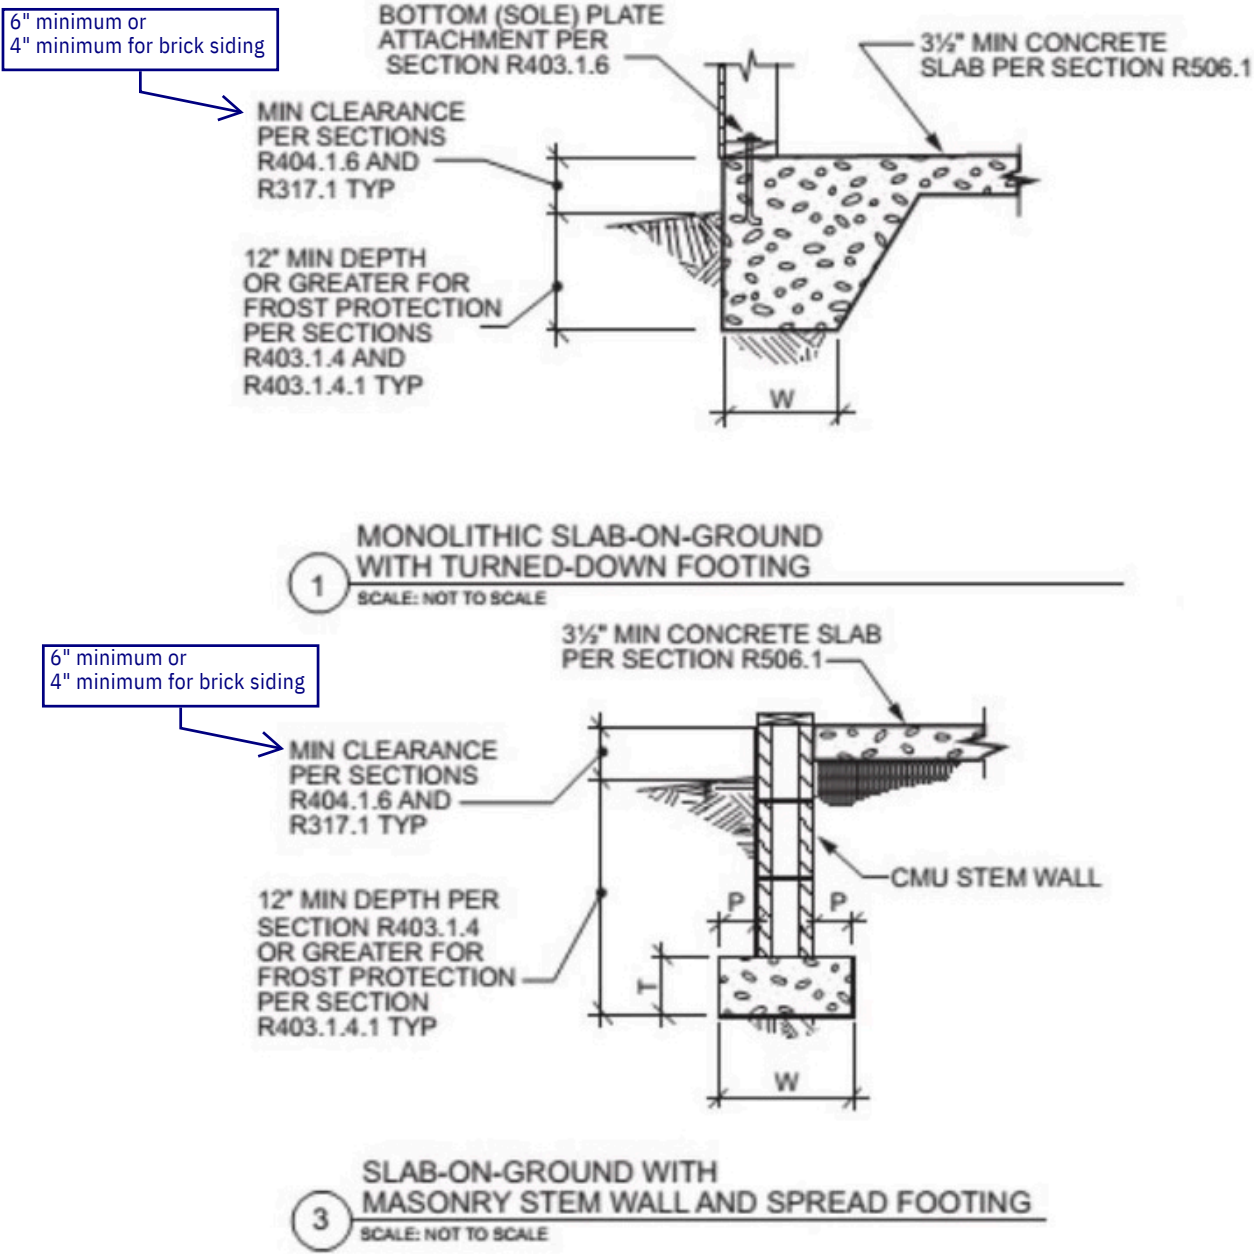
FIGURE R403.1(1)

PLAIN CONCRETE FOOTINGS WITH MASONRY AND CONCRETE STEM WALLS
IN SEISMIC DESIGN CATEGORIES A, B AND C
