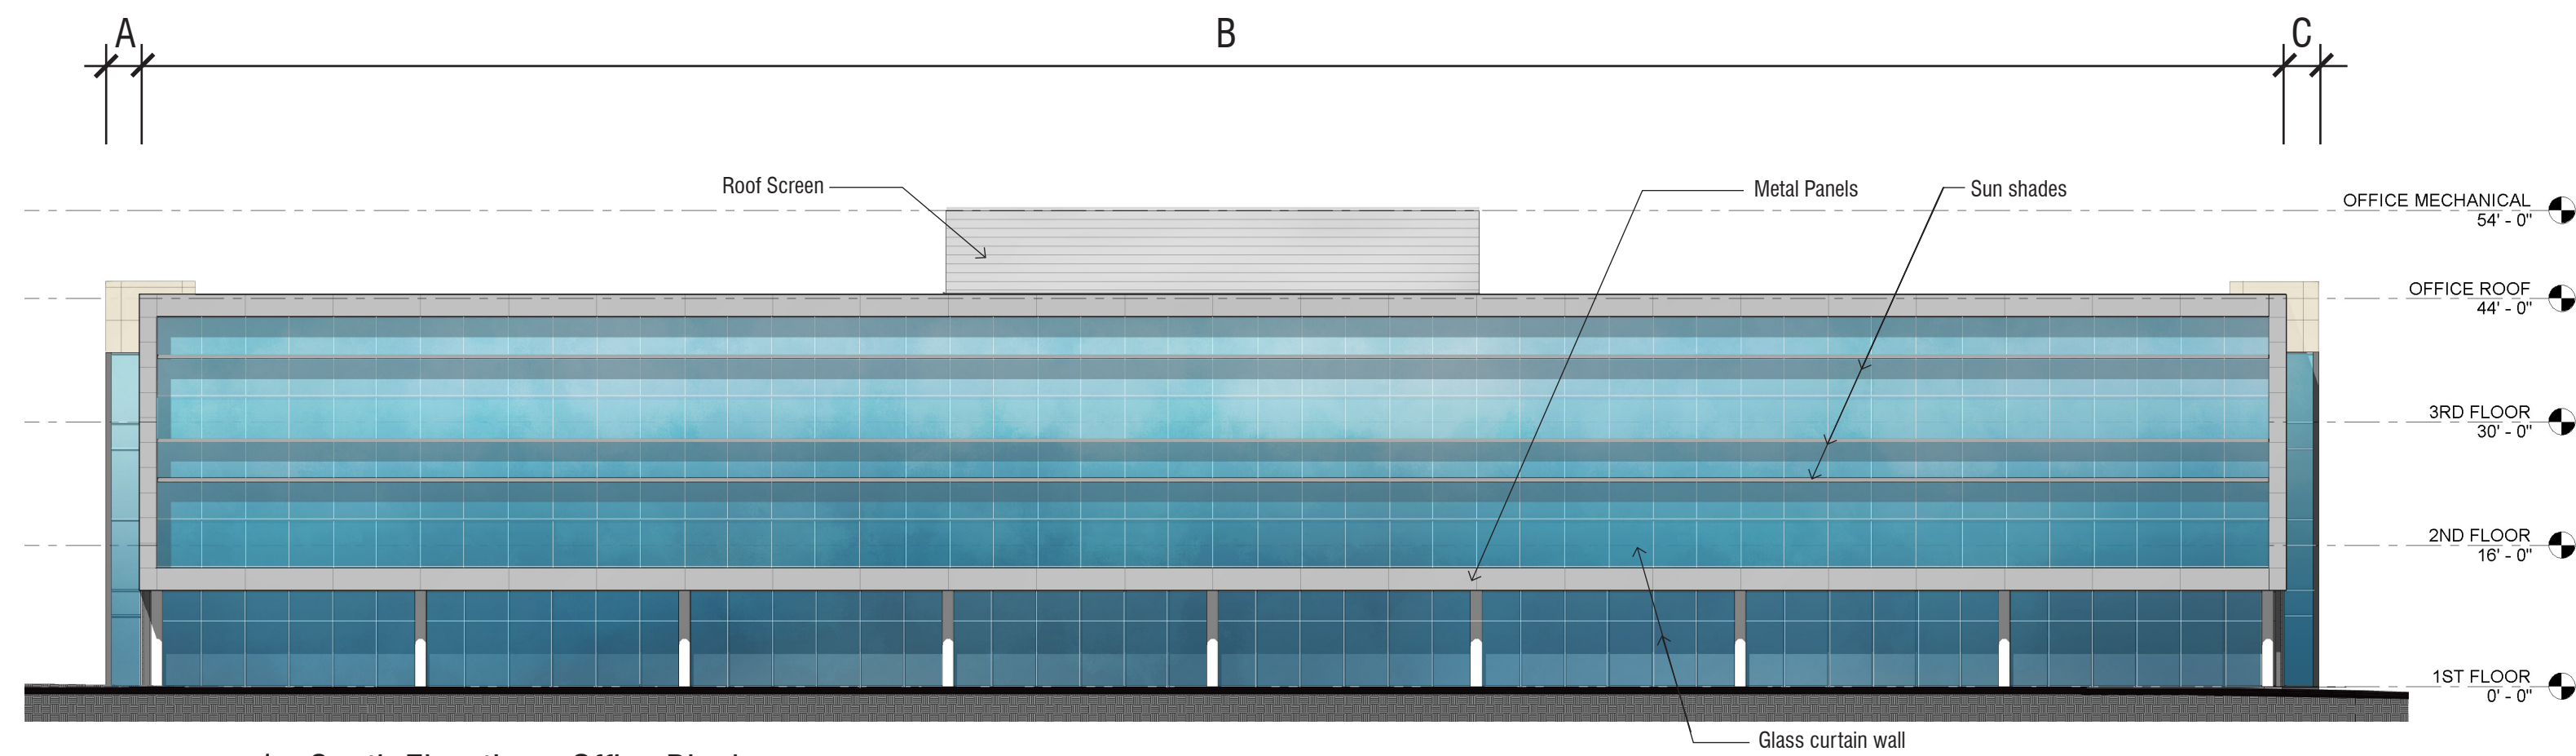
1 - South Elevation - Office Block

**South Elevation - Office Block**

Material	Area (sf)	%
<b>A Façade</b>		
Glass curtain wall	138	78%
Limestone	39	22%
<b>B Façade</b>		
Glass curtain wall	9515	83%
Metal panels	1334	12%
Metal roof screen	592	5%
<b>C Façade</b>		
Glass curtain wall	138	78%
Limestone	39	22%

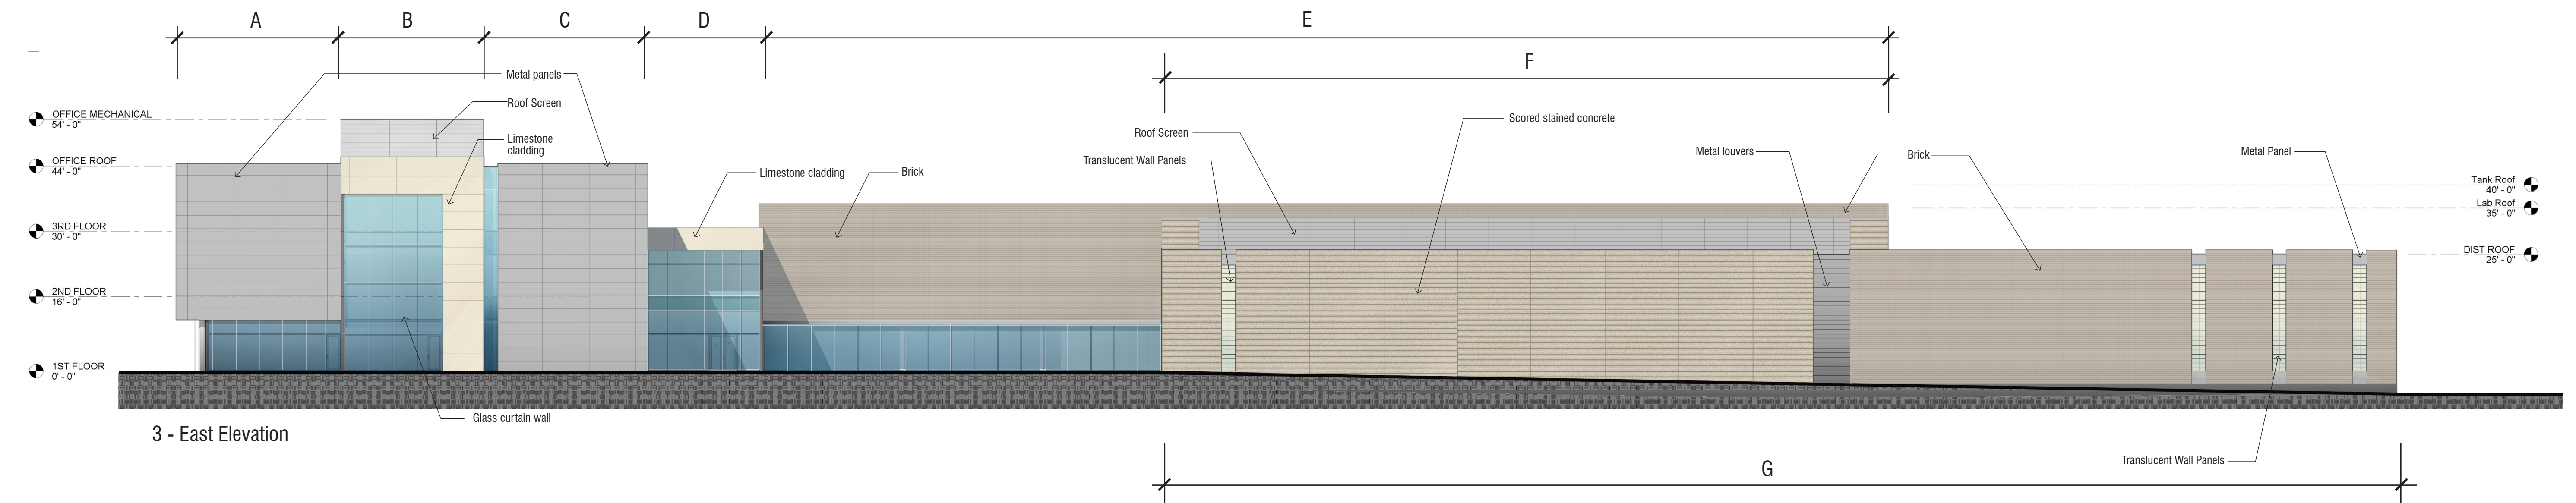
3 - East Elevation

**East Elevation**

Material	Area (sf)	%
<b>A Façade</b>		
Metal panels	1184	79%
Glass curtain wall	310	21%
<b>B Façade</b>		
Limestone	607	34%
Glass curtain wall	857	49%
Metal roof screen	300	17%
<b>C Façade</b>		
Metal panels	1402	92%
Glass curtain wall	127	8%
<b>D Façade</b>		
Limestone	197	21%
Glass curtain wall	735	79%
<b>E Façade</b>		
Brick	7300	89%
Glass curtain wall	857	11%
<b>F Façade</b>		
Scored stained concrete	146	11%
Metal roof screen	1193	89%
<b>G Façade</b>		
Scored stained concrete	3488	48%
Metal louvers	223	3%
Glass curtain wall	336	5%
Brick	3290	45%
Metal Panels	68	1%

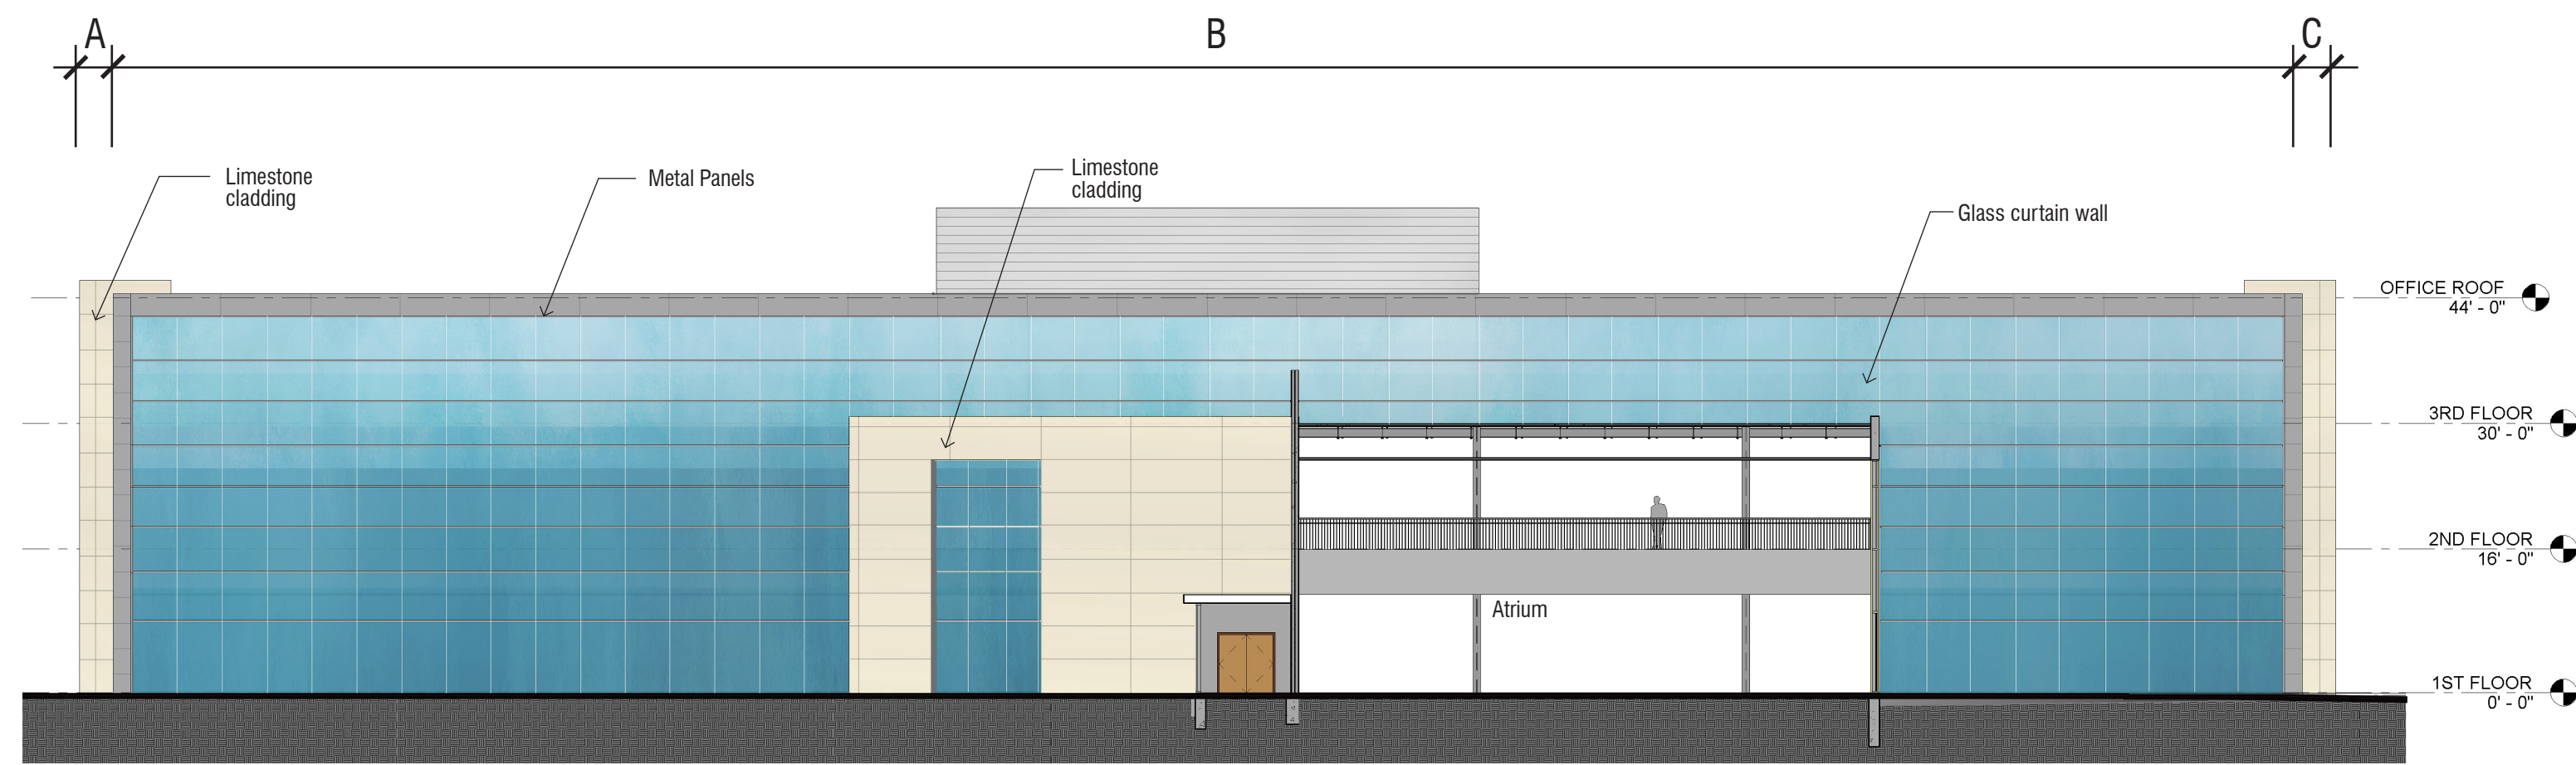
4 - North Elevation - Office Block

**North Elevation - Office Block**

Material	Area (sf)	%
<b>A Façade</b>		
Limestone	238	100%
<b>B Façade</b>		
Glass curtain wall	6597	71%
Limestone	1265	14%
Metal panels	779	8%
Metal roof screen	593	6%
<b>C Façade</b>		
Limestone	238	100%

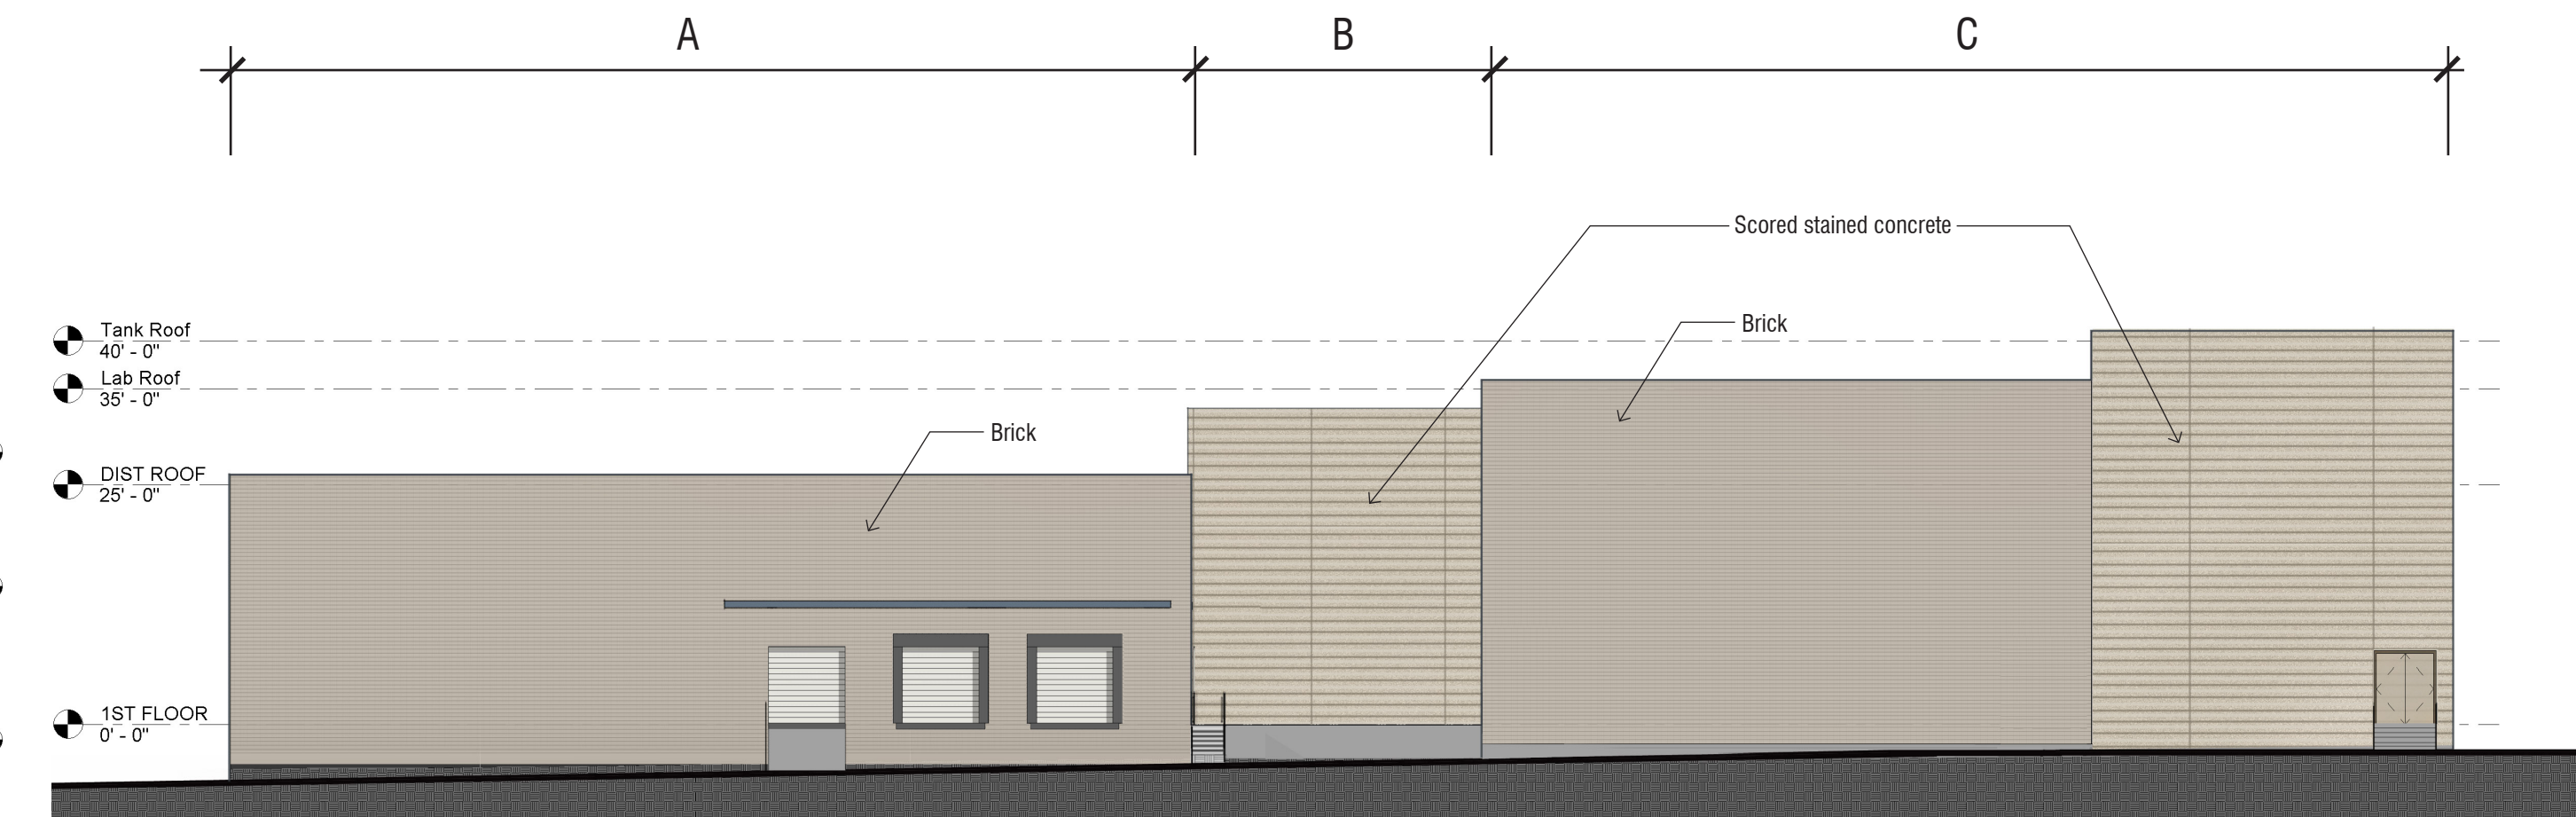
5 - North Elevation - Lab - Distribution Block

**North Elevation - Lab - Distribution Block**

Material	Area (sf)	%
<b>A Façade</b>		
Brick	2867	100%
<b>B Façade</b>		
Scored stained concrete	1323	100%
<b>C Façade</b>		
Scored stained concrete	1474	38%
Brick	2388	62%

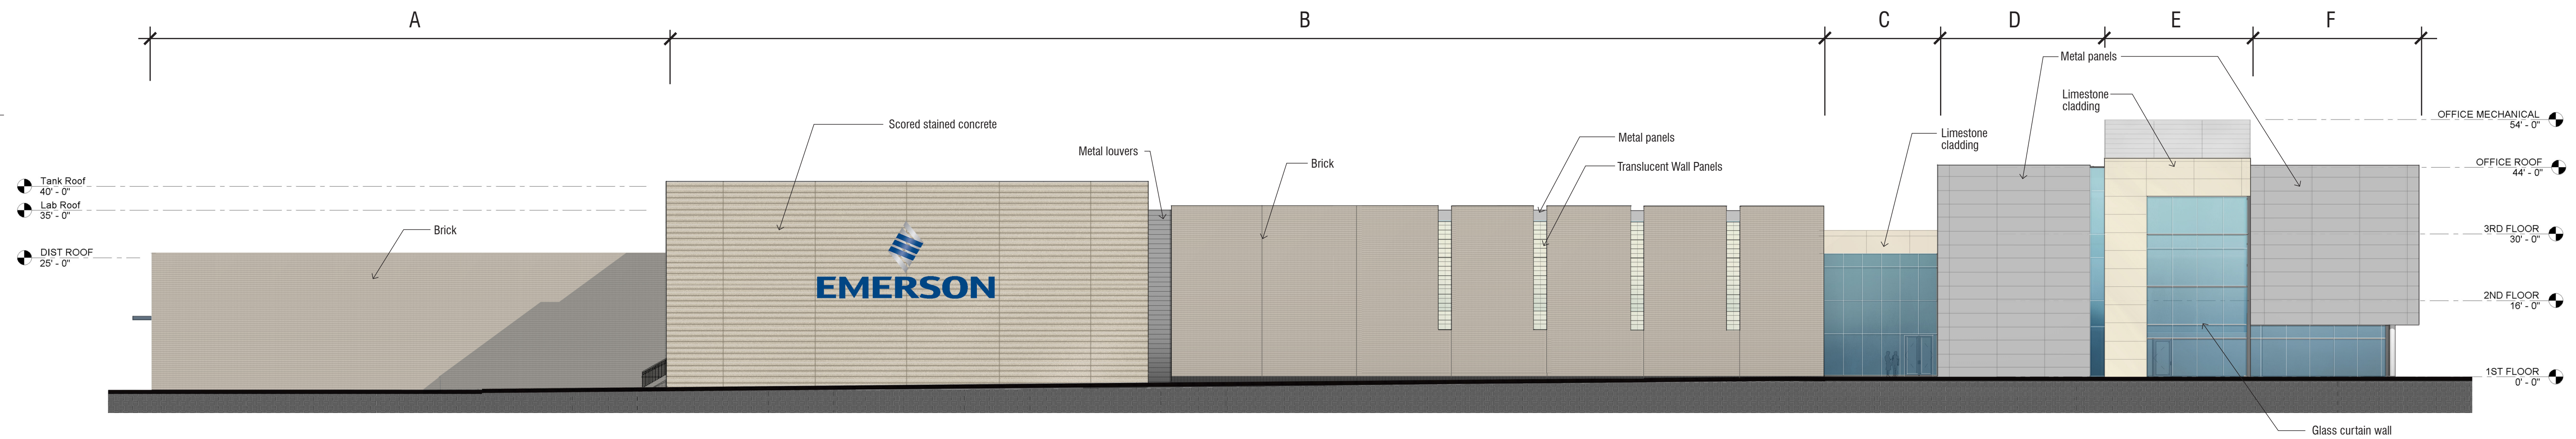
6 - West Elevation

**West Elevation**

Material	Area (sf)	%
<b>A Façade</b>		
Brick	3210	100%
<b>B Façade</b>		
Scored stained concrete	4364	44%
Metal louvers	177	2%
Brick	5007	51%
Translucent wall panels	302	3%
Metal	68	1%
<b>C Façade</b>		
Limestone	135	16%
Glass curtain wall	712	84%
<b>D Façade</b>		
Metal panels	1402	92%
Glass curtain wall	127	8%
<b>E Façade</b>		
Limestone	607	34%
Glass curtain wall	857	49%
Metal roof screen	300	17%
<b>F Façade</b>		
Metal panels	1184	79%
Glass curtain wall	310	21%
