HAYHURST BROTHERS
 1305 10th Street Bridgeport, TX 77642
 940-368-3771

Exterior Elevations

A-6

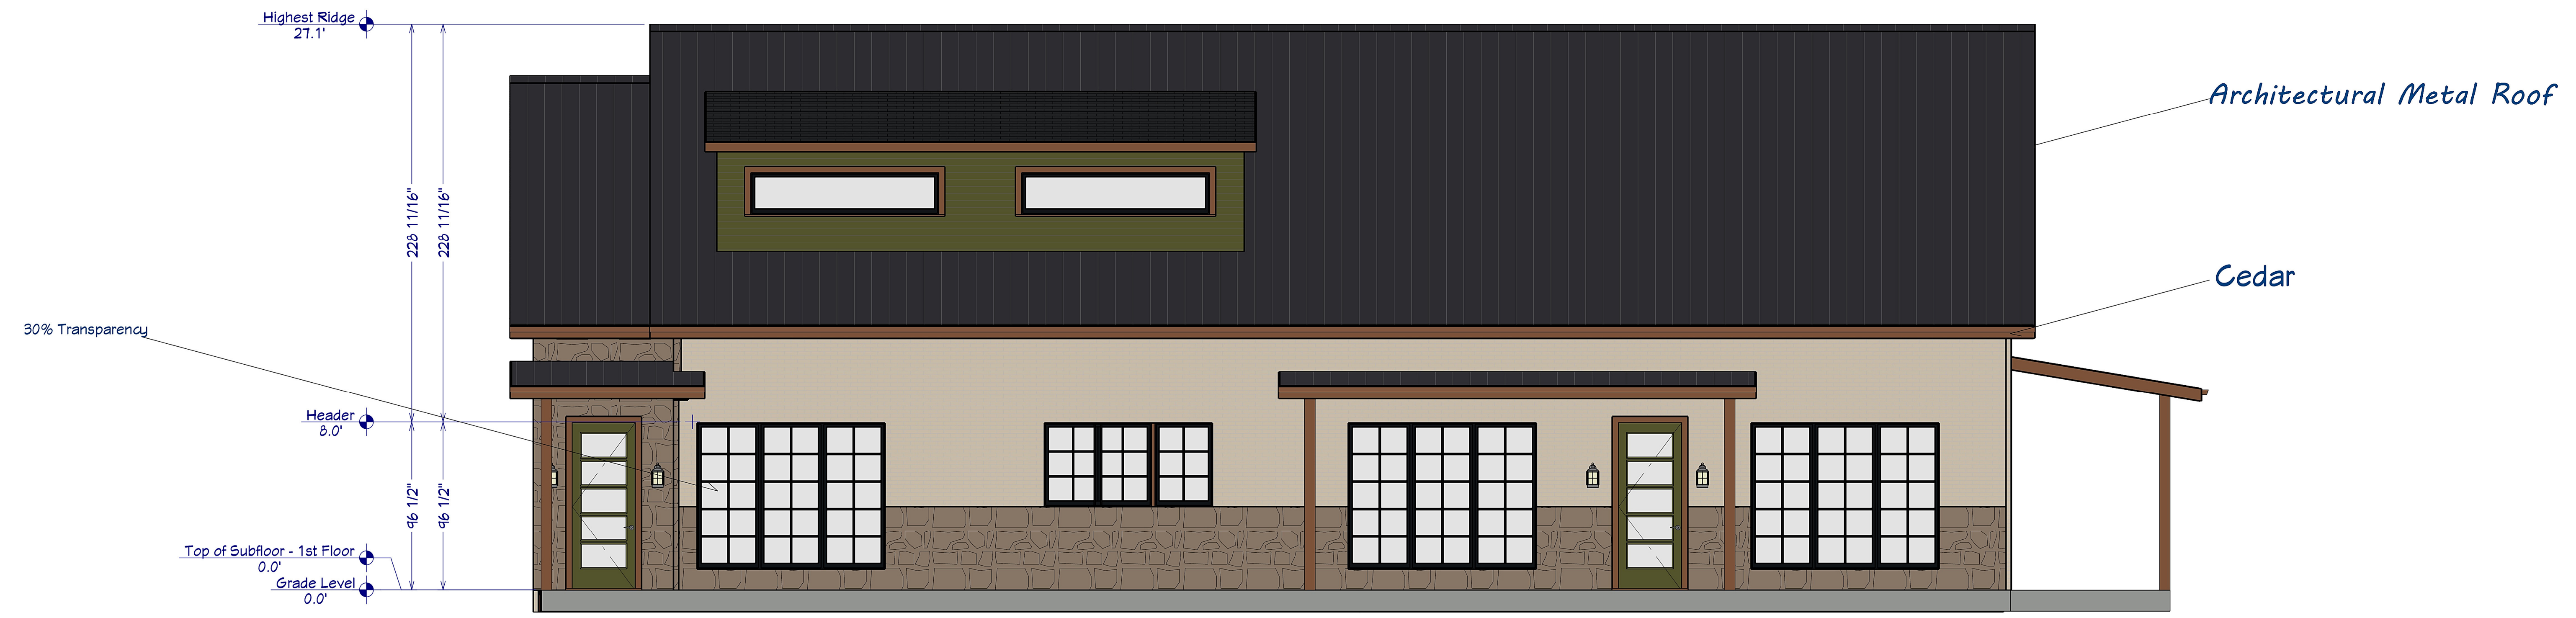
North Facade Material Percentage	%
Rock.....	.33
Brick.....	.52
Fiber Cement Lap Siding.....	.15
East Facade Material Percentage	%
Rock.....	.21
Brick.....	.73
Fiber Cement Lap Siding.....	.6
West Facade Material Percentage	%
Rock.....	.0
Brick.....	.94
Fiber Cement Lap Siding.....	.6
South Facade Material Percentage	%
Rock.....	.0
Brick.....	.100
Fiber Cement Lap Siding.....	.0
