RE: Letter of Intent for Certificate of Appropriateness Application – 311 S Kentucky St,  
McKinney, Texas 75069

Reference: Field Observation Report

Address: 311 S. Kentucky St.  
McKinney, Texas 75069

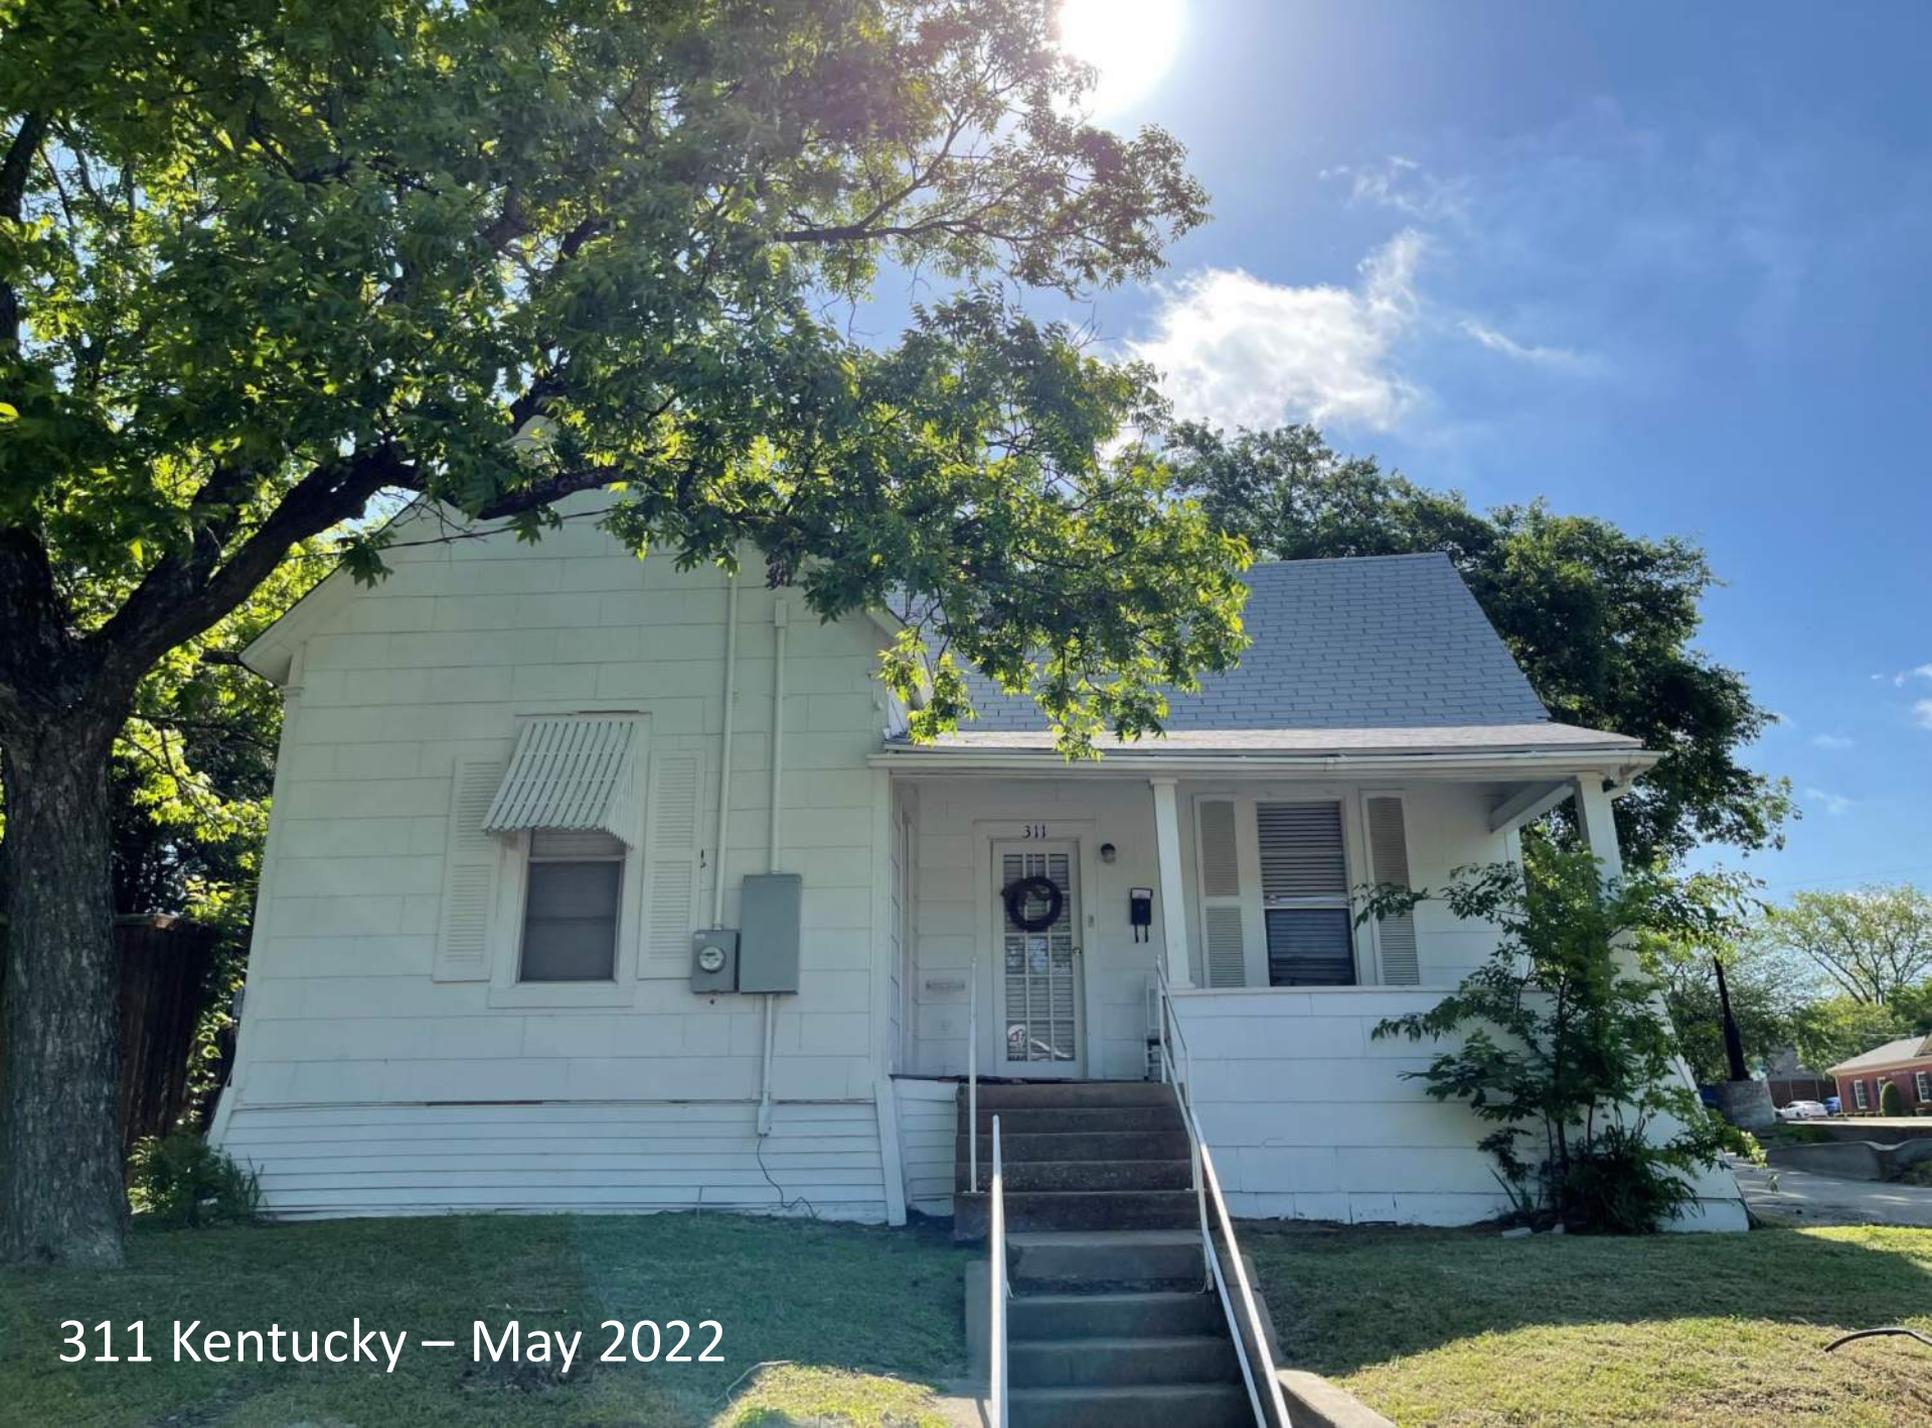
311 Kentucky – May 2022

The current condition of the Residence is fair (exterior photos included in COA application) and we are not requesting any changes to the architectural features of the Residence as part of the COA.

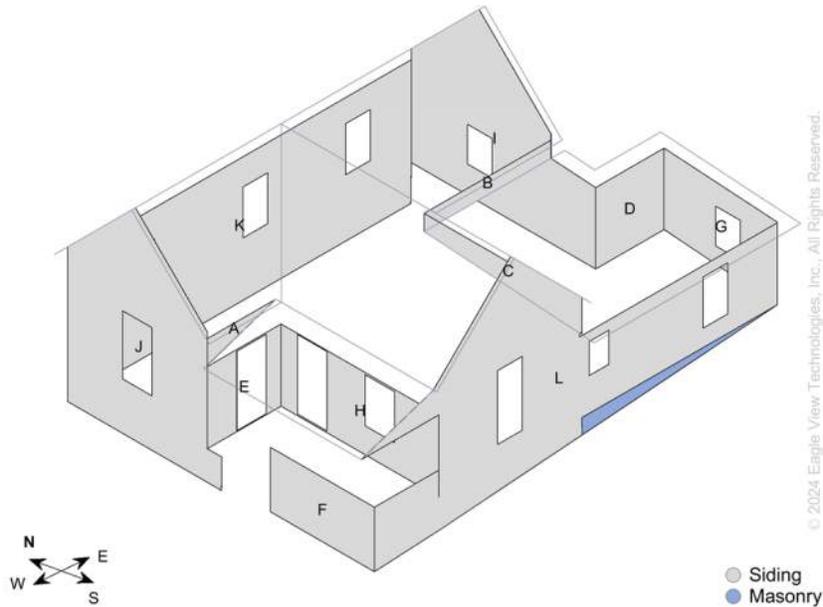
## WALL AREA DIAGRAM

Wall	Siding Wall Area (ft <sup>2</sup> )	Masonry Wall Area (ft <sup>2</sup> )
D	49.7	0.0
K	406.7	0.0
<b>Total</b>	<b>456.4</b>	<b>0.0</b>

Wall	Siding Wall Area (ft <sup>2</sup> )	Masonry Wall Area (ft <sup>2</sup> )
I	213.9	0.0
G	74.1	0.0
C	34.1	0.0
<b>Total</b>	<b>322.1</b>	<b>0.0</b>

Wall	Siding Wall Area (ft <sup>2</sup> )	Masonry Wall Area (ft <sup>2</sup> )
B	20.5	0.0
A	8.1	0.0
E	33.1	0.0
L	392.3	15.2
<b>Total</b>	<b>454.0</b>	<b>15.2</b>

Wall	Siding Wall Area (ft <sup>2</sup> )	Masonry Wall Area (ft <sup>2</sup> )
F	59.8	0.0
H	81.2	0.0
J	226.6	0.0
<b>Total</b>	<b>367.6</b>	<b>0.0</b>

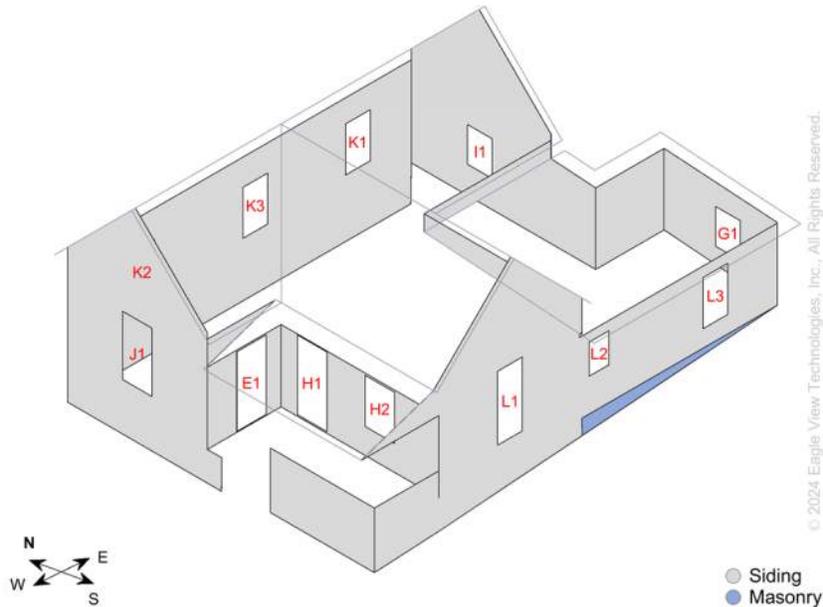
## WINDOW & DOOR DIAGRAM

Note: Window & door measurements include trim.

Window/Door	Area (ft <sup>2</sup> )	Perimeter (ft)	Dimensions W x H (ft)
K1	11.3	14.0	2.5 x 4.5
K2	11.3	14.0	2.5 x 4.5
K3	11.2	14.0	2.5 x 4.5
<b>Total</b>	<b>33.8</b>	<b>42.0</b>	<b>n/a</b>

Window/Door	Area (ft <sup>2</sup> )	Perimeter (ft)	Dimensions W x H (ft)
G1	8.8	12.0	2.5 x 3.5
I1	8.8	12.0	2.5 x 3.5
<b>Total</b>	<b>17.6</b>	<b>24.0</b>	<b>n/a</b>

Window/Door	Area (ft <sup>2</sup> )	Perimeter (ft)	Dimensions W x H (ft)
E1	21.0	20.0	3.0 x 7.0
L1	16.3	18.0	2.5 x 6.5
L2	6.0	10.0	2.0 x 3.0
L3	11.2	14.0	2.5 x 4.5
<b>Total</b>	<b>54.5</b>	<b>62.0</b>	<b>n/a</b>

Window/Door	Area (ft <sup>2</sup> )	Perimeter (ft)	Dimensions W x H (ft)
H1	21.0	20.0	3.0 x 7.0
H2	13.5	15.0	3.0 x 4.5
J1	18.0	18.0	3.0 x 6.0
<b>Total</b>	<b>52.5</b>	<b>53.0</b>	<b>n/a</b>

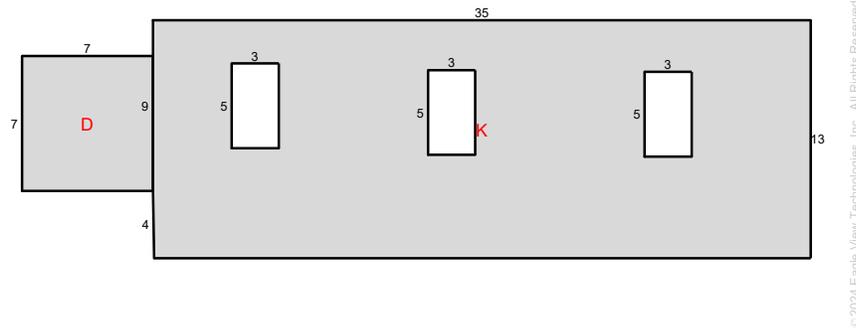
# NORTH ELEVATION DIAGRAM

Top of Siding Walls = 41.8 ft  
 Bottom of Siding Walls = 41.7 ft

Wall	Siding Wall Area (ft <sup>2</sup> )	Masonry Wall Area (ft <sup>2</sup> )	Window & Door Area (ft <sup>2</sup> )	Window & Door Perimeter (ft)	Window & Door Count
D	49.7	0.0	0	0	0
K	406.7	0.0	33.8	42.0	3
<b>Total</b>	<b>456.4</b>	<b>0.0</b>	<b>33.8</b>	<b>42.0</b>	<b>3</b>

**Note: On-site verification of yellow shaded areas is needed. Details are on the Wall Measurement Summary Page.** This diagram shows segment lengths rounded to the nearest whole number. The window & door and wall area in square feet (rounded to the nearest tenth) is based on the actual (non-rounded) value of each segment length.

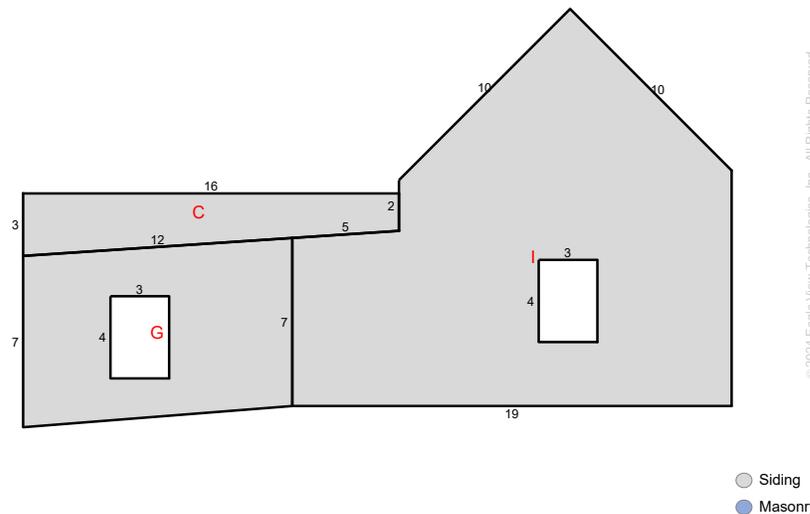
# EAST ELEVATION DIAGRAM

Top of Siding Walls = 52.1 ft  
 Bottom of Siding Walls = 46.2 ft

Wall	Siding Wall Area (ft <sup>2</sup> )	Masonry Wall Area (ft <sup>2</sup> )	Window & Door Area (ft <sup>2</sup> )	Window & Door Perimeter (ft)	Window & Door Count
I	213.9	0.0	8.8	12.0	1
G	74.1	0.0	8.8	12.0	1
C	34.1	0.0	0	0	0
<b>Total</b>	<b>322.1</b>	<b>0.0</b>	<b>17.6</b>	<b>24.0</b>	<b>2</b>

**Note: On-site verification of yellow shaded areas is needed. Details are on the Wall Measurement Summary Page.** This diagram shows segment lengths rounded to the nearest whole number. The window & door and wall area in square feet (rounded to the nearest tenth) is based on the actual (non-rounded) value of each segment length.

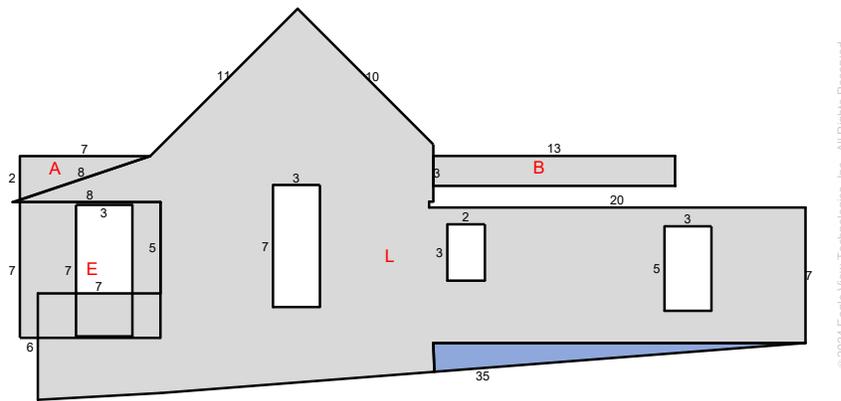
## SOUTH ELEVATION DIAGRAM

Top of Siding Walls = 83.3 ft  
 Bottom of Siding Walls = 76.6 ft

Wall	Siding Wall Area (ft <sup>2</sup> )	Masonry Wall Area (ft <sup>2</sup> )	Window & Door Area (ft <sup>2</sup> )	Window & Door Perimeter (ft)	Window & Door Count
B	20.5	0.0	0	0	0
A	8.1	0.0	0	0	0
E	33.1	0.0	21.0	20.0	1
L	392.3	15.2	33.5	42.0	3
<b>Total</b>	<b>454.0</b>	<b>15.2</b>	<b>54.5</b>	<b>62.0</b>	<b>4</b>

**Note: On-site verification of yellow shaded areas is needed. Details are on the Wall Measurement Summary Page.** This diagram shows segment lengths rounded to the nearest whole number. The window & door and wall area in square feet (rounded to the nearest tenth) is based on the actual (non-rounded) value of each segment length.

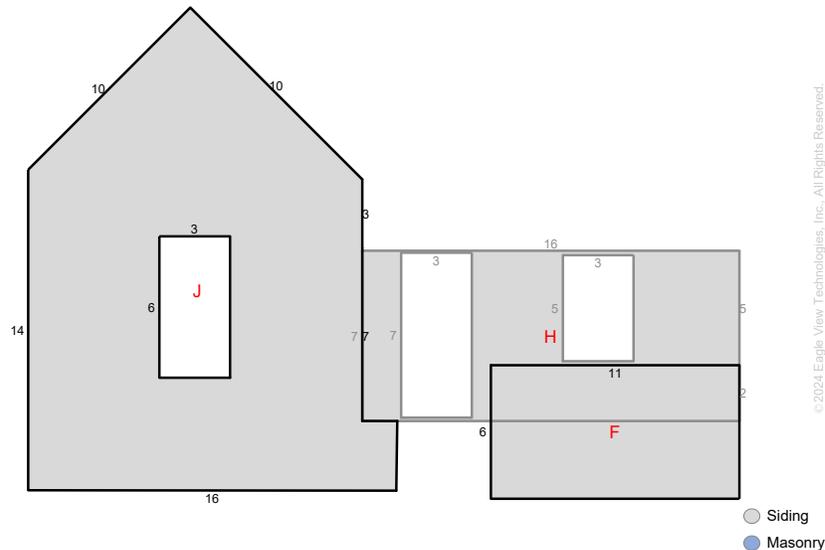
# WEST ELEVATION DIAGRAM

Top of Siding Walls = 48.1 ft  
 Bottom of Siding Walls = 42.1 ft

Wall	Siding Wall Area (ft <sup>2</sup> )	Masonry Wall Area (ft <sup>2</sup> )	Window & Door Area (ft <sup>2</sup> )	Window & Door Perimeter (ft)	Window & Door Count
F	59.8	0.0	0	0	0
H	81.2	0.0	34.5	35.0	2
J	226.6	0.0	18.0	18.0	1
<b>Total</b>	<b>367.6</b>	<b>0.0</b>	<b>52.5</b>	<b>53.0</b>	<b>3</b>

**Note: On-site verification of yellow shaded areas is needed. Details are on the Wall Measurement Summary Page.** This diagram shows segment lengths rounded to the nearest whole number. The window & door and wall area in square feet (rounded to the nearest tenth) is based on the actual (non-rounded) value of each segment length.
