# PROPERTY INSPECTION REPORT

**110 E Davis St**  
**Inspection Prepared For: The Parks Church**  
**Agent:**

**Date of Inspection: 3/11/2024**  
**Age of House: 110 Years, Size: 4,400 SF**  
**Weather: Cloudy/Rain, 50-60 Degrees**

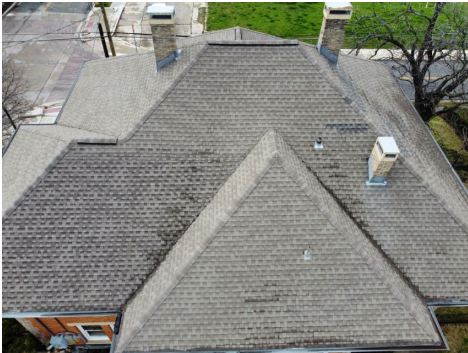
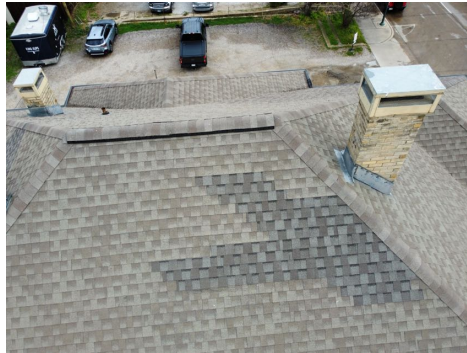
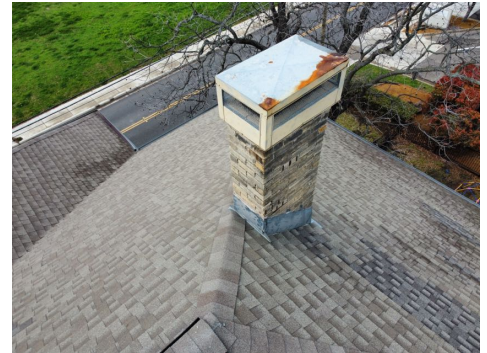
Previous repairs to roofing materials

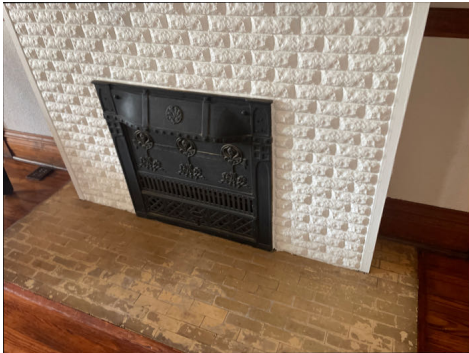
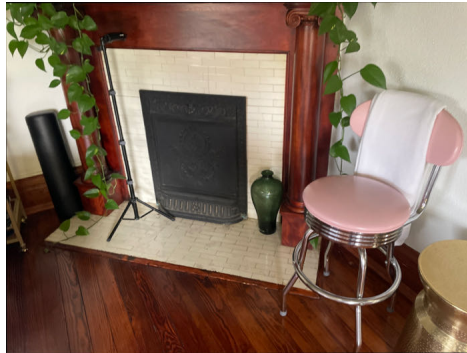
Attic: Chimney terminated
